STANISŁAW BARYCZ*, KAROL FIREK*, WOJCIECH KOCOT*,
AGNIESZKA MALINOWSKA*

**THE EFFECT OF PREVENTIVE CONSERVATION MEASURES ON THE TECHNICAL CONDITION OF
A RELIGIOUS BUILDING LOCATED IN THE MINING AREA**

* AGH UNIVERSITY OF SCIENCE AND TECHNOLOGY, AL. A. MICKIEWICZA 30, 30-059 KRAKÓW, POLAND

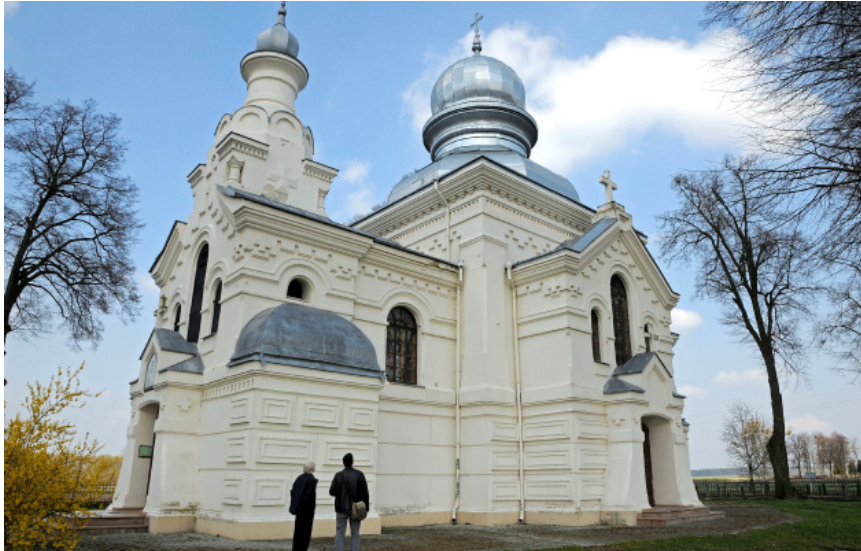
Fig. 6. The Orthodox Church in Dratów (as of 2014), the view from the south.
 Source: Own study

There were no cracks found in the facade, which was renovated after the completion of the preventive conservation works. Few scratches of the window lintels, occurring before the renovation, did not renew themselves. The only damage, currently visible from the outside, are local shrinkage scratches of the plaster of irregular course, as well as local dampness and corrosion of the plaster caused by inaccurate performance of roofing and flashing works. The overall condition of the object was assessed as fair (in a 6-point scale – Wodyński, 2007).

All the conservation works were carried out in late 2002 and early 2003, based on the technical project (Szczeplaniak and Wach, 2002), prepared pursuant to the concept presented in (Barycz et al., 2002). After the completion of the works, a thorough renovation of the facade of the building was carried out, together with replacement of the roofing, guttering and flashing (Fig. 6).
