Effect of fatigue behaviour on fracture in the 4th gear of a pick-up truck

P. Janmanee, R. Saodaen, C. Thanadngarn, T. Kumnorkaew,
K. Jamkamon, K. Utjimajiratthitikarn *

Purpose: This paper aims to investigate the effect of fatigue behaviour on fracture in the 4th gear (helical gear) of a pick-up truck.

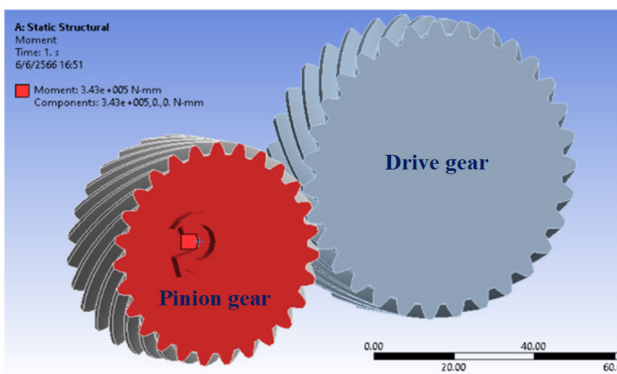
Fig. 3. FE model of the pinion gear and drive gear set

For the simulation setup, the positions of the pinion gear (red-highlighted area) and drive gear set were defined according to Figure 3. It was assumed that the gears worked under the maximum loading condition. However, based on the actual working conditions, the power of about 144 kW was required for a pick-up truck with a power transmission of 3400 rpm. A pick-up truck power and transmission ratio were also considered to calculate the acting moment on the gears. Boundary conditions, such as power, speed, torque, and elastic coefficient, were set according to 343 N-m load. Ultimately, details regarding the dimensions of the gear tooth and the applicable boundary conditions are documented in Table 2.

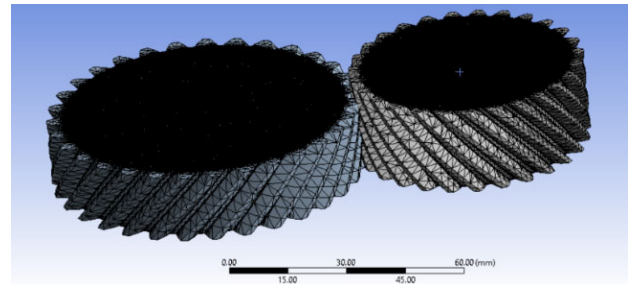
Fig. 4. FE meshing using tetrahedral elements

Furthermore, FE mesh was generated using tetrahedral elements, as shown in Figure 4. The total number of elements was 635,878, with 1,008,839 nodes. Degrees of Freedom (DOF), only x, y, and z axes, were applied for mesh

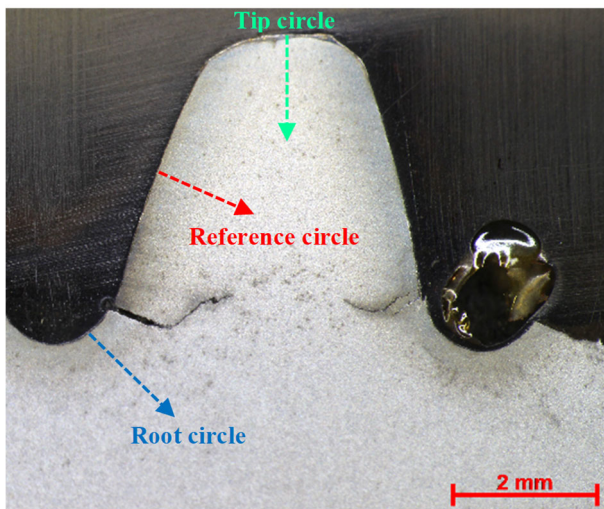
Fig. 10. Hardness measured areas on the failed helical gear

According to Figure 10, hardnesses were measured along three cross-sectional areas: the tip circle (green arrow), reference circle (red arrow), and root circle (blue arrow). The hardness distribution profiles obtained across these areas are displayed in Figure 11.
