## **STRUCTURE STUDIES OF POROUS OXIDE LAYERS FORMED ON 13CrMo4-5 STEELS LONG-TERM OPERATED IN THE POWER INDUSTRY**

*Monika Gwoździk*

The paper contains results of studies on the formation of oxide layers on 13CrMo4-5 steel long-term operated at an elevated temperature. The material studied comprised specimens of 13CrMo4-5 steel operated at the temperature of 455°C during 130,000 hours (steel 1) and 540°C during 120,000 hours (steel 2). The oxide layer was studied on a surface and a cross-section at the outer surface of the tube wall. The paper contains results of studies of porosity in the oxide layer. The oxide layer formed on the studied steel 1 is ~146 μm thick, while on the steel 2 ~248 μm. It has been found that steel 2 has higher porosity.

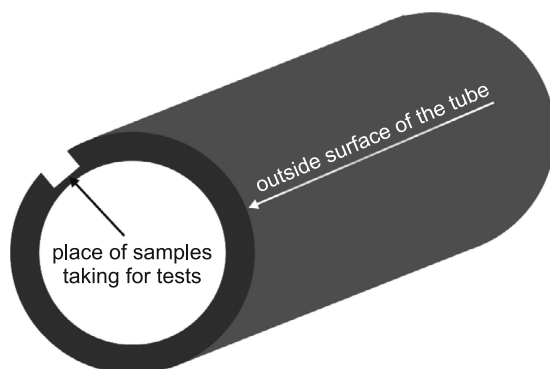
The oxide layer was studied on a surface and a cross-section at the outer surface of the tube wall (Fig. 1).

Fig. 1. Place of samples taking for tests
