## Analysis of damage to medium and low voltage cable lines in tram traction stations – maintenance experience

Andrzej Adamkiewicz<sup>1</sup>, Mariusz Haraburda<sup>2</sup>

<sup>1</sup> Maritime University of Szczecin, Faculty of Mechanical Engineering  
Diagnostics and Machine Repairs Department  
70-205 Szczecin, ul. Podgórna 51/53, e-mail: a.adamkiewicz@am.szczecin.pl

<sup>2</sup> Trams Szczecin Ltd.  
ul. Klonowica 5, 71-241 Szczecin, e-mail: marhar@ts.szczecin.pl

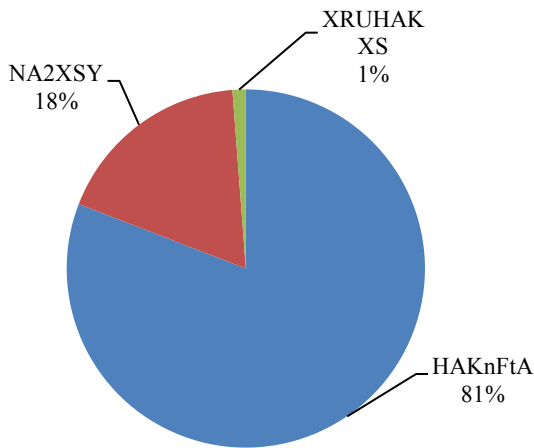
In the case of the MP cables, the HAKnFtA type, also called the traditional one, is the oldest solution and it is not used when cable lines are modernized or when new ones are built, however in the discussed examples they comprise a decisive part of the network. The participation of particular cables in the power system of a substation is shown in the pie diagram presented in figure 1.

Fig. 1. Percentage participation of MP type cables used for supplying traction substations

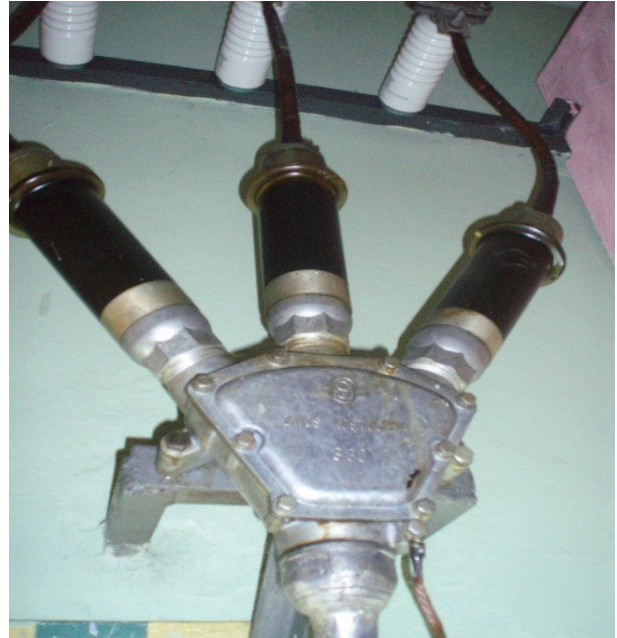
The oldest cables of this type were placed in the first half of the seventies. At their ends cable heads were mounted. Figure 2 shows an example of a cable head construction.

Fig. 2. View of a cable head of the 3GOw type

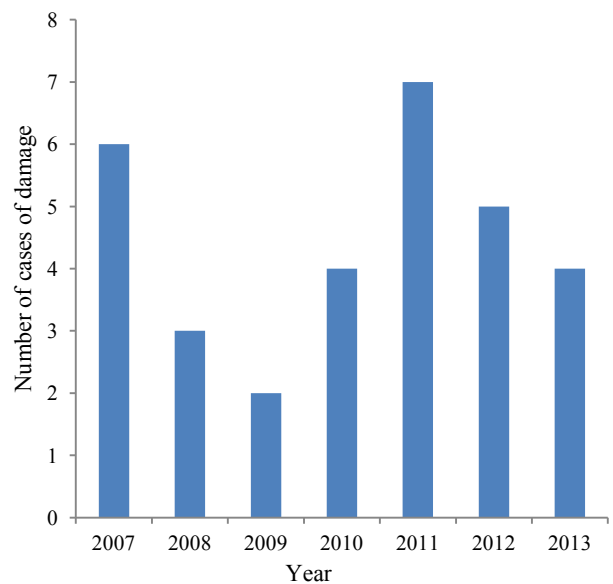
Figure 3 presents a bar graph showing the number of cases of damage to MP cable lines, supplying tram traction substations, which occurred in the period 2007–2013. Traditionally, there are not more than a few cases of damage in a year.

Fig. 3. The number of cases of damage to MP cables in the period 2007–2013

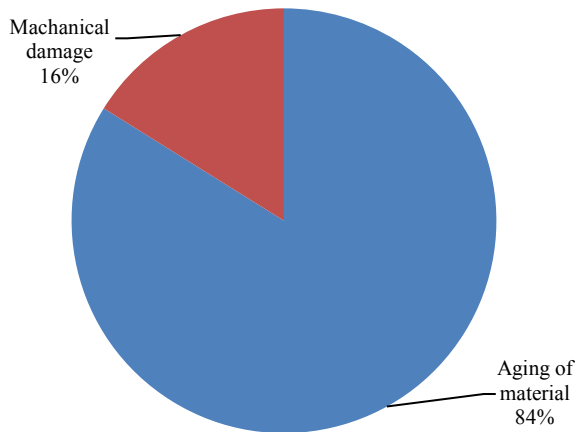
Figure 4 showing percentage participation of different causes of damage to MP cable lines in the years 2007–2013 is a statistical confirmation of the fact that in most cases damage is due to the aging of insulation material. It leads to a conclusion that the lines are to a certain extent worn out and that they were constructed without maintaining proper technological culture (rushing, stretching of the cables by lorries – stretching cable cores and inaccuracies at muff construction) [3, 7].

Fig. 4. Percentage participation of MP cable damage causes in the period 2007–2013

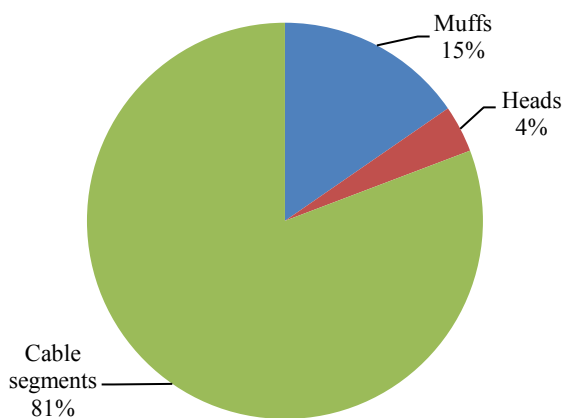
Cable damage may result from degradation of condition of cable muffs, cable heads or segments of cables. The pie diagram in figure 5 presents percentage participation of different locations of damage.

Fig. 5. Percentage participation of location of MP cable damage connected with material aging in the period 2007–2013

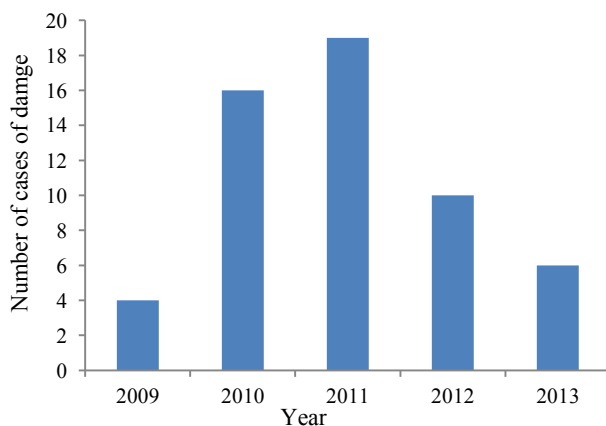
The number of cases of traction cables damage in the period 2009–2013 is shown in figure 8.

Fig. 8. Number of cases of traction cable damage in the years 2009–2013

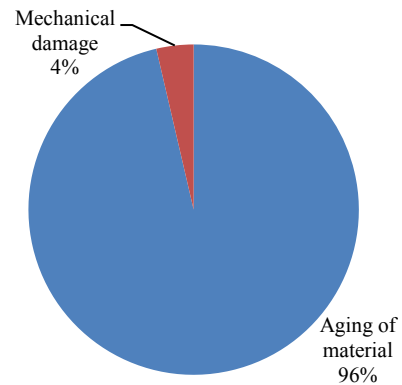
Aging process is the common cause of power cable damage. The other ones occur at earth works (usually because of excavators) when construction works are carried out in highly urbanized areas. Figure 9 presents the causes of traction cable damage in percentages.

Fig. 9. Causes of traction cable damage in the period of 2009–2013 in percentages
