## **Study of the Outflow Conditions of the Weir Skoki on the Paklica River**

## Abstract

The paper presents an assessment analysis of the flow capacity of the barrage on the Paklica river. The analysed barrage consists of a mill weir and bottom outlets, and is supplied with water from Bukowiecki Lake. The reasons for addressing this subject matter were: from the need to determine the technical condition as well as the ecological condition of the lower position. The environmental status of the area below the system was considered as equally important. Field research included photographic documentation of the technical condition of the weir, taking into account the state below and above the structure, its abutments and the threshold. Additionally, there were made velocity

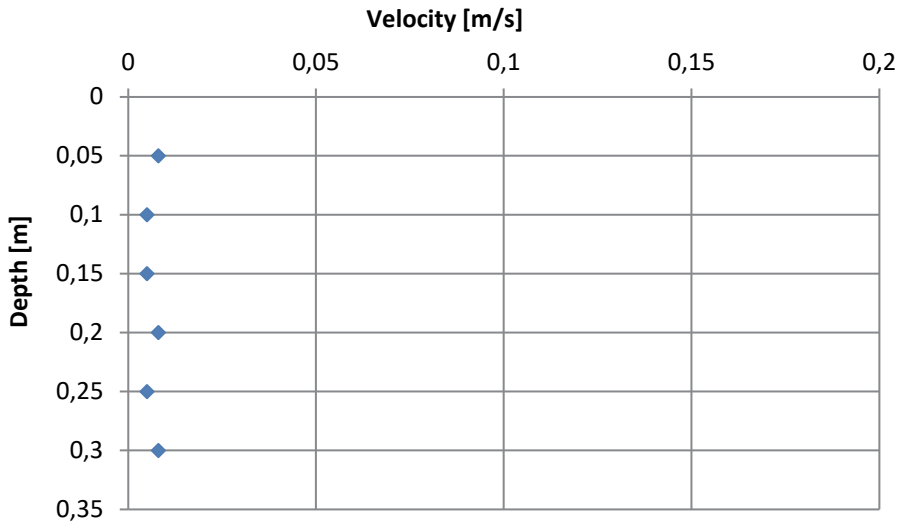
**Fig. 5.** Vertical velocities distribution in axis of cross-section 3 on the Paklica River

Velocity distributions in the central part of the cross-section (Fig. 5) were characterised by a low value of water flow rate resulting from a small depth of the riverbed and a specific location. Velocity values in the hydrometric vertical did not exceed 0.1 m/s.

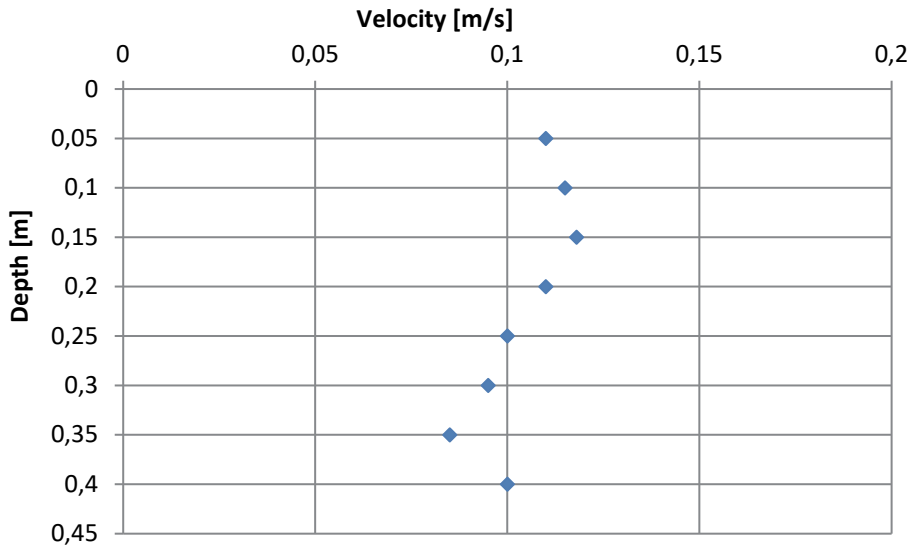
Fig. 6. Vertical velocities distribution in axis of cross-section 4 on the Paklica River

However, an increase in velocity by almost 100% was observed in cross-section 4 (Fig. 6), which was located in the inflow channel where there is a fish trap. The lowest average velocity was measured at a depth of 0.35 m, and the highest 0.1 m from the bottom.

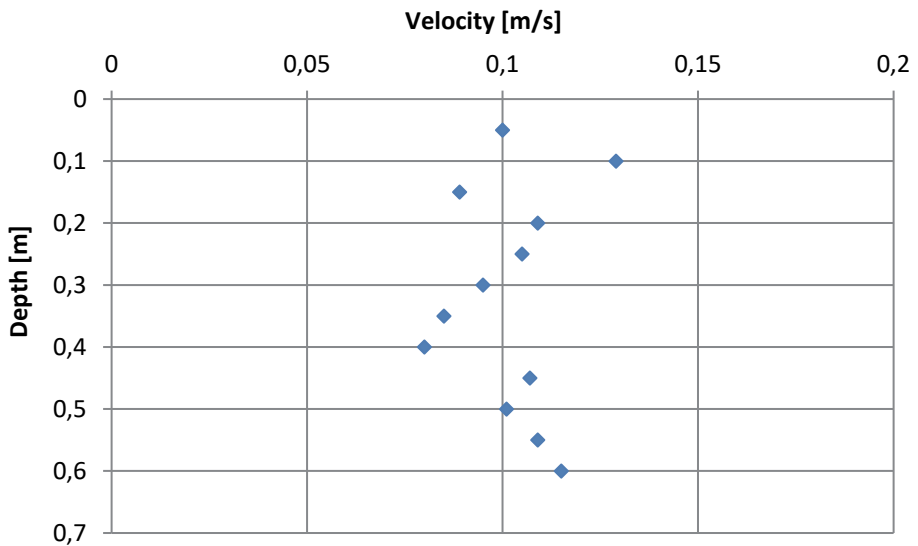
Fig. 7. Vertical velocities distribution 2 m from BL in cross-section 5 on the Paklica River

The average water velocity (approx. 0.1 m/s) was also measured in cross-section 5 (Fig. 7), although the velocities for individual depths varied significantly by up to 0.03 m/s. Variability in velocity values with a simultaneous increase in depth was caused by the location of the cross-section including the connection of the main channel to the inflow channel and the resultant local water accumulation as a direct effect of a large clump of grassy vegetation (Fig. 8).

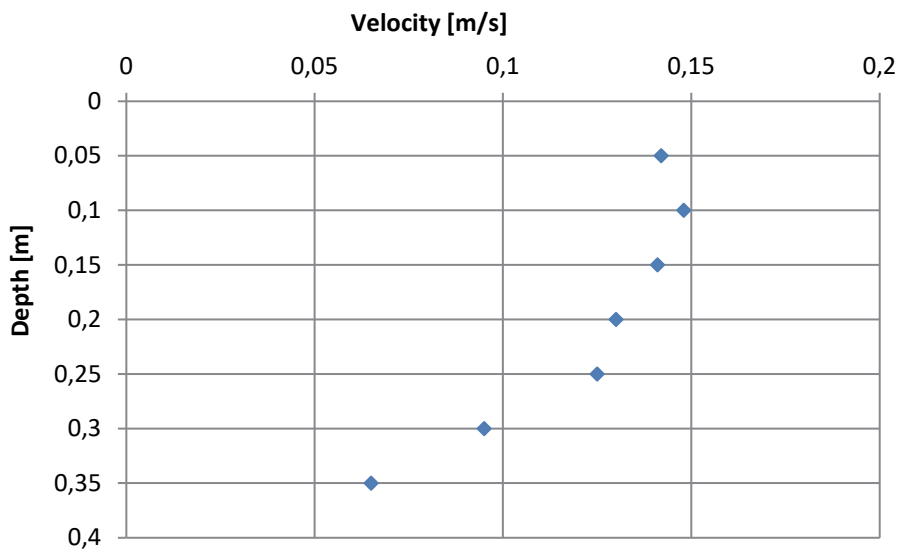
**Fig. 9.** Vertical velocities distribution in axis of cross-section 8 on the Paklica River

The highest average velocity values were measured in the axis of cross-section number P8, which is shown in Figure 9. The location of the measurement cross-section (equal to 10 m) was important here. The area lacks riparian vegetation, and the hydro-technical structure itself is in such a distance that it does not affect flow conditions.
