ANALYSIS OF DAMAGE OF THE COOLING AGGREGATE IN VEHICLE WITH COLD STORAGE CHAMBER

Marek Woźniak, Damian Batory, Krzysztof Siczek

Lodz University of Technology
Department of Vehicles and Fundamentals of Machine Design
Stefanowskiego Street 1/15, 90-924 Lodz, Poland
tel.: +48 42 6312253, +48 42 6312243, +48 42 6312250, fax: +48 42 6312252
e-mail: marek.wozniak@p.lodz.pl, damian.batory@p.lodz.pl, ks670907@p.lodz.pl

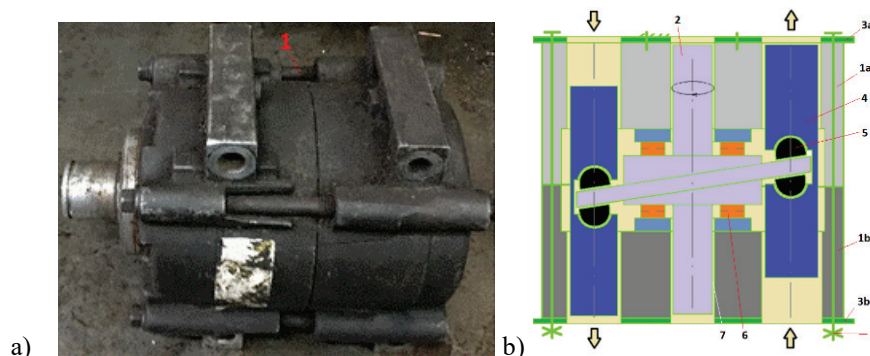
The main assembly of the analysed aggregate was the axial five-piston compressor R57166 (Fig. 1a, b). Some components of the compressor are shown in Fig. 2a. Five small pistons (2) made of aluminium alloy were led, via lubricating rings (7) (surfaces E1), in cylinders (surfaces E2) arranged with the radial pattern in the fixed head (1) made of the other aluminium alloy. It consisted of two almost symmetrical parts. One of them was fixed relative to the compressor housing (Fig. 2b), made of aluminium alloy, through two steel pins. Both parts of the head were connected to the compressor housing by means of four common steel screws (1). Although there existed relatively high normal and friction forces between the front surfaces of head parts (1) (Fig. 2a), small radial displacements of such parts could occur in case of vibrations or loosening of screws.

Fig. 1. a) The axial five piston pump of cooling aggregate compressor R57166, 1 – screw, b) scheme of compressor, 1a, 1b – head components, 2 – shaft with the spatial disc cam, 3a, 3b – compressor body components, 4 – piston, 5 – tappet, 6- needle roller bearing, 7- journal sliding bearing
