Janusz Bialik, Wojciech Ferens, Pascal Troncin
GE Energy Switzerland in Baden, GE Power Sp Z o.o. in Wroclaw, GE France in Belfort

NAPRAWA NA OBIEKCIE POŁĄCZENIA MIĘDZYBIEGUNOWEGO WIRNIKÓW TURBOGENERATORÓW

TURBOGENERATOR FIELD POLE-TO-POLE CONNECTOR IN-SITU REPAIR

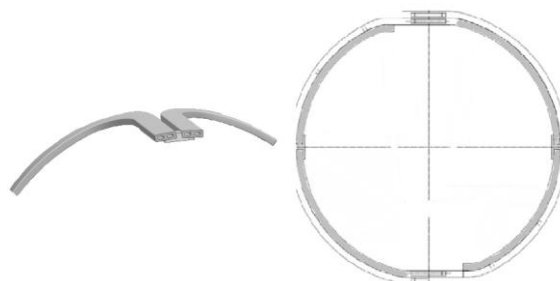
Over the last years, indications have been found on some pole to pole connections of air and hydrogen cooled turbogenerator rotors, both 50Hz and 60Hz. The indications are originating from one of the corners on the T-shaped rotor jumper (Figure 1, Figure 2). Those indications could lead to unit shut down and field windings issues and/ or retaining rings issues together with copper contamination of turbogenerator components. The root cause analysis indicates that low cycle fatigue during start/ stop cycles is the primary root cause mechanism [2].

Fig. 1. Original rotor pole-to-pole connection: T jumper (in the middle) and wishbones

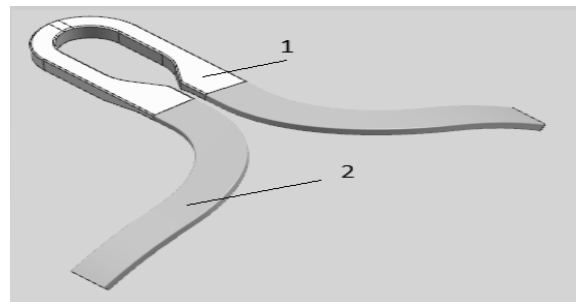
Fig 4. Overview on new rotor connection (3D model) (1) jumper, (2) wishbone arm

Taking into account the above criteria, engineering has developed a solution which does not require unbrazing the original rotor connection. This approach is quite critical as any heat cycle of the rotor might impact the rotor insulation integrity and copper coils properties. Figure 4 represents the proposed upgraded configuration. It consists of three parts: the main connector (jumper) which is brazed to the two wishbone copper connections. The new pole-to-pole connector as a one piece will be brazed only in two points to the existing rotor winding to bypassing the original pole-to-pole connections. No further braze or supports are required, as during operation the centrifugal force will ensure the right radial support. Moreover, adding additional braze points could reduce the flexibility of the repair solution, which might lead to an unplanned outage.

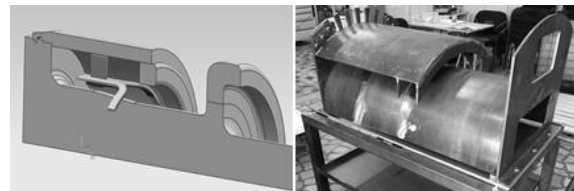
To investigate the possibility of the repair with rotor in-situ, the OEM engineered and built a full scaled rotor mockup. It consists of a rotor body, retaining ring, retaining ring end plate, copper coils, fan hub (fan blades are removed prior repair operation, therefore no need to model them), pole-to-pole connection, all necessary insulation, and clearances. Figure 6 shows the 3D model and the mockup itself.

Fig. 6. Model and mockup of the rotor

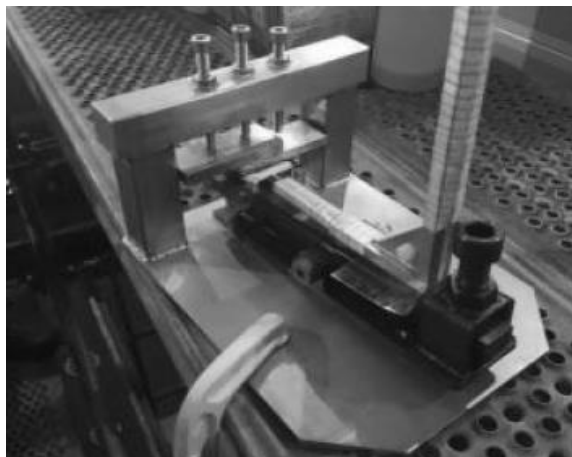
risk of damaging the rotor connection or rotor winding during the brazing process, it is recommended to perform test brazing outside turbogenerator on developed qualification platform (Figure 7).

Fig. 7. Brazing inductor on qualification platform

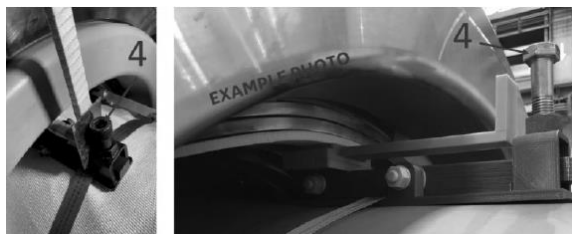
Fig 8. Clamping device (example)

All repair steps must fulfill OEM engineering qualification criteria. The final checks are done with help of the brazing head clamping device (Figure 8).
