## TECHNICAL DIAGNOSTICS OF HYDROPOWER TURBINE USING MODERN MEASUREMENT TECHNIQUES

Grzegorz ŻYWICA<sup>1</sup>, Maciej KANIECKI<sup>2</sup>

### Summary

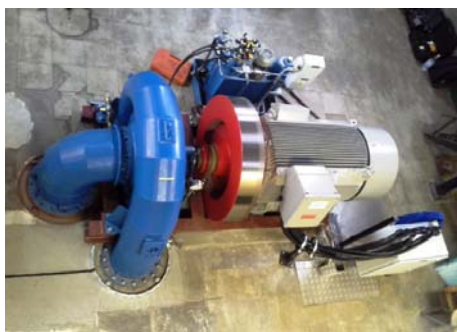
This paper presents the research on the hydro set equipped with a 315 kW generator and Francis turbine, which were conducted in order to find the causes of elevated noise and vibration levels. The consequences of these phenomena were worrying, especially when one notices the continued deterioration of the dynamic performance of the hydro set. Apart from traditional vibration measurements, it was decided to use modern measurement techniques in order to get more information about the observed machine. The authors of this article expected that such an approach will allow to work out the most appropriate solution to the problem identified.

Fig. 1. Picture of the examined turbine set.

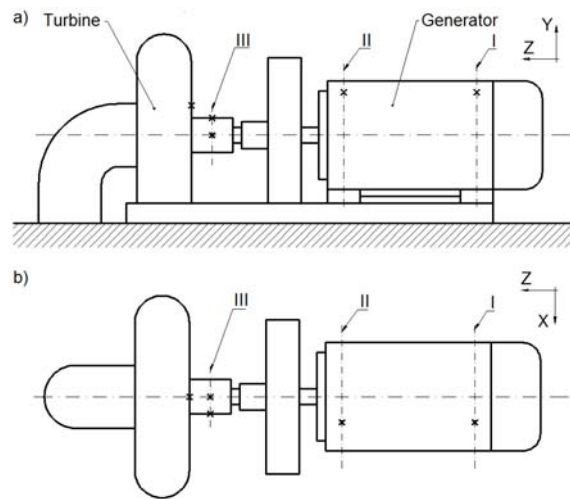
Fig. 2. Turbine set scheme with measuring points (a – side view, b – top view).

The results of this research proved that the machine operated in poor technical condition. The so-called "alarm vibration level" was exceeded in all measuring points placed in the vicinity of the generator. This means that the device should be switched off immediately.

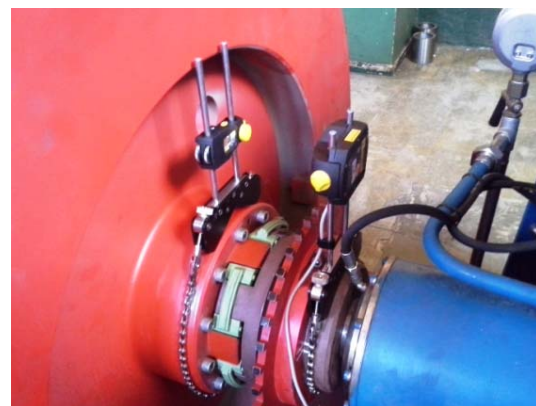
Fig. 7. Laser encoder with reflector used during shaft alignment.

The shaft alignment check revealed the exceedance of limit values in the vertical plane. The height difference between two coupling parts was

only around 0.18 mm, meaning that a change in the heights of front and rear generator's terminals must be applied. These heights were adjusted by 0.25 mm and 0.38 mm, respectively (Fig. 8). Other values were within the recommended tolerances.
