EXPERIMENTAL CRACK PROPAGATION ANALYSIS OF THE COMPRESSOR BLADES WORKING IN HIGH CYCLE FATIGUE CONDITION

Lucjan Witek

*Rzeszów University of Technology
Rzeszów, Poland*

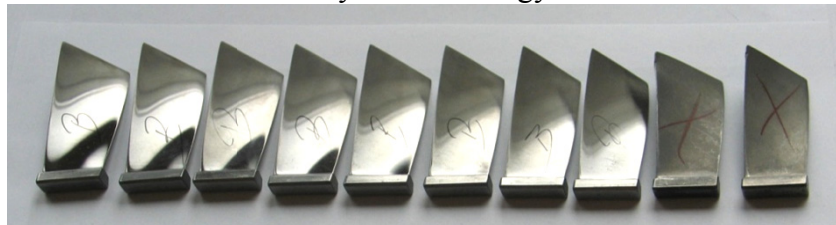
The blades used in experimental fatigue tests were retired from maintenance under technical inspection of engine. After inspection, the blades were checked by fluorescent inspection method and next divided onto two groups: undamaged blades (retired by inadequate dimensional tolerance in results of erosion and polishing) and blades with existence of preliminary cracks or corrosion pits. In presented here investigations, the group of 10 undamaged blades was tested (Fig. 1). Experimental investigations were performed at Research and Development Laboratory for Aerospace Materials of Rzeszów University of Technology.

Fig. 1. Blades of the 1-st stage compressor retired from maintenance under technical inspection of engine, destined for fatigue test.

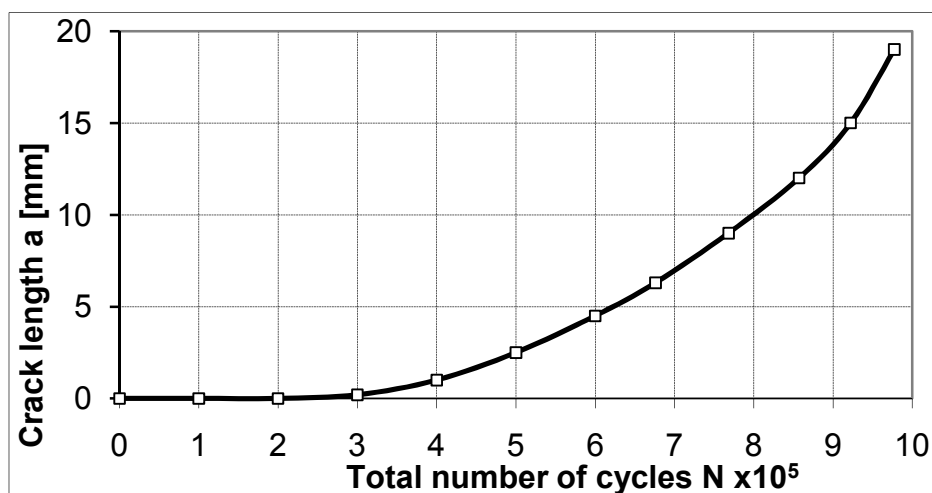
The control parameters of vibration system and results obtained for blade no. 1 are shown in Tab. 1. As seen from this table, the resonant frequency for blade is 774 Hz, and from this frequency test was started. After 4×10^5 total number of cycles, an amplitude of blade tip decreased from 2,5 mm to 2,25 mm. Under cracking, the bending stiffness of blade is decreased. This information is very important, because decrease of amplitude by constant intensity of excitation is often related with start of crack initiation process. In this case 1 mm long crack was detected. From the $6,76 \times 10^5$ number of cycles, the excitation frequency decreased with rate 0,2 and 1 Hz/sek. The crack length in function of the total number of cycles (crack growth plot), obtained for blade no. 1 is presented in Fig. 5.

Fig. 5. Crack length in function of total number of cycles for 1-st stage compressor blade (intensity of vibration 12g, blade no. 1).
