EXPERIENCE IN RENEWAL BWEs BUCKET AT MÁTRAJ ERŐMŰ SA OPEN PIT

RENOWACJA CZERPAKÓW WIELONACZYNIOWYCH KOPAREK KOŁOWYCH W KOPALNI MÁTRAJ ERŐMŰ SA

Ladányi Gábor, Zoltán Virág - University of Miskolc, Department of Geotechnical Equipment, Hungary

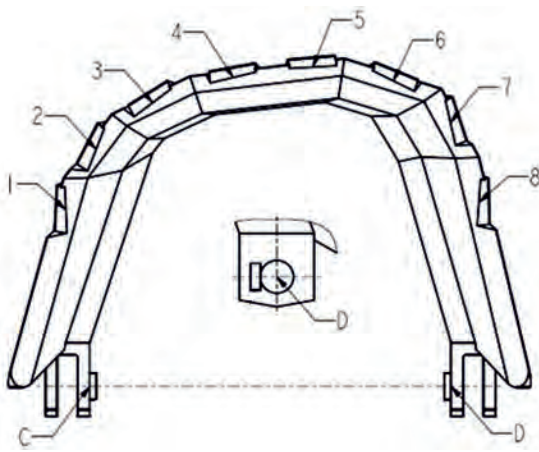
Fig. 8. Measure points of blade geometry verification
Rys. 8. Punkty pomiarowe geometrii ostrza

In this respect, the examination measurements were focused on the verification of the bucket’s and connected parts. This task has been performed by measuring the diagonal point to point distances between the numbered points as in figure 8 (from point C to 2...8 and from point D to 7...1). Accordingly, we measured for each bucket 14 distances, which is an overall amount of 238 measurements on 17 buckets, which is enough to have a statistical population. The measured distances selected for verification of the shape (geometry) modifications are connected to the cutting blade, because it is the main load carrying element of the bucket. Any distortion on its shape is responsible for any modification on excavation capability of the bucket.

In selecting measurement points and distances we considered those which are accessible and usable even in case of worn buckets. That is the reason for which we selected the points as in figure 8, and the diagonal distances between each bucket connecting pin centre (C and D) and the centre points of teeth lips supporting cavities on the blade. For reasons of comparison possibility, we calculated the relative deviation of each measured value related to the average. The corresponding data were drawn out for each bucket, as an example the diagram for the bucket no. 14 is presented in figure 9.
