MONITORING VERTICAL DISPLACEMENTS OF AN ENGINEERING OBJECT WITH MASONRY WALLS

Keywords: vertical displacements, geodesic monitoring, engineering object

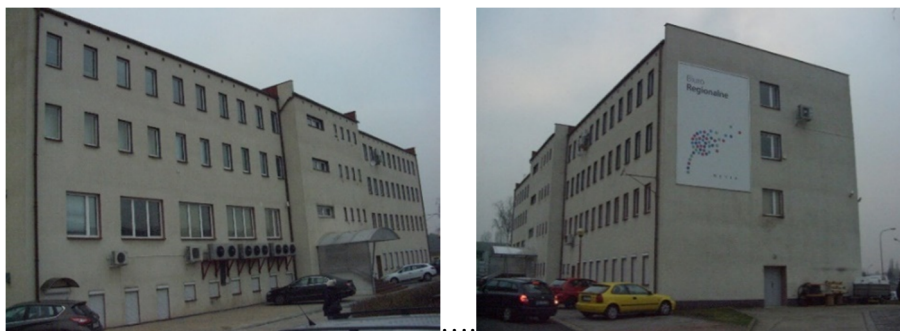
Fig. 1. The building's elevation from of the main entrance, east side. The building's elevation from the north-east side

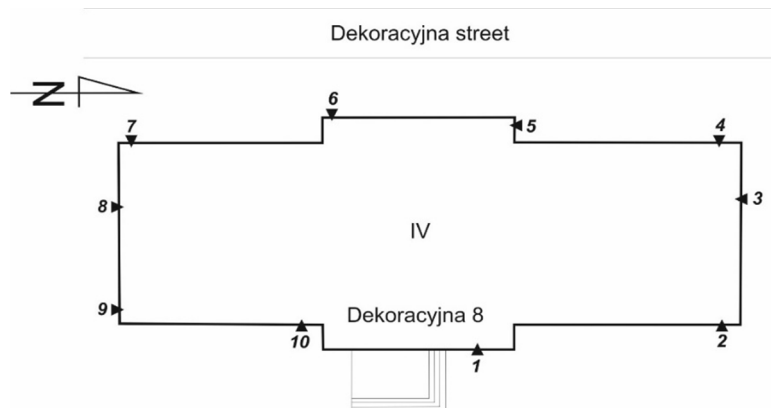
Fig. 2 shows the inner corner of the north-west wall. At that place the wall is cracked. Point 4 of the external measurement network is located not far from that place. At that point the displacement is greatest (-2.93 mm).

Fig. 4. A sketch of the measurement and control network set up outside the building

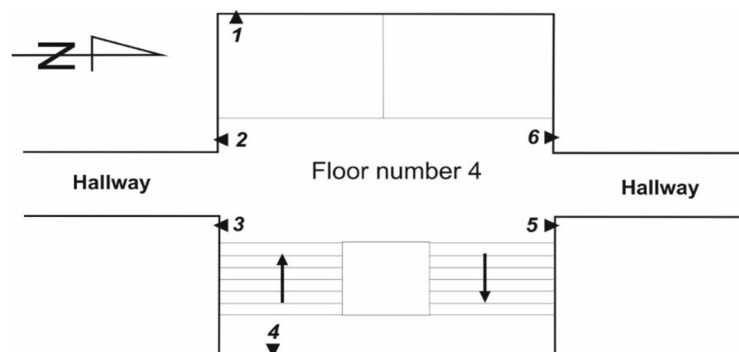
Fig. 5. A sketch of the measurement and control network set up inside the building on the fourth storey
