Monitoring of a historic sacral building on an example Basilica St. Nicholas in Gdańsk

Abstract

The paper describes the case of monitoring the technical condition of a historic sacral building after a failure and during renovation works. In order to monitor the condition of the building, safely conduct diagnostic work, identify the causes of failures and safely carry out renovation works, a detailed Facility Monitoring Program has been developed, which has been implemented, is operational and is a source of valuable data used to assess the current condition of the facility.

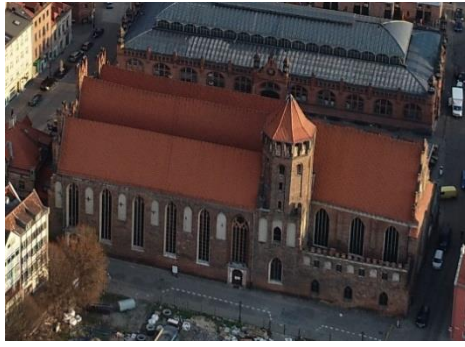
Photo 1. Basilica of St. St. Nicholas in Gdańsk: view (*photo by T. Majewski*)

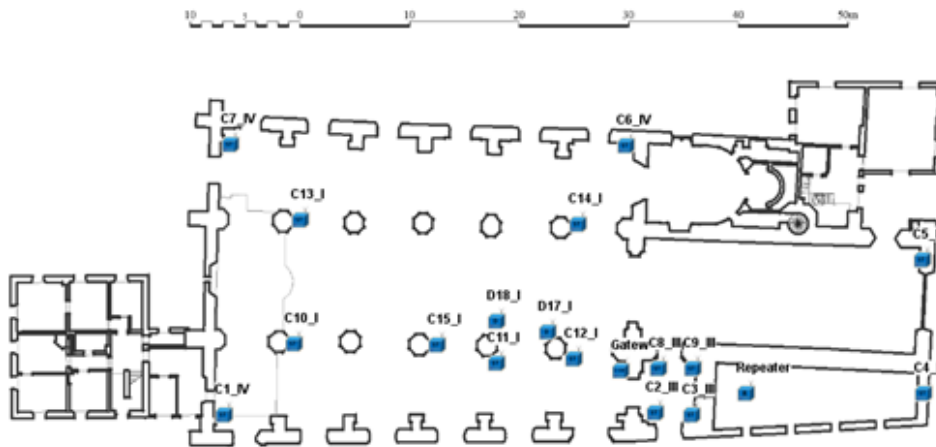
Fig. 7. Floor plan of the Basilica of St. St. Mikołaja in Gdańsk with the location of measuring

sensors marked (*own elaboration*) [50]

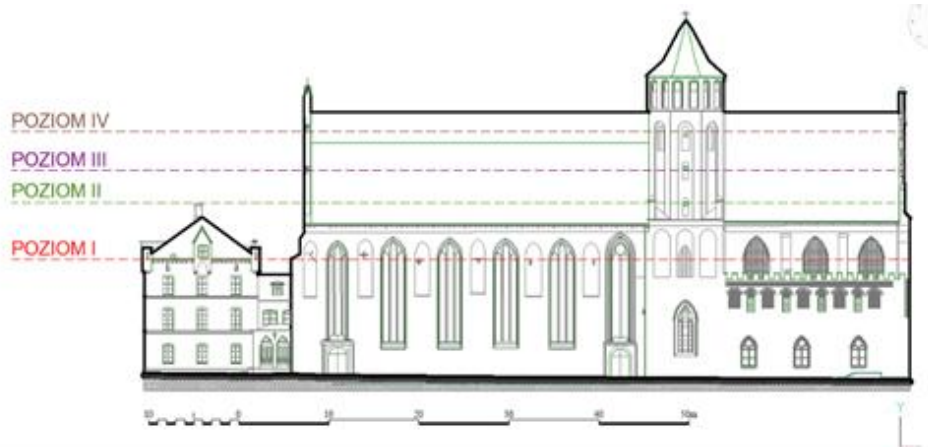
Fig. 8. Vertical (longitudinal) section through the Basilica of St. St. Mikołaja in Gdańsk with marked levels of measuring sensors placement (*own elaboration*) [50]
