IMPACT LOADS AND CRASH SAFETY OF THE COCKPIT OF A COMPOSITE GLIDER

Łukasz Lindstedt • ORCID 0000-0001-9481-4694,
Mirosław Rodzewicz • ORCID 0000-0003-1424-8624,
Cezary Rzymkowski • ORCID 0000-0003-1131-8113,
Krzysztof Kędzior • ORCID 0000-0002-0411-9039.

Warsaw University of Technology, Institute of Aeronautics and Applied Mechanics
plac Politechniki 1, 00-661 Warsaw, Poland

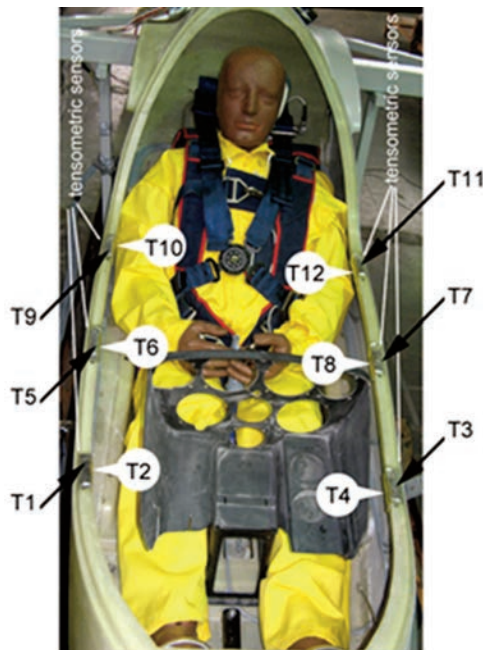
Figure 4. View of the dummy and location of the strain gauges glued on the cockpit sill

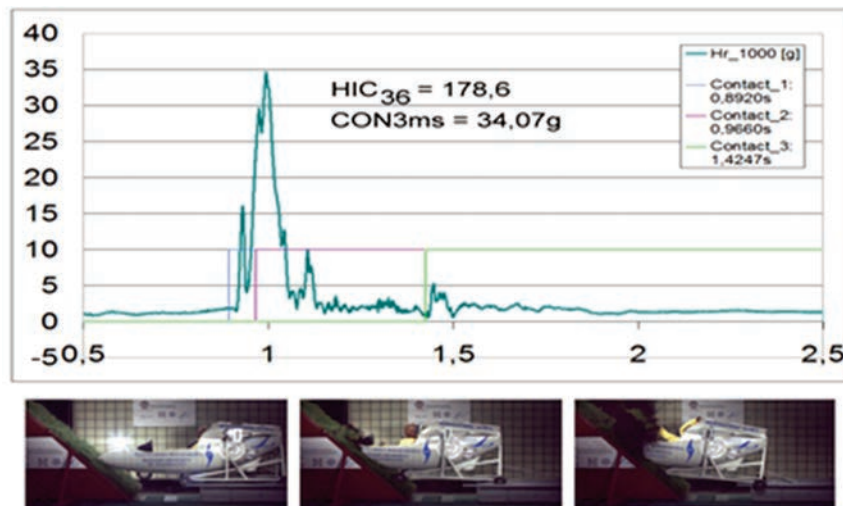
The chart presenting time course of acceleration acting upon the pilot is shown in Fig. 11. The stages of the crash are correlated with the frames of the movie.

Figure 11. Time course of acceleration acting upon the pilot's head

The first stage is the time between the moment when the glider hit the ground barrier and the time when the front wheels of the sled contacted the ground. In this phase one can observe the highest increase in the structural deformation (the sled structure did not affect the cockpit's structure behavior) because all loads were entirely transmitted by the composite cockpit. In this period of time the glider's nose cone penetrated the soil softly, which was the reason why the loads affecting the pilot were relatively low. This phase of motion occurred to be the most important from the cockpit structure's point of view.

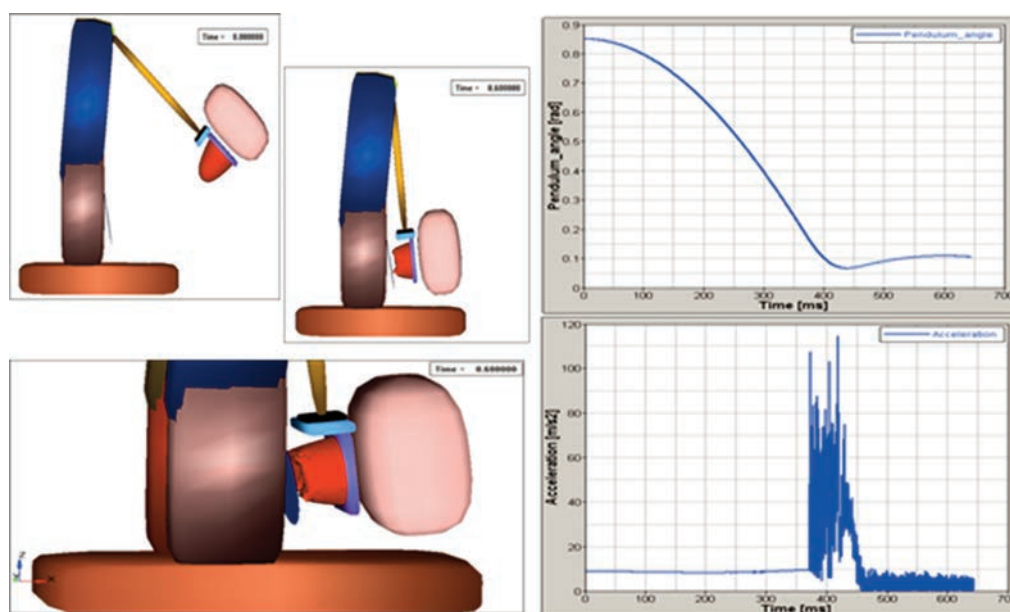
Figure 17. Results of an impact test stand experiment

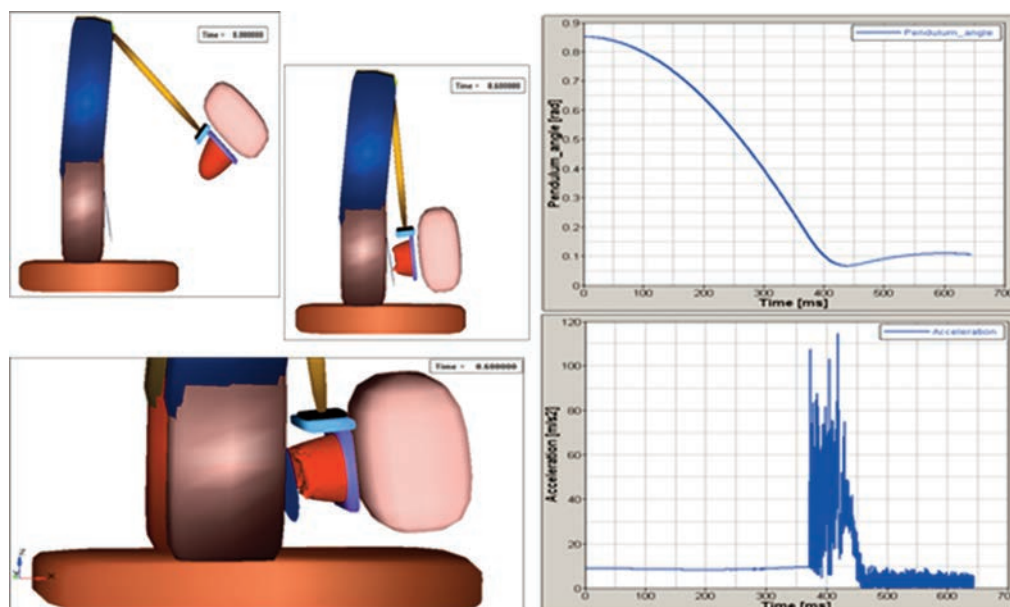
Figure 18. Results of numerical simulation (MADYMO)

Time histories of some quantities (pendulum angle and acceleration) allow for validation of a numerical model by choosing proper values of the model parameters. One can observe that the values as well as the time histories obtained from the numerical simulation (Fig. 18) are in quite good accordance with the results of the experimental test.
