PANSI XIE^{*,**}, YONGPING WU^{*,**}**DEFORMATION AND FAILURE MECHANISMS AND SUPPORT STRUCTURE TECHNOLOGIES FOR GOAF-SIDE ENTRIES IN STEEP MULTIPLE SEAM MINING DISTURBANCES****MECHANIZMY POWSTAWANIA ODKSZTAŁCEN I PEKANIA ORAZ TECHNOLOGIE WZMACNIANIA I ZABEZPIECZANIA ŚCIAN CHODNIKÓW W WYROBISKACH NACHYLONYCH**

Entries in steeply pitching seams have a more complex stress environment than those in flat seams. This study targets techniques for maintaining the surrounding rock mass stability of entries in steep seams through a case study of a steep-seam entry at a mine in southern China. An in-depth study of the deformation and instability mechanisms of the entry is conducted, employing field measurement, physical simulation experiment, numerical simulation, and theoretical analysis. The study results show that the surrounding rock mass of the entry is characterised by asymmetrical stress distribution, deformation, and failure. Specifically, 1) the entry deformation is characterised by a pattern of floor heaving and roof subsidence; 2) broken rock zones in the two entry walls are larger than those in the roof and floor, and the broken rock zone in the seam-floor side wall is larger tha

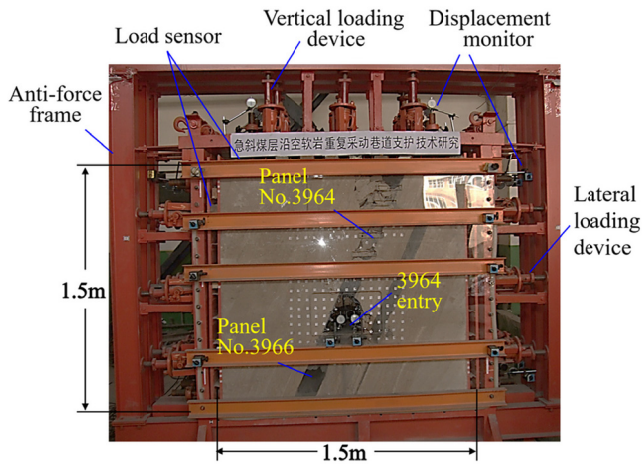
Fig. 6. Physical simulation model on simulation bench capable of two-dimensional and three-dimensional loading

Vertical and lateral loads were simultaneously applied to the model. At 5-MPa pressure, the deformation rate of the surrounding rock began to increase, with relatively large deformation in the entry floor and seam-floor side wall. The deformation and failure of the surrounding rock that developed along the direction of the seam dip angle was monitored. At 15-MPa pressure, failure of the coal seam occurred in the entry roof and floor as well as in the seam-floor side wall; specifically, transpression failure occurred in the entry roof owing to slipping and squeezing of the rock strata on both sides, as well clear heaving in the seam-floor side of the floor, as shown in Fig. 7.
