RENOVATION OF LARGE-PANEL BUILDINGS IN CONTEXT OF URBAN RENEWAL

Abstract

The article presents issues connected with renovating multi-storey precast concrete buildings, resulting from the consequences of construction defects occurring over the course of the building process and use of the buildings, as well as design flaws and construction defects when insulating external partitions. Analyses and conclusions which stem from them cover issues of renovation in the light of: damage in the vertical and horizontal joints, damage to the connection of layers in three-layer load-bearing and curtain walls, the effect of the damage on the possibilities of carrying out functional modernization of residential units, the effect of the damage on the effectiveness of thermo-modernization - new problems related to faulty insulation.

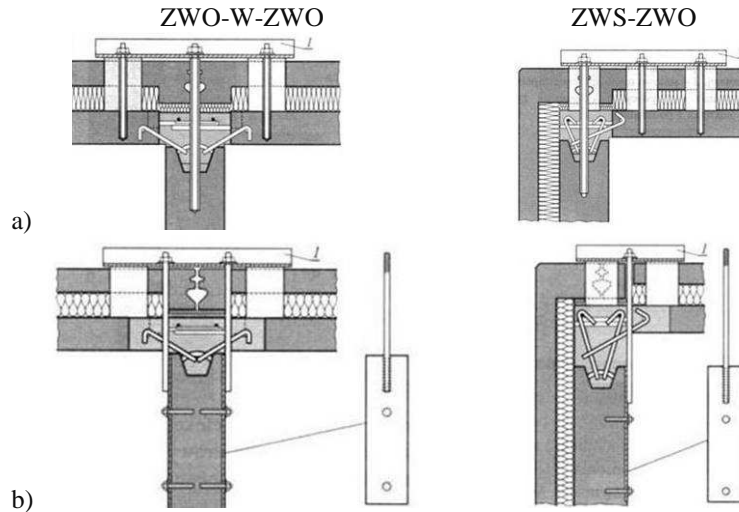
Fig. 10. Examples of mechanical strengthening of vertical joints from the outside of a building: a) with application of screws (for adequate concrete strength), b) with application of anchors (for inadequate concrete strength) [18]

When cracks in vertical joints are structural or reveal a tendency to progress (active cracks), or when inclination of the curtain wall has taken place as a result of injecting the expansion gap underneath the ceiling (Fig. 6), it is necessary to remove the source of the cracking and then apply reinforcement in order for the building to meet safety requirements [10, 18]. Reinforcements should be made from the outside (from scaffolding) and should not infringe on

the structure of existing construction elements of the joint and the adjoining parts of prefabricated walls of the building (Fig. 10).

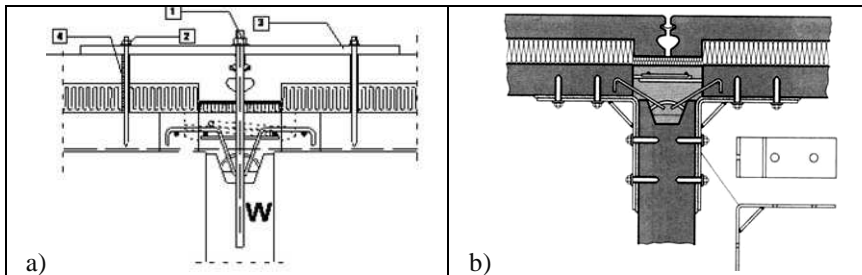
An alternative solution minimizing the destruction of the vapor-control layer has been presented in Figure 11a. In the case of local damage, the joints can be reinforced from the outside of the building using angle plates attached with expansion bolts (Fig. 11b).

Fig. 11. Strengthening of vertical ZWO-W-ZWO type joints: a) alternative solution realized from the outside [15]; 1 - screw fastened to the W type wall, 2 - screws fastening the resistant element to the load-bearing layer of ZWO type wall, 3 - resistant element - steel flat bar (instead of C-shaped cross-section), 4 - distance-marking case (instead of concrete cork), b) strengthening realized from the inside of the building using angle plates [18]

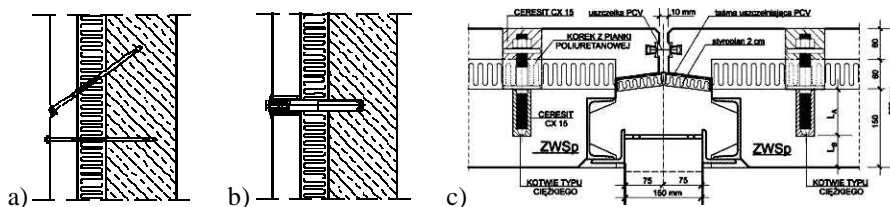
Fig. 13. Examples of additional anchoring of texture layer: a) scheme for band connector, b) scheme for shank connector, c) shank connector [5]

The main problem as of currently is finding answers to the questions of: What is the actual safety risk to the vapor-control layer and how can it be assessed? Should the level of safety be assessed through invasive (non-invasive) methods of research? What about the safety of the vapor-control layer in insulated buildings? Perhaps it is better to resign from identifying defects in the connection of the vapor-control layer and load-bearing layer and instead choose to make it mandatory to mechanically connect these layers (Fig. 13) (or maybe remove these layers and insulate the load-bearing layer)?
