BOŠNJAK S, ARSIĆ M, SAVIĆEVIĆ S, MILOJEVIĆ G, ARSIĆ D. Fracture analysis of the pulley of a bucket wheel boom hoist system. *Eksploatacja i Niezawodność – Maintenance and Reliability* 2016; 18 (2): 155–163, <http://dx.doi.org/10.17531/ein.2016.2.1>.

FRACTURE ANALYSIS OF THE PULLEY OF A BUCKET WHEEL BOOM HOIST SYSTEM

This paper presents the results of the pulley fracture analysis. Experimental investigations confirmed that the chemical composition and basic mechanical properties of the pulley material, except the impact energy at a temperature of -20°C , meet the requirements of the corresponding standard. The impact energy value at the temperature of -20°C is for $\approx 45\%$ lower than the prescribed value which has considerable influence on the appearance of the brittle fracture, especially having in mind the fact that the bucket wheel excavators operate at low temperatures. Metallographic examinations as well as magnetic particle inspections indicated that initial cracks in the welded joints occurred during the manufacture of the pulleys. Characteristic levels of the rope load cycle are obtained by using in-house software which includes the dynamic effects of the resistance-

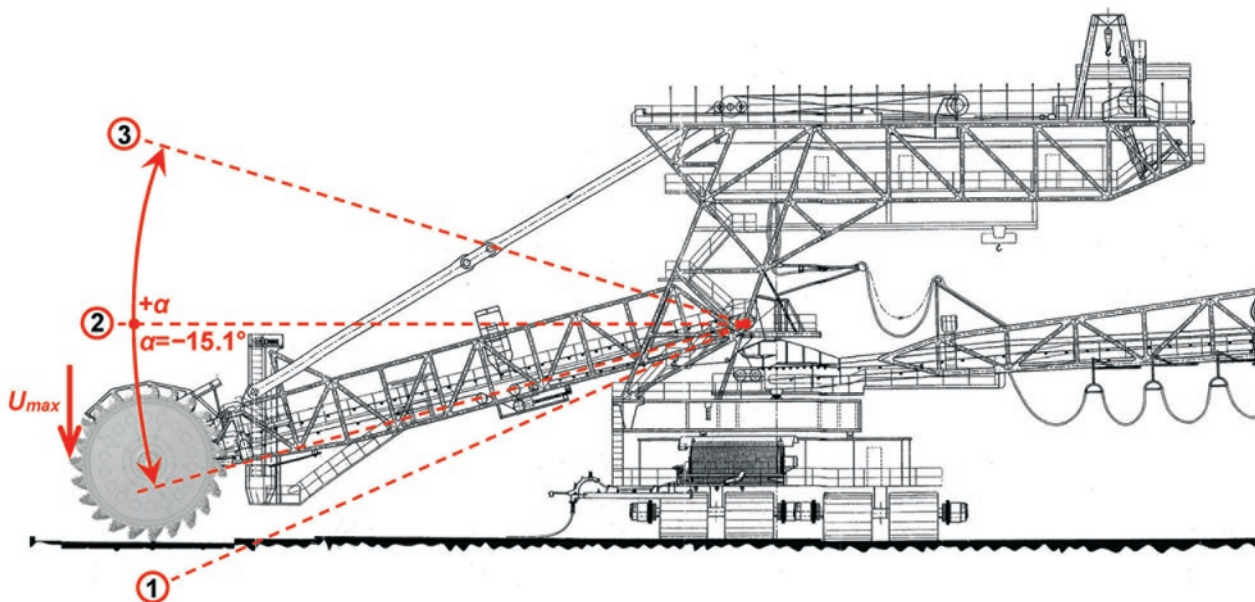
Fig. 10. Characteristic BWB positions: 1 – low, $\alpha_{BWB}=-24^\circ 2' 22''$; 2 – horizontal; 3 – high, $\alpha_{BWB}=16^\circ 34' 48''$ (U -cutting force)

The load analysis of the BWE structure is very complex due to its changeable geometry configuration (Fig. 10).

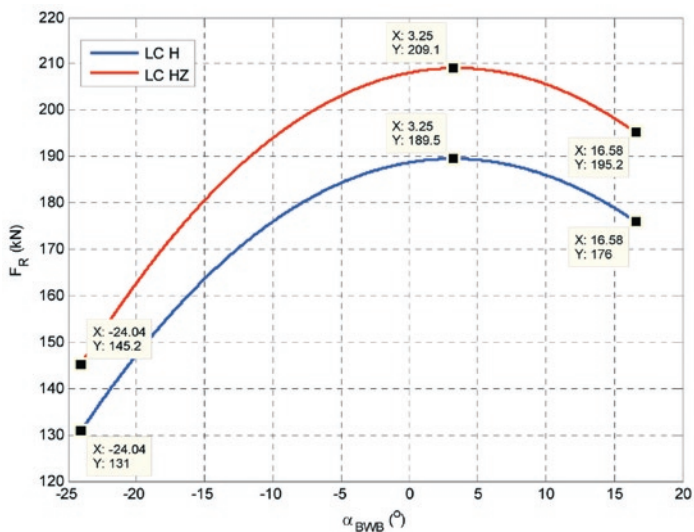
Fig. 11. The dependence of the rope force (F_R) on the BWB inclination angle (α_{BWB})

The forces in the rope of the BWB hoist system, shown in Fig. 11, are determined using standard [12]. The intensity of the cutting force is calculated based on the parameters of the BW drive, adopting [12] that the total cutting force is realized on one bucket only (Fig. 10). For load case (LC) H [12] the intensity of the cutting force ($U_{nom}=298.5$ kN) is calculated based on the nominal torque of the BW drive motor, whilst in LC HZ [12] its intensity ($U_{max}=376.4$ kN) is calculated based on the maximum torque of the clutch. In both LCs, rope force reaches its maximum for $\alpha_{BWB}=3^{\circ}15'$ (Fig. 11). It can be

rope and the pulley was simulated by contact connection. Maximum values of von Mises stresses are obtained in the T-fillet welded connections of the rim (Fig. 15). The characteristic stress levels of the pulley load cycle during excavation for both considered LCs are presented in Table 7. For the maximum rope force (209.1 kN, Fig. 11) ob-

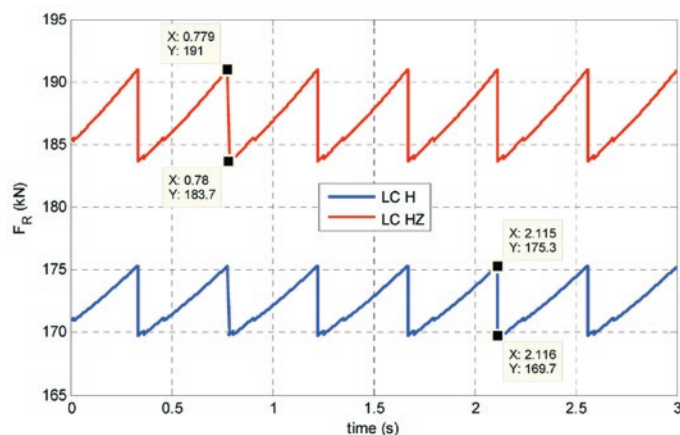
Fig. 12. Simulation of the rope force during the excavation process ($\alpha_{BWB}=3^\circ 15'$)

noted that usage of the procedure prescribed in [12] leads to the loss of one of the key properties of the BWEs’ working process – the dynamic character of the external load caused by resistance-to-excitation [2, 4, 6–8, 22–24, 29, 30, 32, 33, 35–39]. By extracting the static influence of the cutting force from the curves shown in Fig. 11 and introducing its dynamic influence determined in the manner presented in [2, 4], a more realistic character of changing of the rope force during the excavation process is obtained (Fig. 12, Table 6).

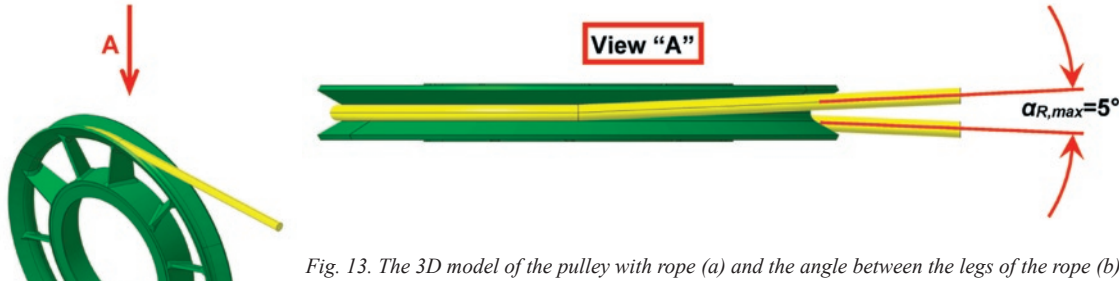
Fig. 13. The 3D model of the pulley with rope (a) and the angle between the legs of the rope (b)

The stress state analyses are done by applying the finite element method (FEM). The 3D model of the pulley and rope (Fig. 13) was discretized by 10-node tetrahedron elements in order to create the FEM model (317,066 nodes, 185,852 elements, Fig. 14). Calculations are carried out for the maximum value of the angle between the legs of the rope $\alpha_{R,max}=5^\circ$ (Fig. 13b). Interaction between the

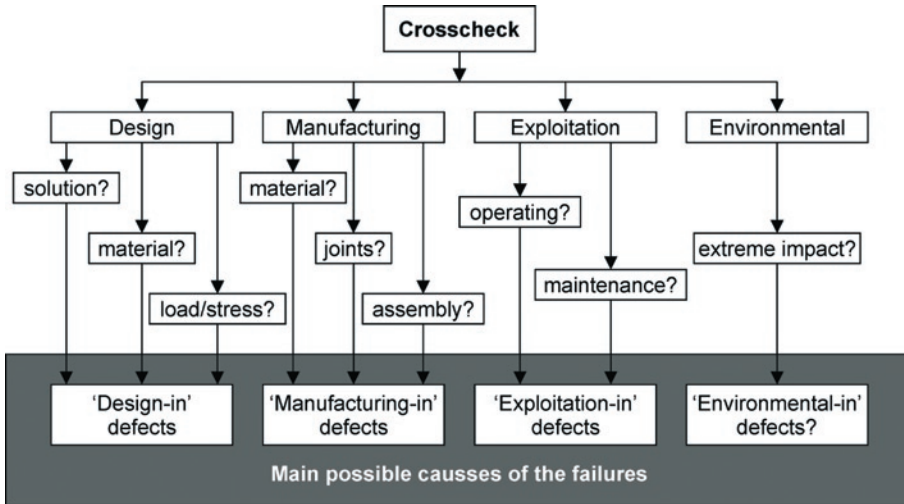
Fig. 16. The procedure of determining the causes of pulley fracture

In order to make a decision on whether to repair or redesign the pulleys, it was necessary to conduct a complex procedure whose basic stages are shown in Fig. 16.

Based on the presented results, it was concluded that the pulley fracture was caused by the ‘manufacturing-in’ defects. That is why it was decided to carry out the repairs of the pulley spokes’ welded joints, without modifying their design.
