Geomatics, Landmanagement and Landscape No. 3 • 2018, 7-22

APPLICATION OF SOUND TOMOGRAPHY IN THE REVITALIZATION OF THE AREA SURROUNDING THE NATIVITY OF THE BLESSED VIRGIN MARY ORTHODOX CHURCH IN WŁODAWA

Margot Dudkiewicz

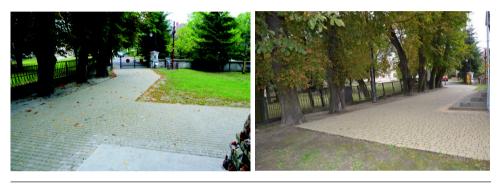
Within the area of the surrounding estate there are 20 trees growing, varying in age and in health status, with a quantitative advantage of horse-chestnut trees (Photos 5 and 6). Some trees have been self-sown, and some have been planted without adherence to the proper compositional layout or sacred symbolism. Around the temple there is a churchyard cemetery with four tombstones (Photos 7 and 8). The compound is enclosed with a fence, which is partly in the form of an old brick wall (Photos 9 and 10), and partly in the form of brick posts and metal spans.

Photos 5 and 6. The courtyard and the lane outside the entrance to the orthodox church (photos by M. Dudkiewicz, 2017)

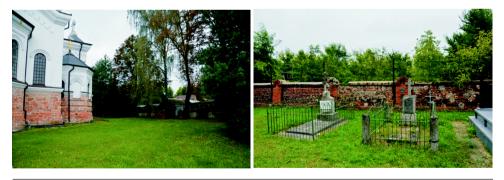
Photos 7 and 8. Surroundings of the orthodox church. Burial ground around the church (photos by M. Dudkiewicz, 2017)
