TOMASZ SIOSTRZONEK
PIOTR TRÓJCA
JAKUB WÓJCIK

Winding machine additional overload state indication as supporting solution for mine shaft hoist operators

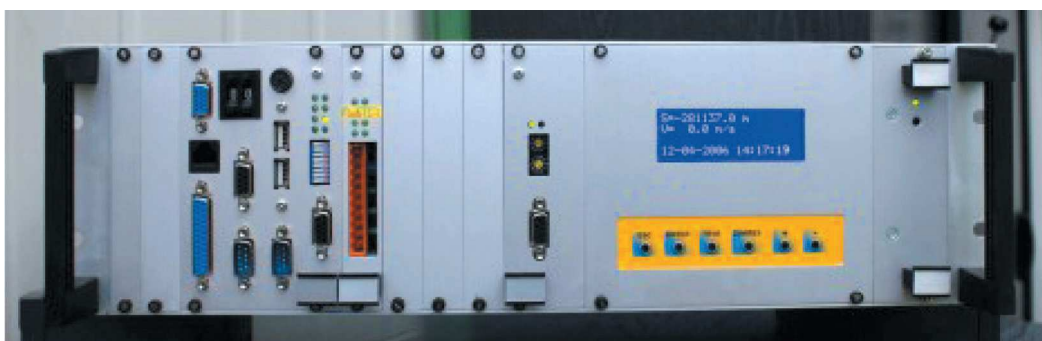
Fig. 3. AR-3c logger

An AR-3c logger is built in Compartment A. It is setup to log all control and diagnostic signals required to analyze any incorrect behavior of the mining shaft elements [4].

In the case of stopping Vessel No. 2 by the construction of the spill bunker, the load torque suddenly decreased.
