VERIFICATION OF THE COMPUTED TOMOGRAPHY RESULTS OF ALUMINUM ALLOY WELDED JOINT

Maciej Malicki, Kamil Sobczak

Institute of Aviation, Warsaw, Poland

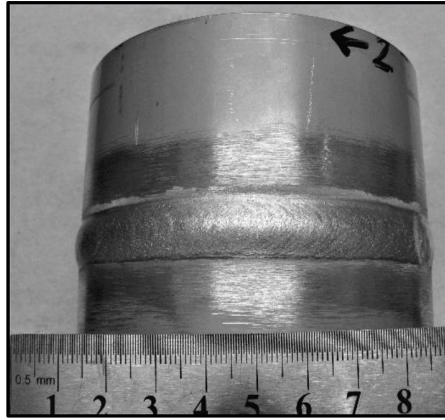
Fig. 1. Tested welded joint

For the CT scans, the Industrial X-ray computed tomography system v/tome x s240 was used (Fig. 2). The weld joined two parts of the pipe of the 100 mm diameter and 5 mm wall thickness. The two scans were made: for the whole welded joint and for the specimen cut from the weld being tested. The CT scans of a higher resolution were also done for the welded specimen to visualize the defects invisible in the CT image made at a lower resolution (Fig 3). The cut specimen contained an around 35 mm part of the weld with a heat affected zone
