Bogusław ŁADECKI\*, Sławomir BADURA\*, Filip MATACHOWSKI\*

## STRENGTH ANALYSIS OF A GANTRY CRANE OF A COATING STRUCTURE

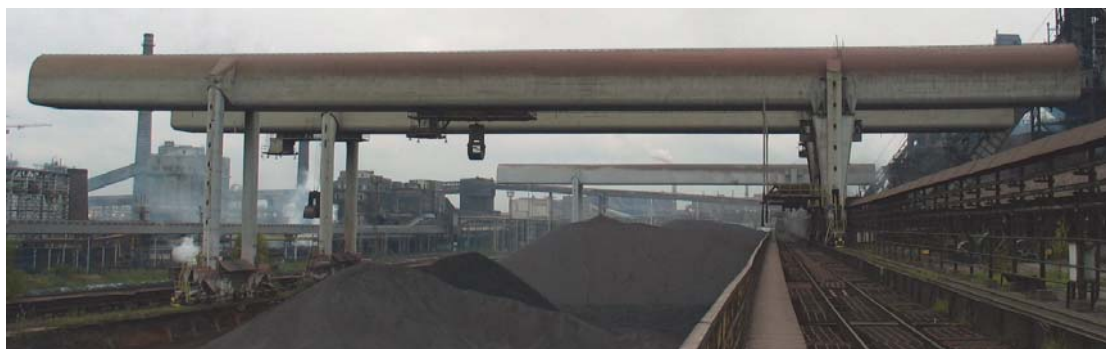
of 350 kN, operating in one of the Polish steelworks. The bearing element for these cranes constituted the span, 133 m long, of the coating structure, made of steel plates strengthened by axial and transverse ribbing (Fig. 1).

Fig. 1. Gantry cranes of a coating structure
