Radosław PRZYSOWA¹, Marek CHALIMONIUK¹, Danuta GRZELKA-GAJEK¹,
 Ruslan SHAKALO², Artem KARPENKO²

¹ Air Force Institute of Technology (Instytut Techniczny Wojsk Lotniczych)

CT INSPECTION OF COOLED TURBINE BLADES

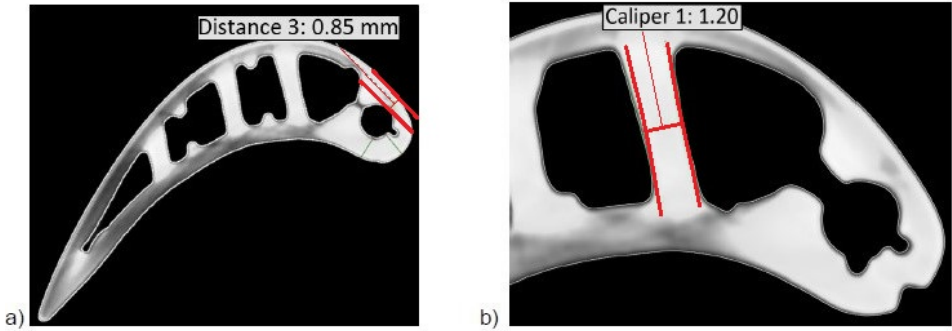
Keeping dimensional tolerance of the blades' walls is important for strength reasons. Fig. 6 shows the examples of dimensional control conducted in VGStudio, which aims to

determine the deviations from reference geometry (model or structural, drawing). Figure 6b presents the thickness measurement of the rib, which is not possible to be taken with surface non-destructive methods.

Fig. 6. Thickness control of the walls and internal ribs of blade 1

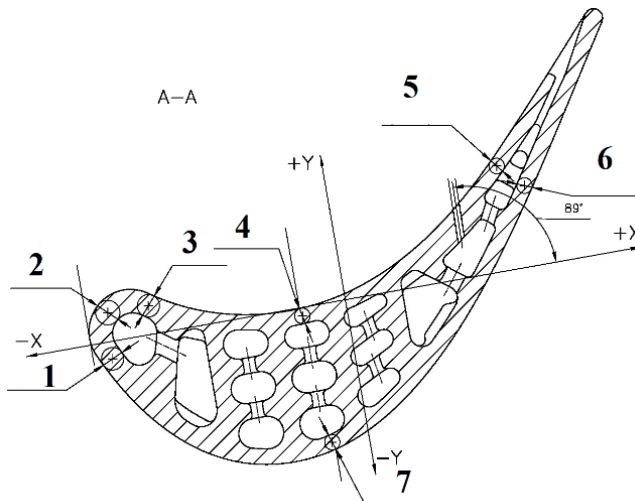
For the selected cross-section A-A of the blade 2 (figs. 7 and 8), measurement results of wall thickness were presented in seven points, and they were referred to the tolerances defined by the manufacturer (fig. 9). Points 1-3 are situated on the leading edge, 4 and 5 on the pressure side, 6 and 7 on the suction side. In five points, the wall is within the tolerance; for point 5, it slightly exceeds it while in point 7, the exceedance is significant (0.2 mm).

Fig. 7. Points where the wall thickness of blade 2 was controlled

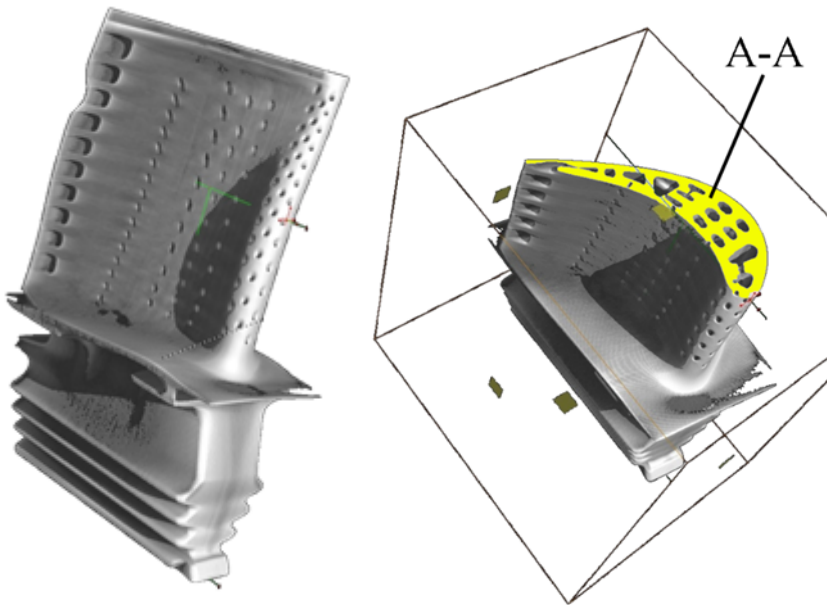
Fig. 8. Cross-section A-A selected to measure wall thickness

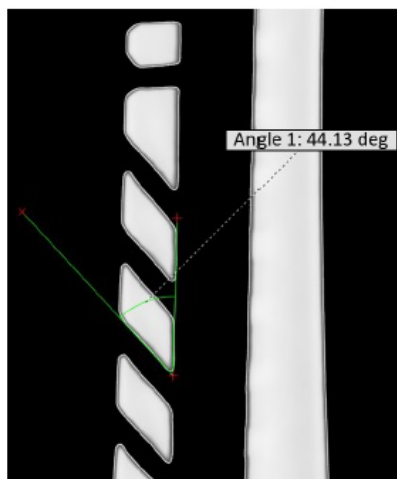
The correct machining of cooling passages and perforation allows for the supply of the appropriate amount of cooling air to the specific part of the blade [11]. Fig. 10 depicts an example of checking the perforation angle.

Fig. 10. Control of the perforation angle of cooling passages

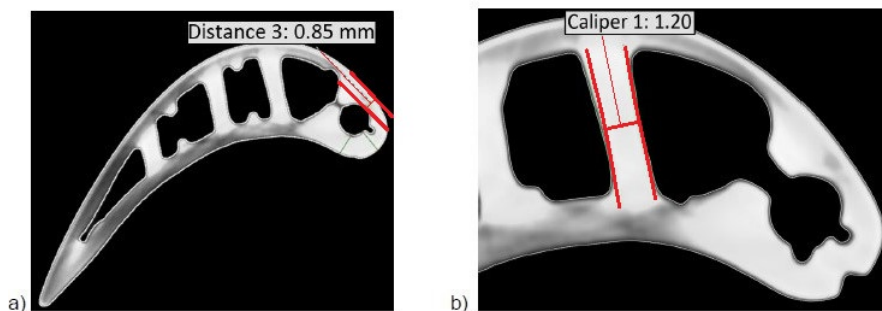
Utrzymywanie tolerancji wymiarów ścian łopatek ma istotne znaczenie ze względu na wytrzymałościowe. Na rys. 6. przedstawiono przykłady kontroli wymiarów wykonanej w programie VGStudio, której celem jest określenie odchyłek od geometrii wzorcowej (modelu lub rysunku konstrukcyjnego). Rysunek 6b przedstawia pomiar grubości żebra, niemożliwy do wykonania powierzchniowymi metodami nieniszczącymi.

Rys. 6. Kontrola grubości ścianek i kontrola grubości żeber wewnętrznych łopatk TNC

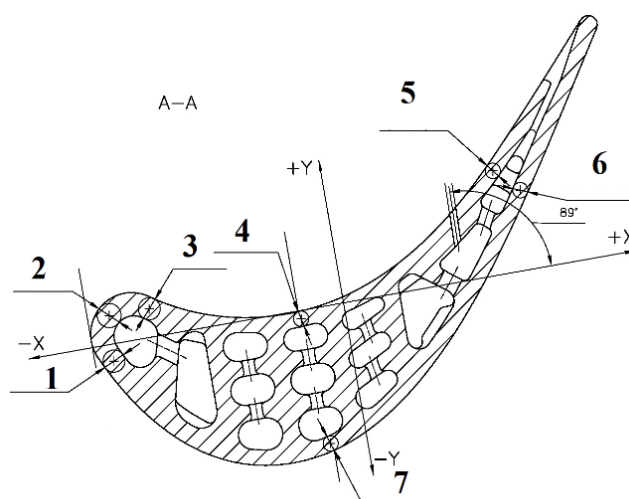
Dla wybranego przekroju A-A łopatk TWC (rys. 7 i 8) przedstawiono wyniki pomiaru grubości ściany w siedmiu punktach i odniesiono je do tolerancji zdefiniowanych przez producenta (rys. 9). Punkty 1-3 położone są na krawędzi natarcia, 4 i 5 w korycie, a 6 i 7 na grzbiecie łopatk. W pięciu punktach ściana mieści się w tolerancji, dla punktu 5 nieznacznie ją przekracza, natomiast w punkcie nr 7 przekroczenie jest znaczne (0,2 mm).

Rys. 7. Konstrukcyjne punkty kontroli grubości ścianek łopatk TWC

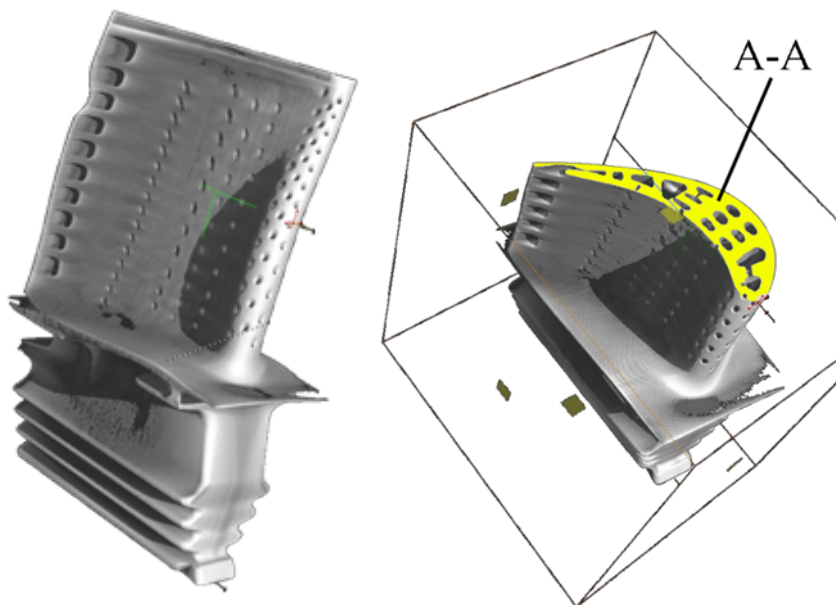
Rys. 8. Przekrój A-A wybrany do analizy grubości ściany

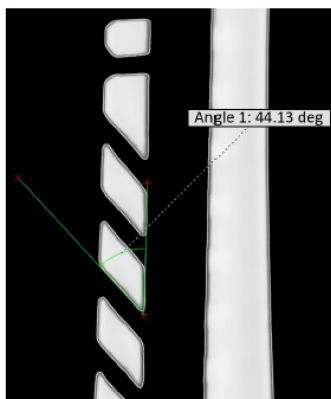
Prawidłowe wykonanie kanałów chłodzących i perforacji, pozwala na doprowadzenie odpowiedniej ilości powietrza chłodzącego do określonej części łopatki [11]. Rysunek 10 przedstawia przykład kontroli kąta perforacji.

Rys. 10. Kontrola kąta perforacji kanałów chłodzących
