## BUILDING STRUCTURE FAILURES CAUSED BY DEFECTS IN WORKMANSHIP

Sylwester KOBIELAK\*, Edward HUTNIK\*, Zenon ZAMIA\*\*

The article presents the characteristics of collapses of three building structures which occurred as a result of defects in workmanship, including the Hyatt Regency Hotel building in Kansas City, a building in Shanghai and the roof over a part of the grandstand at the stadium of FC Twente in Enschede. These events had a global impact. The paper describes also the construction of and the repair of damage to the elevated reinforced concrete tank for storing liquids.

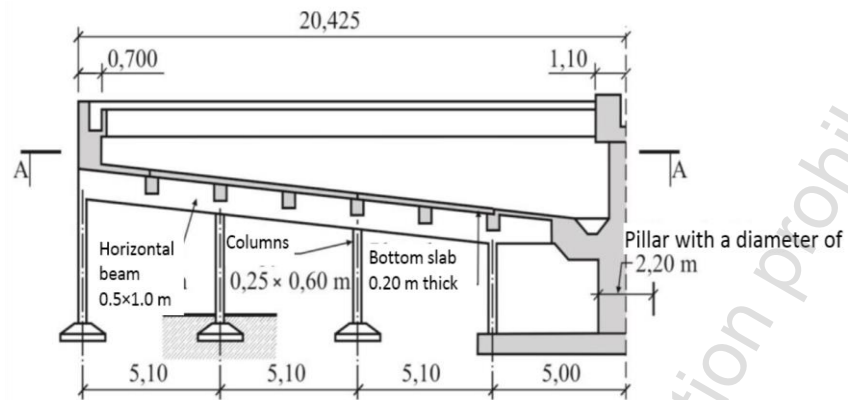
After 23 years of operation in the elevated clarifier made of reinforced concrete (circular plan see: Figure 4a, b, c), intended for process liquids (Figure 4d), cracks were detected in its supporting structure (Figure 4e, f) as well as seepages and damp patches (bloom) visible from outside (Figure h) [4]. The supporting structure of the clarifier is formed by 24 radially arranged frames, composed of four-span horizontal beams, having the dimensions of 600 × 1,000 mm, supported by the central pillar, with a diameter of 2.20 m, and three columns, having the dimensions of 250 × 600 mm. In the direction of the circumference beams are placed, with a cross-section of 500 × 500 mm and spaced every 2.55 m. The arrangement of horizontal beams and beams forms a grate on which the bottom slab of the clarifier, 200 mm thick, rests. In the direction of the circumference, there are three expansion joints in the bottom slab, owing to which its three concentric parts can be distinguished, namely: a) circular central slab, with a diameter of 10.00 m, monolithically connected to the central pillar, limited by the circumferential beam from the outside, b) external ring slab, with the slab strip 2.55 m wide, monolithically connected with the vertical wall of the clarifier, 2.53 m high and 700 mm thick, and c) two strips with the width equal to the spacing of the columns, i.e. 5.10 m, separated with expansion joints. Both these strips are also radially separated by expansion joints in the axis, spaced every third horizontal beam. Expansion joints are filled with a 19 mm thick strip of soft fibreboard. At the top, the pointing of expansion joints was made with monolith. To make it possible for the bottom slab to move (except for the circular central part) in relation to the supporting frame structure, a separator made of building paper was placed between them, but it did not serve its purpose.

**Fig. 4.** Structural damage to the elevated Dorr's clarifier at Huta Miedzi (copper smelting plant) [4]: a) vertical cross-section of the clarifier, b) plan of the clarifier, c) general view of the clarifier, d) view of the clarifier filled with sludge
