DAMAGE ANALYSIS OF THE BLADE TO THE ROTOR HUB CONNECTION IN THE WIND TURBINE

The paper analyzes possible causes of bolts fracture in the connection of the blade to the hub of the wind turbine rotor. This failure has been growth shortly after the wind turbine was started, a few days after the storm. During the storm, electric power was turned off in the whole surrounding area for many hours, therefore it was impossible to control the device. After an initial analysis of failure modes in other wind turbines, it was found, that the bolts failure in the analysed case may be regarded as quite rare. Due to the fact that a significant part of bolts was broken brittle (flat fracture surfaces and lack of permanent elongation), it was decided to analyse the structure of the material in the direction of stress corrosion and hydrogen embrittlement. Among others, microscope analysis of fracture surfaces after their proper cleaning from corrosion products was carried out. The broken bolts were made as undersized, what is mainly used in fasteners intended for hot-dip galvanizing. On the basis of the purchase documentation analysis, it was presumed that the bolts were not galvanized by their manu

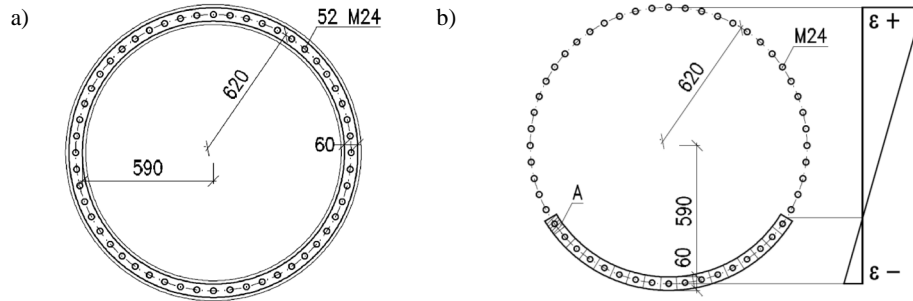
In the connection of the blade with the hub (Fig. 8a), a linear distribution of deformations was assumed, as in the structural members subjected to alternate actions [3]. It was assumed that the load in the compression zone is transferred by a pressure of a ring of bearing on the hub, and in the tension zone – by the bolts tension. In this model, a pressure of the ring on the hub caused by preloaded bolts is not taken into account. The effective section was determined, in which the bolts transmit tension and the flange transfers pressure (Fig. 8b). In the calculation of the connection characteristics, the nominal cross-section of the bolt has been adopted.

Fig. 8. Connection: a) view, b) scheme of calculation (effective cross-section)

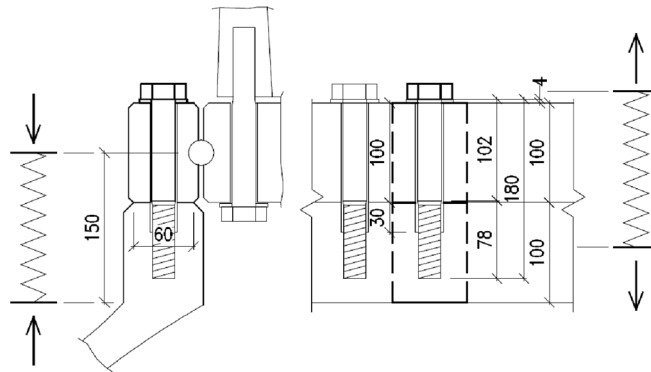
The connection of the rotors' blade to the hub was calculated using a mechanical model consisted of 52 basic components of the joint. The number of these components corresponds to the number of bolts. Each component was modelled as a spring (Fig. 9), whose axis coincided with the bolt axis, both in tension and compression zone. The stiffness of the spring in the compression zone was estimated based on the elastic shortening of the pre-compressed part of the ring (bearing race) and the hub with a length corresponding to 1/52 of the connection perimeter and a thickness of 15 cm – see Fig. 9. In the calculations, Young's modulus $E = 210$ GPa and the pressure area of the ring for the hub $A = 39.5$ cm² (see fig. 8b) were adopted. The stiffness of the spring $k_c = EA/l = 5\,530$ kN/mm was obtained, where $l = 150$ mm is an effective length of the spring – see fig. 9.

Fig. 9. Fragment of the joint and its modeling as springs in compression and tension zones

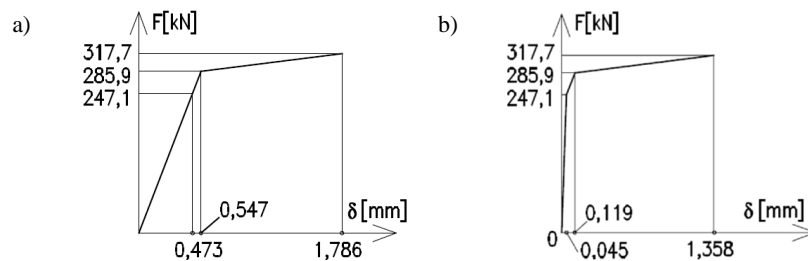
The obtained characteristic of the basic part of the joint in the tension zone is shown in Figure 10b.

Fig. 10. Force – displacement characteristics: a) for bolt M24 class 10.9, with the actual length of its shaft and its threaded part b) for the basic component in tension in the pre-stressed connection

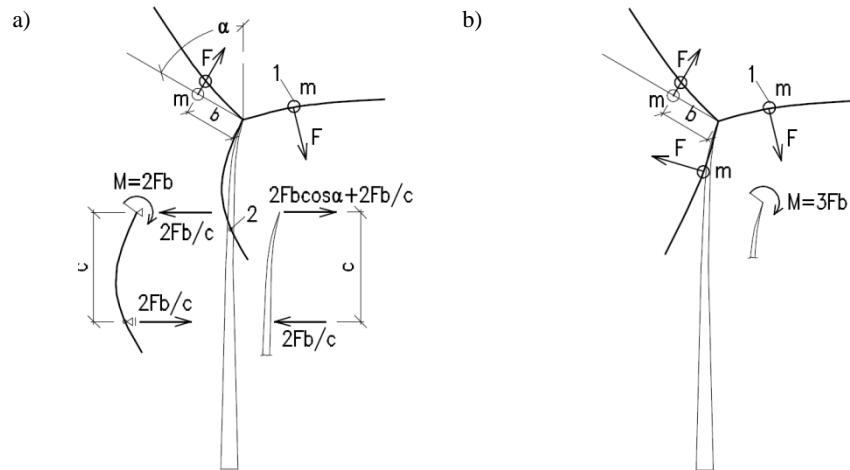
Adopting the highest operational rotational speed of the rotor $\Omega = 30.8$ rpm, the velocity at the point of the centre of gravity of the blade $V = 25.65$ m/s has been obtained. It was assumed that the two upper blades stop as a result of blocking the movement by the third lower one, which acts as a brake together with the tower (similarly to a bump post e.g. in crane girders). The upper two blades (Fig. 11a) act on the axis of the system with the horizontal force F_{hub} and the moment M_{hub} :

Adopting the above assumptions and calculating necessary stiffness coefficients, the bending moment in the connection of the lower (blocked) blade to the hub equal to 5 949 kNm was obtained. (Detailed formulas allowing the calculation of the bending moment in the connection together with their derivation will be presented in a separate publication.)

Fig. 11. Schemes of a structure work: a) blade collision with the tower, b) sudden shaft locking

Similarly to the point 7.3. the greatest operational rotational speed of the rotor 30.8 rpm was adopted. It was assumed that the rotor at the moment of its sudden blockage acts on the tower with a moment (Fig. 11b):

In the case of the load resulting from the blockage of the movement of the blades, bolts fracture would be potentially possible, because the forces acting on them would be slightly larger than their design resistances calculated in accordance with the standards.
