Historical wooden-pillared Kenan Dede Yanık Mosque – restoration proposal

Historical wooden-pillared Kenan Dede Yanık mosque – restoration proposal

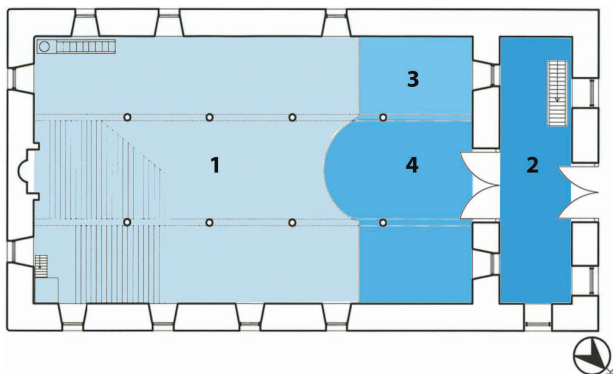
Fig. 1. The plan of the Kenan Dede Yanık Mosque: 1 – haram, 2 – last congregation place, 3 – Imam's room, 4 – women's room (source: [21, p. 310])

the imam addresses the prayers before praying on the eastern nave, the mihrab which is the niche inside the mosque that shows the direction of the place on the middle nave, and the pulpit which is an elevated place with steps where the imam speaks to the public during a religious ceremony and the imam room on the western nave (Fig. 1).

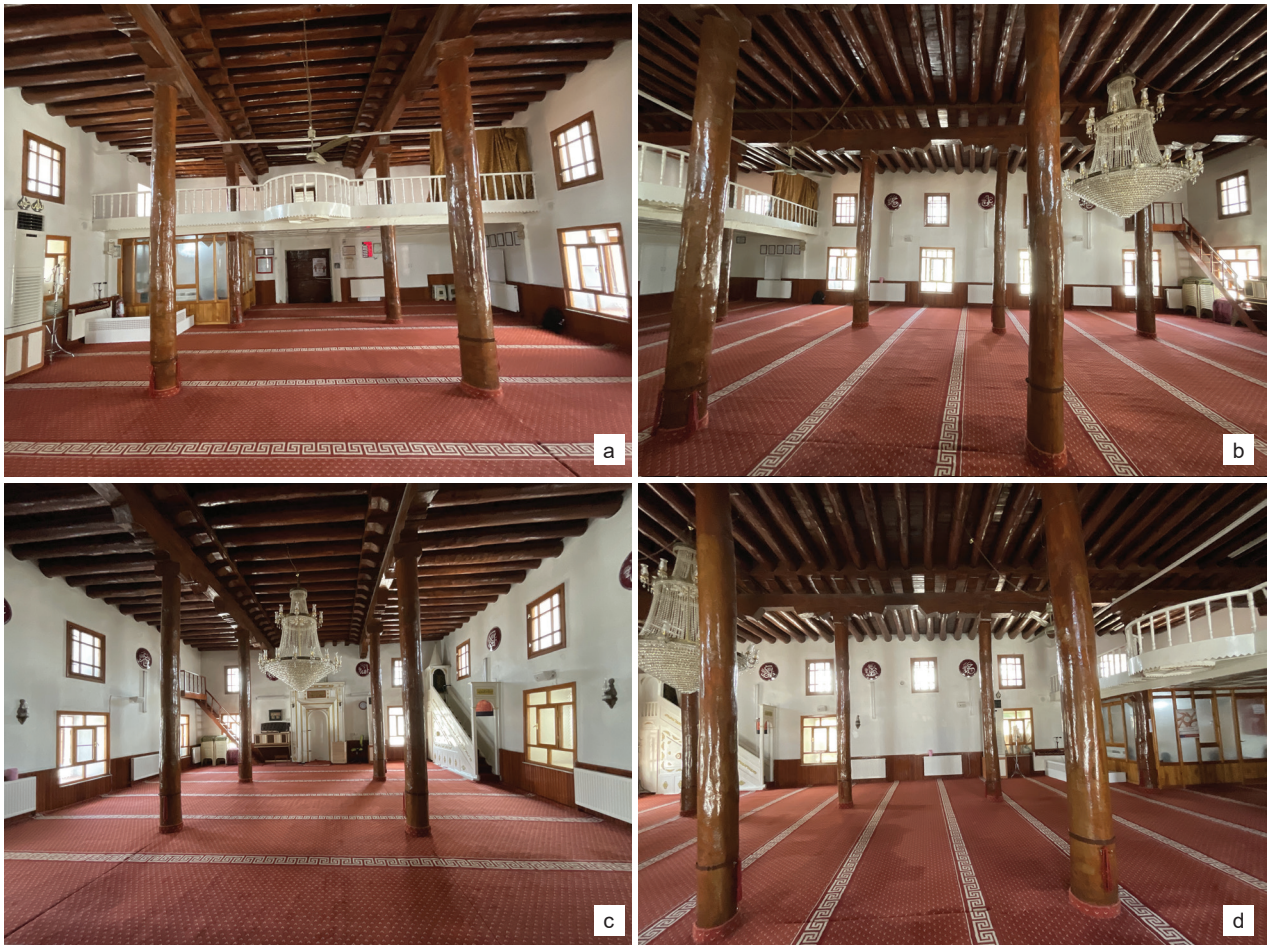
The west façade of the building cannot be seen because of the other buildings on the west façade. On the western wall of the haram, there are five small windows in the upper row and two large windows in the lower. There is a pulpit in the south of this wall, while the imam's room is located in the north (Figs. 2, 3).

Fig. 2. The views of the inner walls of the Kenan Dede Yanik Mosque: a) northern, b) eastern, c) southern d) western (photo by F. Bademci)

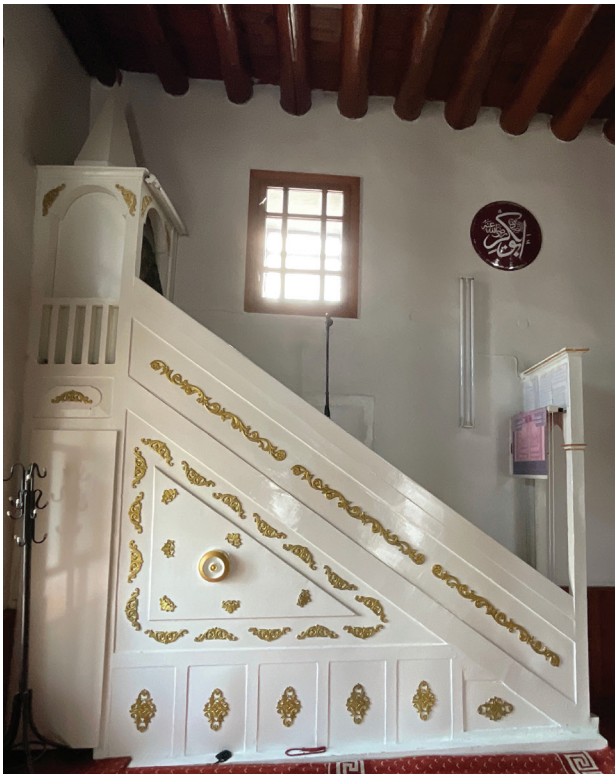
mirror, there are five rectangular and one trapezoidal section. These sections have stylized branch and flower motifs. In rectangular shaped areas, the motifs are in the same direction, while in trapezoidal shapes, the motif turns sideways. In the railing section of the pulpit, there are 3 uniform stylized branch motif ornaments. The walkway part of the pulpit is covered with chipboard material, and there is a stylized branch motif in the outer triangle ornament of the side transom section on the panel above the passage. There are columns on the sides of the pavilion section, and in between these pillars lies an arch. On the arch corners, on the other hand, there is a stylized branch motif in the outer triangle ornament of the side mirror section. There are wooden poles on the railing of the pavilion section. At the end of the pavilion, protruding plain borders can be seen. There is a simple pulley and cone on the pavilion section. On the cone is a crescent made of metal. Between the ends of the crescent, "Allah" is written (Fig. 6).

Fig. 6. The view of the pulpit of the Kenan Dede Yanık Mosque
(photo by F. Bademci)
