The Impact of Material Selection on Durability of Exhaust Valve Faces of a Ship Engine – A Case Study

Hanna Smoleńska¹, Włodzimierz Kończewicz², Sylwia Bazychowska^{2*}

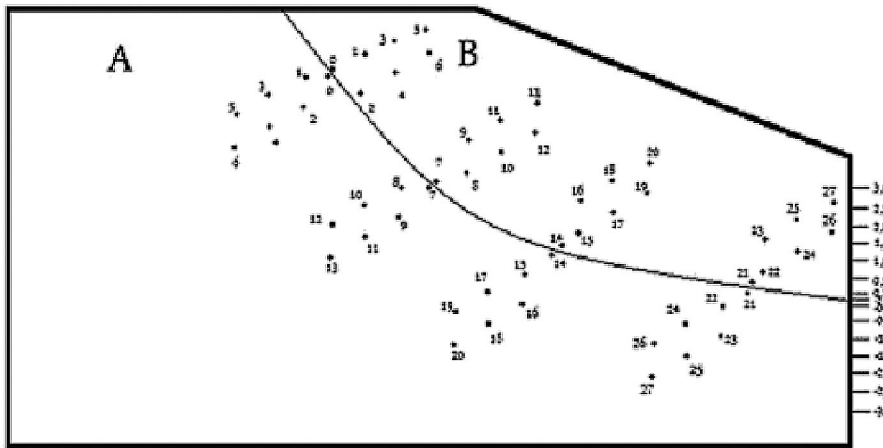
Fig. 9. Positions of the hardness measurement points on the cross-section of the clad layer and the substrate; A – steel base, B – cladding layer

After the operation period, the hardness profiles across the thickness of clad and substrate were measured on a FM800 hardness meter at 49N load using the Vickers method. Any hardness data reported here were statistic averages of at least four measurements. Due to the technology of applying the layer, the hardness measurement was carried out according to developed scheme shown in Figure 9.

Due to the heterogeneous structure of the material four measurement series were made, the mean hardness value and the confidence interval were determined. The non-uniform hardness across the coating was a result of multilayer producing process and structure of this layer. The heat affected zone (HAZ) was observed in the steel under the clad layer. From the morphological point of view, the measured differences in hardness

were affected by the dendrite structure and can also be attributed to the morphology of the carbides [6, 12, 16]. This phenomenon is related to the multiple heating and cooling during the multilayer cladding process. The heat treatment in high temperature and exhaust gases atmosphere may led to the changes in the hardness especially in the upper part of the clad. The results are shown in Figures 10–12. In each of the examined cases, the hardness of the surfacing layer was significantly higher than the hardness of the substrate. In the case of L12 sample hardness was found in the range 473 to 581 HV5.0 at distance 3mm from the steel-clad interface (close to clad top surface) and remained at a similar value to a distance of 1mm from the interface. In the fusion line hardness was rapidly falling to value 231-251 HV5.0. The obtained results indicate an uniform hardness of the entire weld. In the case of N sample hardness was
