DIAGNOSIS AND REPAIR TECHNOLOGY OF DAMAGED ELEMENTS OF CASA AIRCRAFT

Michał Salacinski
Piotr Synaszko

Air Force Institute of Technology, Warsaw, Poland

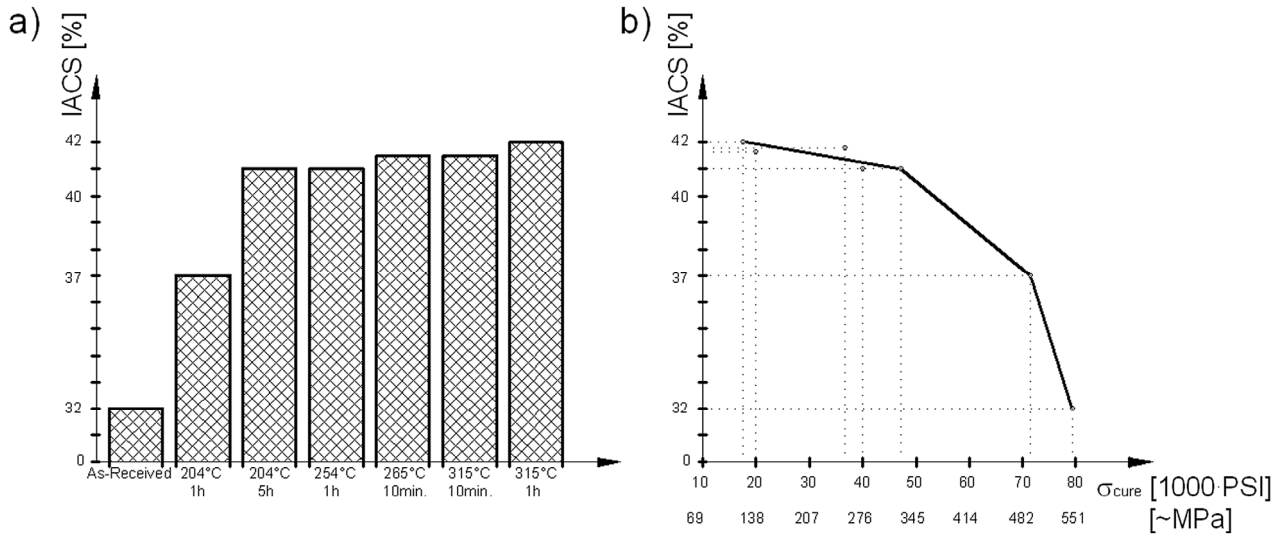
Fig. 2. The dependence aluminum alloy's conductive – module

There was discovered a relation between temperature and conductivity of aluminum alloy, as well as between conductivity and strength [3].

Based on NDT performance and the diagram (Fig. 2), the repair technology of riveting the alloy fastener to the longeron was developed. The properties of the alloy are same as those of the longeron (Fig. 11).

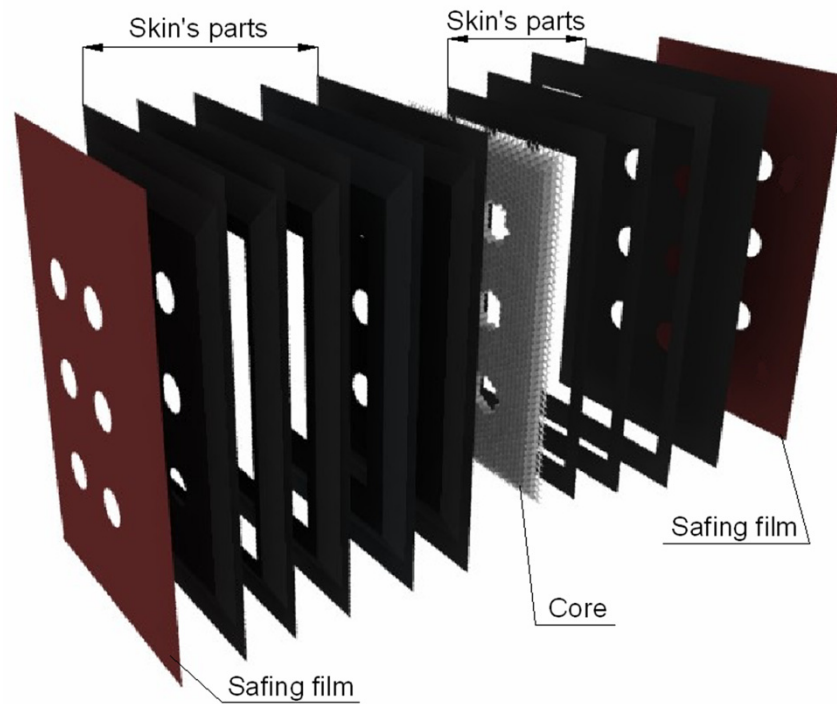
Fig. 5. Panel's structure

The fire caused failure in three composite elements, but this paper focuses on the vertical panel only (Fig. 1).

The fire caused disbonding between the skin and the core. The first step is removing the damaged skin and cleaning the core. The corner is a notch, so the corners radiuses should be increased.

The failure found should be repaired by different methods: replacing the damaged part with a new one, filling up with resin gaps between the skin and the core, removing and reconstructing the damaged panel's parts: the skin, core and protective layer.

The latter is the best method. It is a popular method, especially when the structure is resistant to fast changes of temperature in a wide range. Resin used in these composites is resistant to high temperature (up to $\sim 130^{\circ}\text{C}$), however, the temperature during the cure is still higher ($\sim 180^{\circ}\text{C}$). In these cases, temperature is usually reduced and time of cure is extended accordingly.

So, in such cases, composite elements are repaired using the wet layup method. It is important that the patch has properties equivalent to the original structure properties after curing.
