Miloslav Kopecký*, Martin Ondrášik*, Darina Antolová*

UNSTABLE SLOPES ON RIGHT-SIDE END OF THE DAM BODY OF LIPTOVSKÁ MARA WATER RESERVOIR**

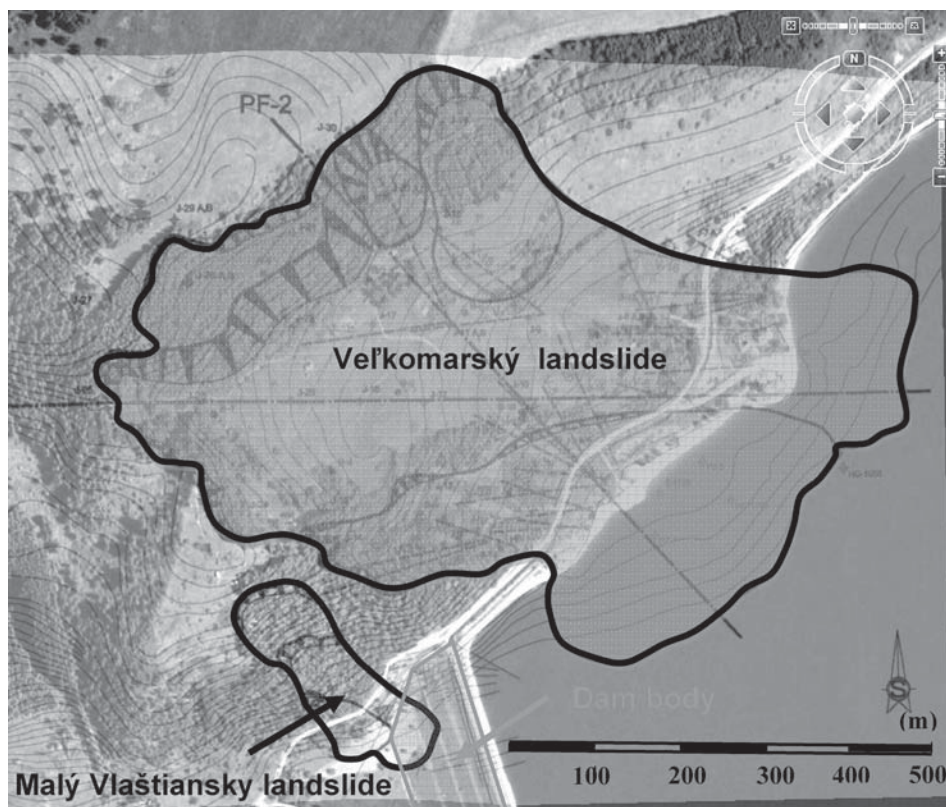
Fig. 2. Localization of the dam profile between Veľkomarský and Malý Vlačiansky landslides, (satellite photo by Google Earth)

On the right-side of the dam body of WR Liptovská Mara there are located two landslides. On the water-side bank it is Veľkomarský landslide and on the downstream face of the dam it is Malý Valčianský landslide (fig. 2).

The Malý Vlačiansky landslide is sited in close vicinity of the dam body, even part of its accumulation zone is located under drainage and stabilization foot slope of the downstream face of the dam body. The length of the landslide is approximately 320 m, width about 100 m. The landslide thickness ranges from 5 to 12 m.
