Aleksandra Borecka *

DESCRIPTION AND EVALUATION OF THE LANDSLIDE HAZARD. A CASE STUDY IN A LANDSLIDE IN RADZISZOW

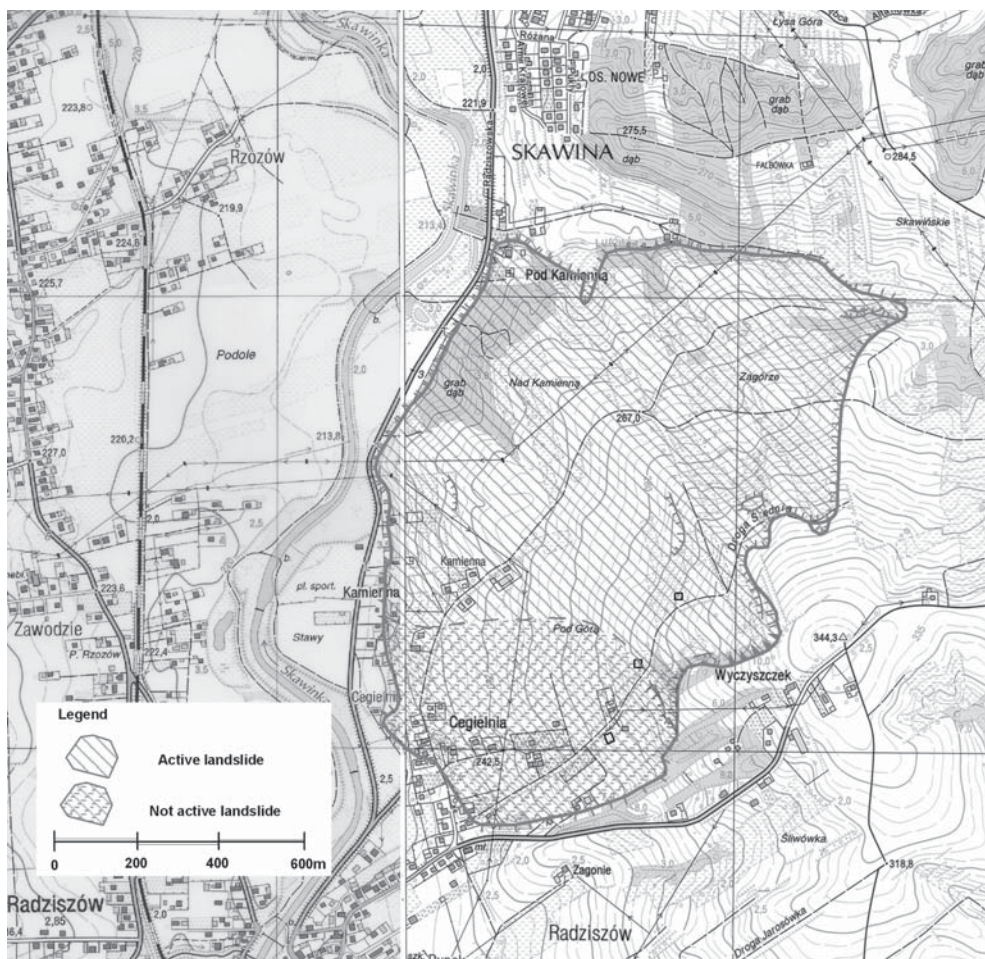
Fig. 1. The location of the landslide in RadziszówM-34-76-B-a-4 (Bukow), M-34-76-B-a-3 (Radziszów) [1]

incline at a considerable angle, which is the reason for the height difference of approximately 2 to 5 metres (Fig. 1.) The study area on the site planning is marked as a terrain for: a single-family and homestead building development (MNR), agricultural area (R), green wastelands areas (ZR) and, a small part, belongs to woodlands (ZL) [14]. The piece of land was heavily exploited as an agricultural area until the 1990s. Currently, it is idle land, covered with grass, bushes and trees. There are about 30 dwelling houses and more than 15 utility buildings in the study area. It is bordered by the valley of the Skawinka river from the west and by Lutowka Creek, which is the right-bank tributary of Skawinka. Its southern side, is adjacent to a valley where a local road from Radziszow to Bukow runs through. On its eastern side, it adjoins another landslide form. Hydrographically, it belongs to the Vistula basin, whose bed is about 5 km away north-westward. The surface runoff flows in a western and north-western direction.
