## NON-DESTRUCTIVE DIAGNOSTICS OF CONCRETE CANTILEVER BEAM AND SLAB BY IMPACT ECHO METHOD

Magdalena RUCKA<sup>1</sup>, Krzysztof WILDE<sup>1,2</sup>

<sup>1</sup> Department of Structural Mechanics and Bridge Structures, Faculty of Civil and Environmental Engineering, Gdansk University of Technology

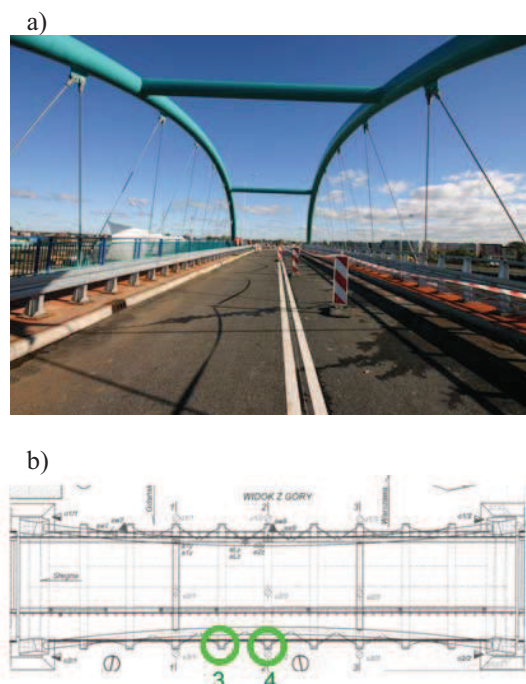
The object of the study is the road bridge (Fig. 2) in Nowy Dwór Gdański over the road no. 7 Gdańsk-Warsaw. During construction process the cantilevers of transverse beams were prestressed according to the plan (this state is referred here as 'state 0'). After prestressing process, cracks and cavities appeared on the cantilever surfaces (Fig. 3). Therefore repair operation was undertaken in the form of additional reinforcement and new gunite parts, but the cracks were not injected before gunite process. The aim of performed diagnostics was assessment of technical condition of cantilevers after repair (this state is referred here as 'state 1'). The impact-echo method was applied to non-destructive testing of the considered structure.

Fig. 2. The road bridge in Nowy Dwór Gdański: a) the photo; b) top view

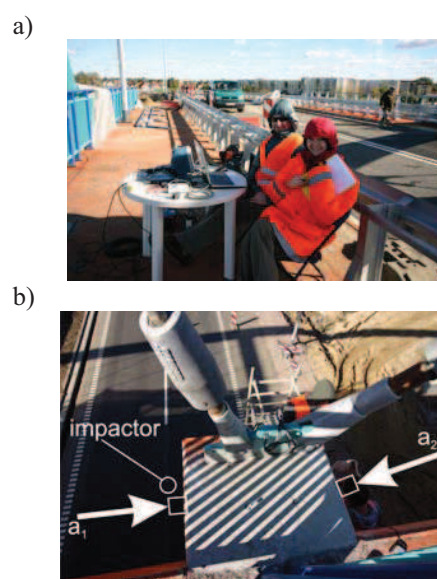
The photo of data acquisition setup is presented in Fig. 4. The elastic waves were induced by a mechanical impactor in the form of a steel ball with a handle. The diameter of the impactor was 5 mm, what enables excitation of waves of frequency up to 58.2 kHz. The propagating signal was registered by two accelerometers ( $a_1$  and  $a_2$  in Fig. 4b) connected to the oscilloscope.

Fig. 4. Field tests: a) instrumentation setup; b) cantilever under examination

Measurements have been made on two cantilevers, no. 3 and no. 4, as indicated in Fig. 2b. Waves were generated on the left side of the cantilever, while the accelerations were measured on the left side as well as the right side (Fig. 4b). Measurements were performed at selected 59 points distributed on the cantilever surfaces. Location of measurement point is illustrated in Fig. 5. The distance of the wave travelling was constant for each point and equal to 0.986 m.
