## SERVICE PROBLEMS OF AN AXIAL COMPRESSORS OF A LAND BASED, HIGH POWER, REACTION GAS TURBINES

*A compressor blade failure was experienced at the 69 MW gas turbine of a combined cycle (C.C.) unit after four years operation since the last overhaul. Three unit failure events occurred at small periods, which caused forced outage. Visual examination carried out after the failure events indicated that the compressor vanes (diaphragms) had cracks in their airfoils initiating at blade tenons welded to the diaphragm outer shroud at some stages. Also, many stationary vanes and moving blades showed foreign object damage (FOD), rubbing and bending. A compressor failure evaluation was completed including cracked vane metallographic analysis, unit operation parameter analysis, history-of-events analysis, and crack initiation and propagation analysis. This paper provides an overview of the compressor failure investigation, which led to identification of the vane high cycle fatigue (HCF) failure mechanism generated by rotating stall during unit start-ups, highly accelerated by corrosion generated by the fogging system and influenced by high stationary vane and moving blade brittleness as the pri

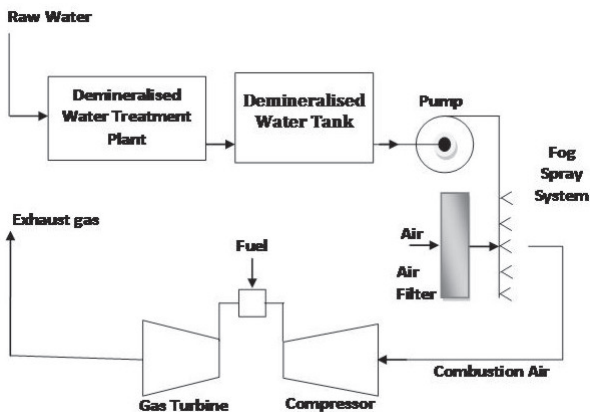
Fig. 1. Outline of the fog inlet air cooling system

Fog water nozzles were installed upstream of the compressor inlet air filter without any water filter/catcher before the water spray nozzles. Since the last overhaul up to the date of the first failure event in December 2008, the unit had accumulated 27,000 operation hours and 97 start-ups in total, and 740 hours operation and 4 start-ups with a fogging system [3]. Three failure events of the unit occurred at small periods. The first failure occurred in December 2008, a second event in March 2009 and

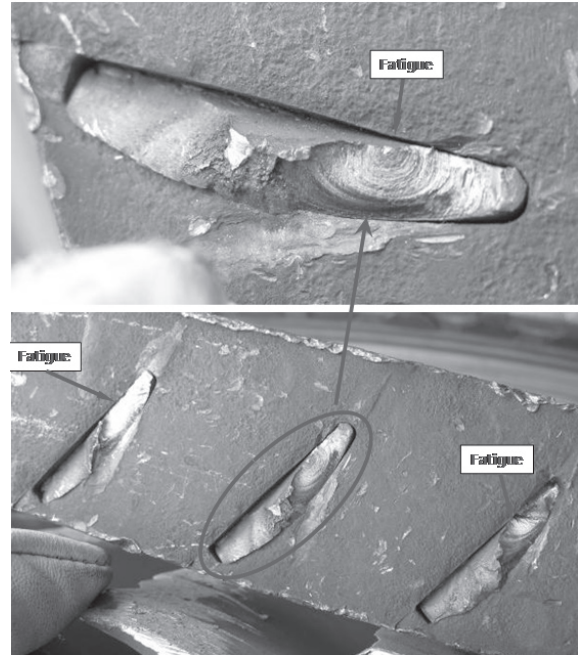
Fig. 12. Diaphragm first three vibratory mode shapes

Vane cracks were developed in the vane tenons at the outer shroud of the diaphragm (fig. 11). As mentioned before, these cracks were of the high cycle fatigue type (fig. 10) and initiated in the heat affected zone adjacent to the tenon weld. They were caused by vibratory stresses which occurred during start-up acceleration as a result of diaphragm resonance in one of its first three natural frequencies [7] with local air flow disruptions associated with the presence of rotating stall cells, as explained before, and upstream rotating blade wakes. The first three diaphragms vibratory mode shapes corresponding to mentioned previously diaphragms natural frequencies are shown in fig. 12 [7]. The manufacturer reported that the stress concentration factor due to the weld heat affected zone of diaphragm tenons is 3.5 approximately [7]. Due to this fact and the presence of corrosion pits on the vane/tenon, local stresses rise significantly in this zone, leading to fatigue failure initiation and propagation.

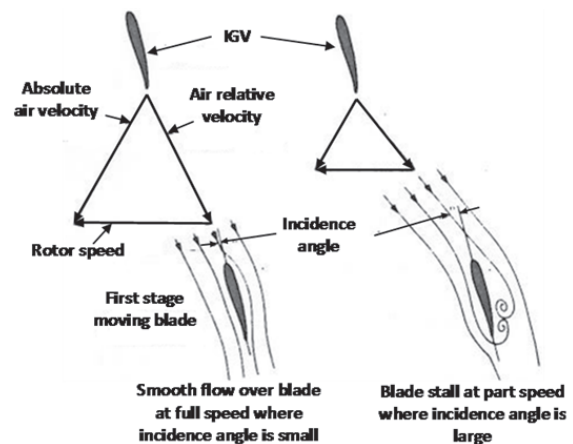
Fig. 13. Stall diagram in compressor blades when the incidence angle exceeds a boundary angle

The rotating stall phenomenon is generic to all axial flow compressors and can be explained as follows. The throat area and vane and blade angles at each compressor stage are designed to operate with maximum efficiency at full speed. In the low speed range, the air is not sufficiently compressed in the front stages to allow it to flow readily through the smaller throat areas in the rear stages. This choking in the rear stages reduces incoming air flow and, hence, velocity. This reduction in velocity in turn causes an increase in the incidence angle of air impinging on blades in the front stages. When this incidence angle exceeds a given amount, the blade in question stalls; i.e., the air flow separates from the suction side of the blade causing turbulence and low velocity flow (fig. 13).

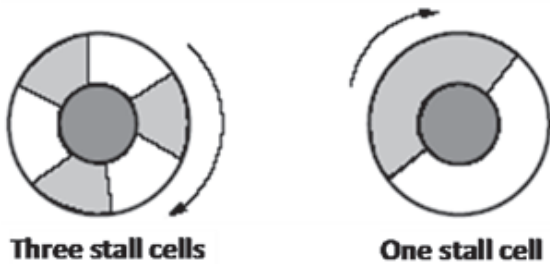
Fig. 14. Typical stall cell patterns.

This stalling does not occur simultaneously over all the blades in the stage but instead occurs as one or more pockets, called stall cells, distributed around the stage circumference (fig. 14). By a somewhat involved mechanism these cells rotate, hence, the term “rotating stall”. The speed range over which rotating stall can occur in the analyzed unit identified by the O.E.M. referring to the same frame is between 1500 rpm and 2600 rpm [7]. The manufacturer reported some similar cases of diaphragm failures in other units of the same frame caused by rotating stall [7].

There may be one to four cells present, with the number of cells decreasing with increasing speed, and they rotate at 50 % to 65 % of rotor speed [7]. Each time a stall cell passes over a rotating blade or stationary vane, the aerodynamic load on that component is sharply reduced as a result of low velocity flow in the cell. Hence, the effect of rotating stall cells is to induce vibratory stresses on vanes and blades. These stresses reach their maximum when the rotating stall excitation frequency or one of its harmonics is coincident with the blade natural frequency. The stall excitation frequency is relatively low even when compared to the blade first mode resonance frequency; thus only the higher harmonics will cause resonance and only to the first blade mode. However, due to the number of cells which can occur and their irregular shape and spacing, many harmonics of the fundamental stall excitation frequency can be present. Although rotating stall during start-up cannot be eliminated, its effects are minimized by modulating the inlet guide vanes (IGV) and increasing inter-stage bleeding. Normally the vibratory stresses generated at blades/vanes are low, but the presence of corrosion pits on blade/vane surfaces can dramatically reduce material fatigue strength, causing small surface cracks which propagate due to stress concentration at the crack front. Since rotating stall only exists in the low speed range, cracking is related to the number of startups rather than operating hours at full speed.

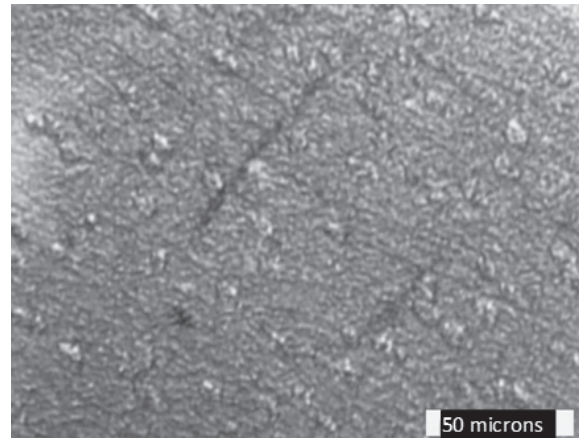
Fig. 15. Microstructure of AISI 410 alloy obtained by SEM

A metallurgical investigation of the failed vanes was carried out, including metallography, SEM (scanning electronic microscopy), fractography and chemical analysis. The vane airfoil zone microstructure is shown in fig. 15. The microstructure consists of tempered homogenous martensite typical for forged stainless steel according to specification AISI 410. Chemical composition and hardness tests of the failed vanes confirmed concordance of the blade material used to the design specification. The average blade material hardness was 24 HRC, which falls within design limits. Also, a hardness test was performed on the fracture surface of vane/tenon stage 13. The hardness

falls within the range 40–56 HRC. This value is very high (brittle material) and means that, after vane-to-shroud welding, no stress relieving process of the diaphragms was executed. Fractography evaluation was achieved on the exposed vane/tenon crack surface using scanning electronic microscopy (SEM) to determine the origin of the fracture. Fig. 16 shows a general view of the vane/tenon fracture surface. Two different zones were found: a dark zone with appearance of sudden fracture and a shiny zone with beach marks typical of a HCF failure mechanism.

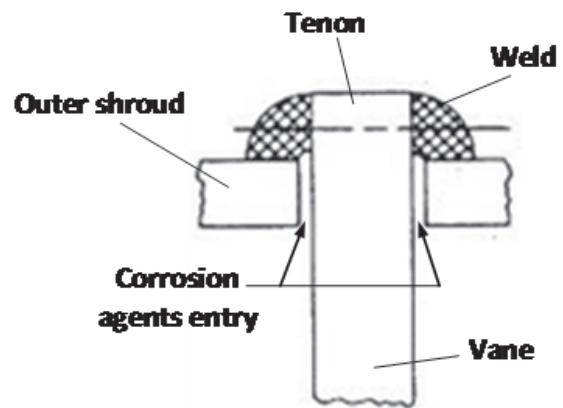
Fig. 20. Scheme of the union of diaphragm vanes with the outer shroud

results revealed that fracture initiation points were localized in corrosion pits that raise local stresses compared to the original unaltered surface. Corrosion products (deposits) were also found in the same zone. The fog water nozzles had been installed upstream of the compressor inlet air filter without any water filter/catcher before the water spray nozzles. Because of this, many compressor stages operated with humid air which, in contact with corrosive agents, developed a corrosion process. These findings lead to the conclusion that blade high cycle fatigue failure initiation and propagation were highly influenced by corrosion processes. From fig. 20 it can be appreciated that the existence of assembly clearances between the vane and outer diaphragm shroud is an open way for corrosive agents to deposit on the vane/tenon heat affected zone (weakest zone), causing corrosion pits that lead to accelerated fatigue initiation of the vane/tenon.

Severe FOD impacts on the vanes close to the diaphragm outer shroud during the first failure event (December 2008) could generate sudden partial fractures of the vanes/tenons due to their high hardness and related brittleness, as appears in the dark zone in fig. 16. Diaphragm stages 13 and 14 in which vanes/tenons fatigue fractures occurred during the third failure event (fig. 10, May 2009) operated continuously since the overhaul in 2005 and were present during all unit failure events. These vanes were probably fractured partially during the first failure event by FOD and not detected by non destructive examination. As can be seen in fig. 11, if tenon fracture is localized within the diaphragm outer shroud width (not propagated to the vane airfoil), this fracture is covered by the weld and outer diaphragm shroud, making it impossible to detect by the magnetic particle examination commonly used for diaphragm non-destructive testing. It supports the conclusion mentioned above that tenon partial fractures (dark zone in fig. 16) were developed during the first failure event. This conclusion is supported also by the chemical analysis of the vane/tenon fracture surface presented in fig. 19, which indicates that the fracture dark zone (fig. 16, sudden fracture) is more oxidized than the shiny zone (fatigue fracture), meaning that sudden fracture was developed some time before fatigue fracture. A pre-existence of initial sudden fractures at the vanes/tenons before the unit third failure event is also supported by the fact that vane fatigue failure soon developed during the third failure event after only two unit start-up attempts. Diaphragm vanes are joined to the shrouds by one

weld in the case of stages 12 to 19 (fig. 21a) and by two welds in the case of stages 1 to 11 (fig. 21b). It may be seen from fig. 21 that the joint with two welds (fig. 21b) provides a better distribution of flexural moments ( $M$ ) because each weld is loaded by half of the moment ( $M/2$ ). In the case of joints with only one weld (fig. 21a) the load is twice as high, and the probable failure of this joint is much greater. During the first and third failure events, vane fatigue fracture is related to rotating stall initiated at vanes of the front stages, before air bleeding, see fig. 2a) and fig. 2c) which is consistent with the rotating stall mechanism described in previous sections. Fatigue fracture of the rear stage vanes, after air bleeding during the third failure event (fig. 2c) is related to upstream rotating blade wakes associated with rotating stall. Also, the weaker vane-to-shroud weld joint design of the rear stages (fig. 21a) accelerated the fatigue fracture of these vanes. Other possible causes of vane failure were verified including IGV angles and IGV schedule control logic, excessive water injection by fogging (water overspray), possible off-design operating conditions and compressor blades/vanes degradation, but no related irregularities were found.
