## SUSTAINABLE RESTORATION OF THE ROOF OF A LARGE INDOOR POOL

**Abstract:** During an inspection of the roof of an indoor pool from 1971 in Potsdam (Germany) it was observed, that the roof and the column structures of the building are partially damaged by corrosion. The roof construction is a suspended simple-bent pre-stressed shell between two stiff edge beams. The span of the roof is 39.5 m. The edge beams are supported by A-frames. After further investigation on the damaged areas (including tension tests, tension tests on notched tendons with different load cycles, tests of the bearing capacity of sleeve splices and screw nuts) the conclusion was that the joint of the tension rod and the concrete column had to be restored. This was accomplished through the attaching of a new supporting construction to the existing parts, which took over the load from the old connection. At both sides of the columns pre-stressed DYWIDAG-single-tendons (St1080/1230, diameter of 36 mm) were used. They have to bear a maximal tension force of 835 kN. With this unusual restoration technique, a fast and relative inexpensive retrofitting of the construction could be carried out. The existing constructi

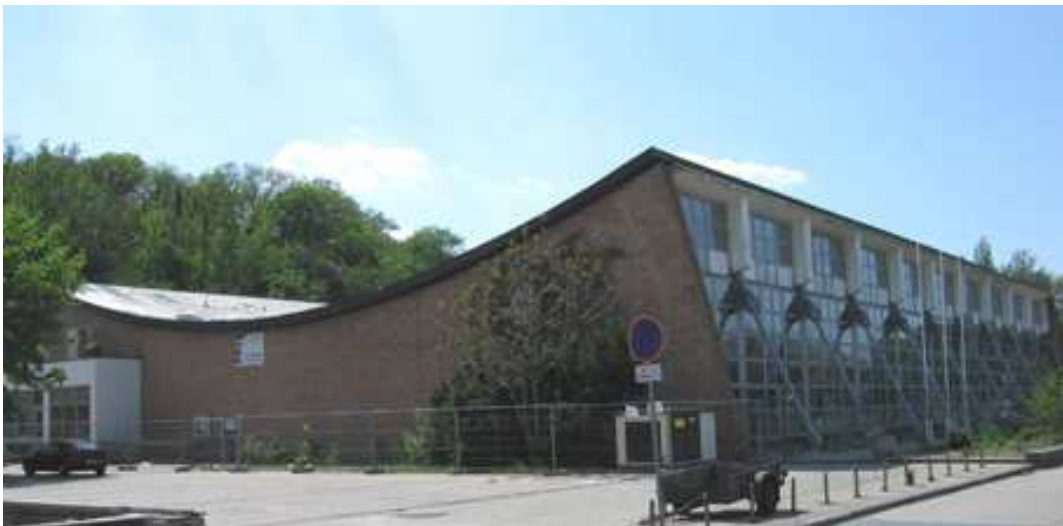
Fig. 1. The indoor swimming pool.

The indoor pool was completed in 1971. Already at the end of the 80's the roof construction turned out to be leaky. That is why first restorations and modernisations were done at the beginning of the 90's. In 2006 the indoor pool was temporarily closed because of heavy damages on the construction.

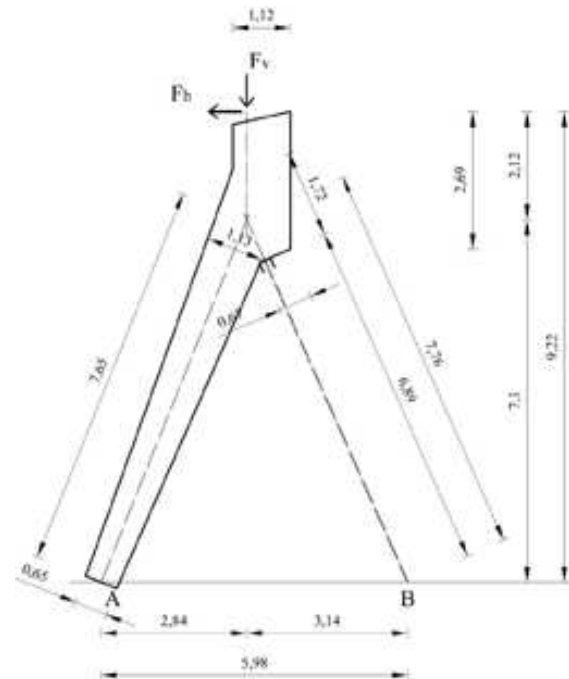
The columns (Fig. 3) on which the edge beams bear on are prefabricated A-frames. They are 9.22 m high and below the height of 2.69 m divided into a tension rod from steel and a compressed rod from concrete, with a span of 5.98 m at their foot. The head part and the concrete bar are rectangular concrete sections which are restricted to their foot. The tension rod is a steel eye bar with

Fig. 3. The geometry of the columns.

a 200×150 mm cross section in the middle of the bar and 200×355 mm cross sections with 122 mm diameter pinholes on its ends. The head part has a length of 2.177 m, the compressed bar a length of 7.65 m and the tension rod a length of 7.76 m.

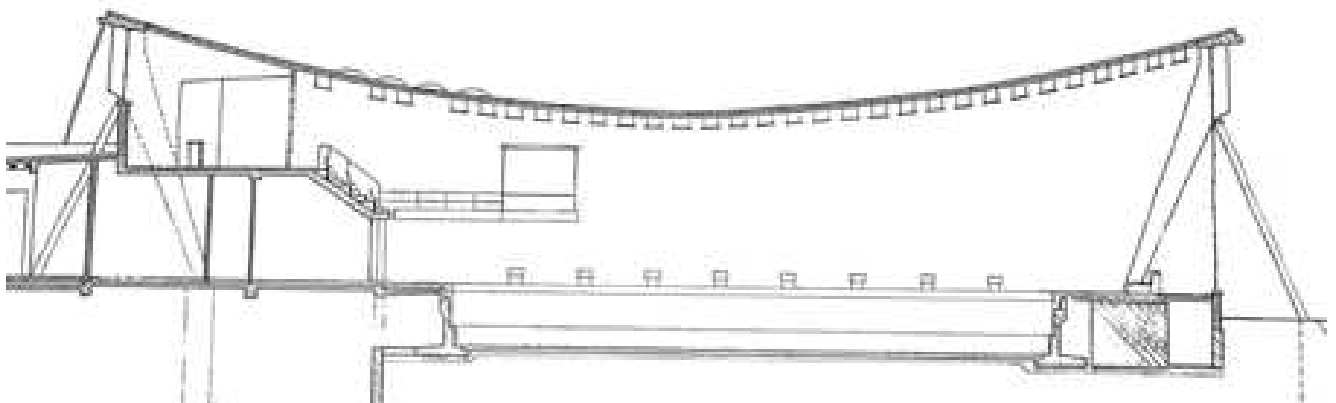
The roof construction over the hall area is a suspended simple-bent prestressed shell between two stiff edge beams (Fig. 2). The span width of the roof is 39.5 m. The edge beams are supported by A-frames. The walls are entirely separated from the roof. Between the edge beams cables are hang up. The roof cladding is made from prefabricated concrete panels which are connected with suspension hooks to the cables and have small steel pins at the cables to provide a shear-proof connection between each other. The longitudinal groove is made of C25/30 concrete. In the groove are 4 longitudinal reinforcing rods (2  $\varnothing 10 + 2 \varnothing 12$ ) with a yield stress of 400 N/mm<sup>2</sup> and every 20 cm flat  $\varnothing 6$  binder with a yield stress of 220 N/mm<sup>2</sup>. The concrete panels are 4.5 cm thick. The corrosion protection of the steel parts in the roof construction should be ensured by the prescription of a minimal concrete coverage and a coating with epoxide resin containing paint.

Fig. 2. The section of the roof structure of the building.

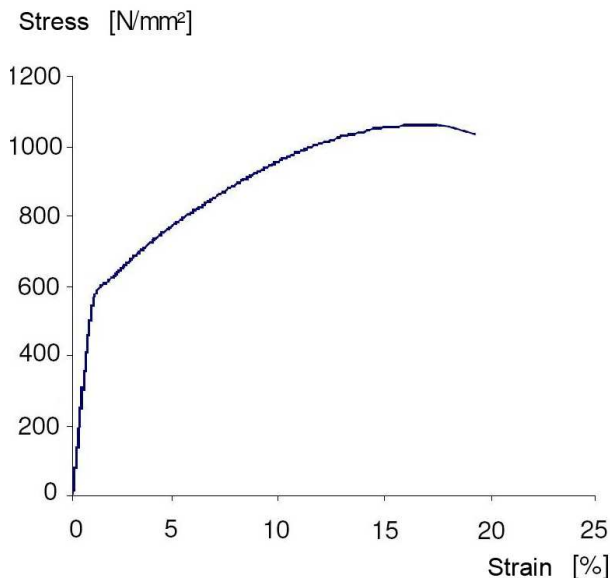
After the tension tests the stress-strain curves were calculated on the basis of the load-displacement diagrams. The values of the tensile strength as well as the ultimate strain and the contraction at failure were determined through calculations. The determination of the yield point  $R_{p0.2}$  was made graphically based on the stress-strain curve with an appropriate big scale. The values of the yield strength  $R_e$  can not be specified, because the material shows a discontinuous transition from the elastic to the plastic region.

In Table 1 it can be seen, that the measured yield strength of the material St 60/90 lies between 556 and 566 N/mm<sup>2</sup>, what is under the nominal yield strength of this steel of 600 N/mm<sup>2</sup>.

Fig. 5. The stress-strain curve of the specimen Z-1.

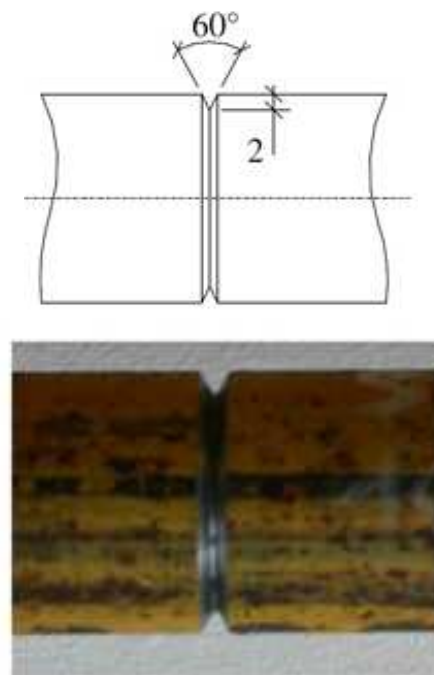
Within the tests on the notched bars round specimen were tested with a rising tensile load with 1 000 and 10 000 load cycles. This was made to investigate the behaviour of the tendons in case of a sectional weakening, caused by corrosion or potential notches. These round specimen are made from the material of the roof construction. At the fabrication the original diameter of the tendons was kept and a 2 mm deep revolving notch with an angel of 60° between the sides was milled. In the notch base is according to the geometry of the machine a radius of ca. 0.1 mm (Fig. 6). The tests were carried out with 1 000 and with 10 000 load cycles. The load was applied with a sinusoidal cycle with a frequency of 1 Hz. The test duration was according to that 17 minutes at 1 000 cycles and 170 minutes at 10 000 cycles. The summary of the results of the tests are shown in Table 2.

Fig. 6. The rod with the circumferential groove.

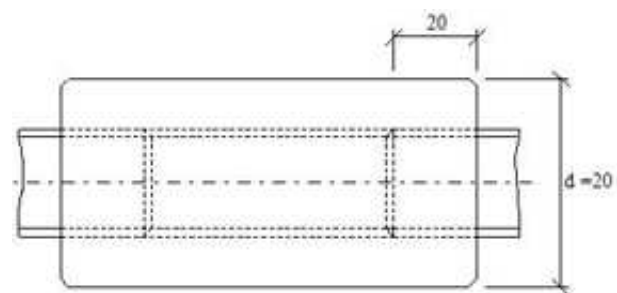
For the bearing capacity tests of the sleeve splices, four sleeves from S235J2G3 were fabricated according to the plans at hand. The length of load transmission is 20 mm on both sides of the sleeves (Fig. 7). Table 3 shows the relevant loads and the causes of failure for the particular sleeve splices.

Fig. 7. The sleeve splice.

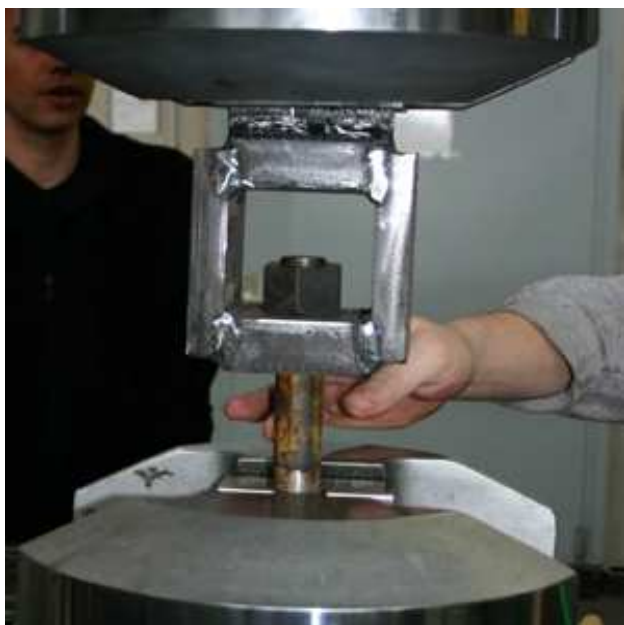
For the bearing capacity tests of the screw nuts, a device was built according to Figure 8 for a tightening test. The diameter of the hole is  $d = 30$  mm, the nut was shortened to 28 mm. The peak load for the failure here was  $F_{\max} = 461$  kN. The limit of elasticity lied at  $F_e = 171$  kN. The displacement contains the unavoidable deformation of the load transmission device. The cause of the failure was in the majority of cases the fracture of the tendon at the end of the thread.

Fig. 8. Experimental set-up for the load capacity test of the screw nut.
