THE CONDITION ASSESSMENT OF IN-SERVICE VANES OF GAS TURBINE NOZZLE UNIT WITH HELP OF DIGITAL ANALYSIS OF VANE SURFACE

Mariusz BOGDAN, Józef BŁACHNIO

Białystok Technical University

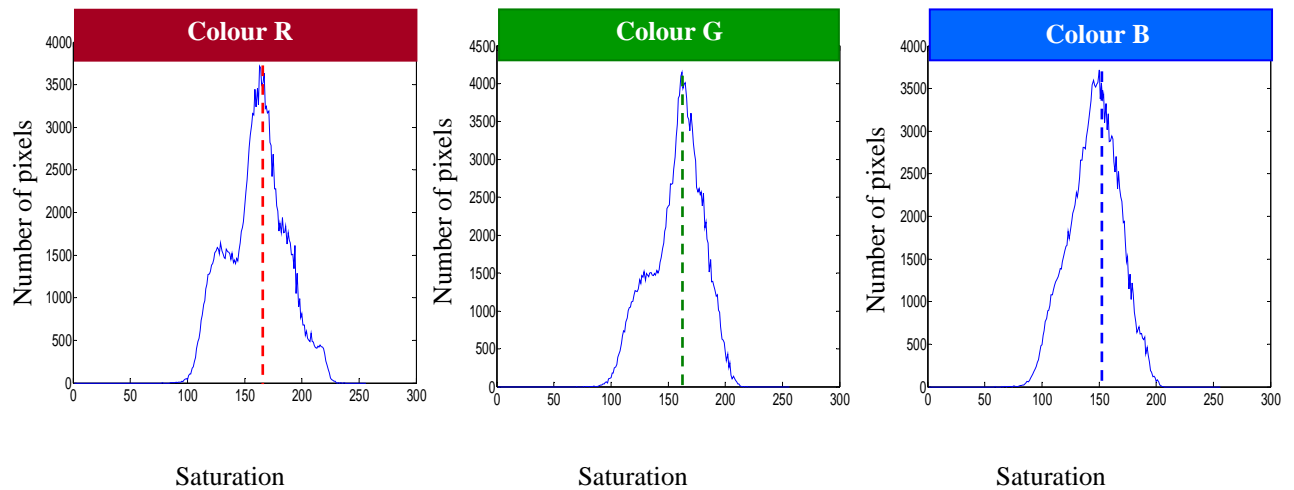
Fig. 8. Histograms of distribution of basic RGB colours for the vane in state V

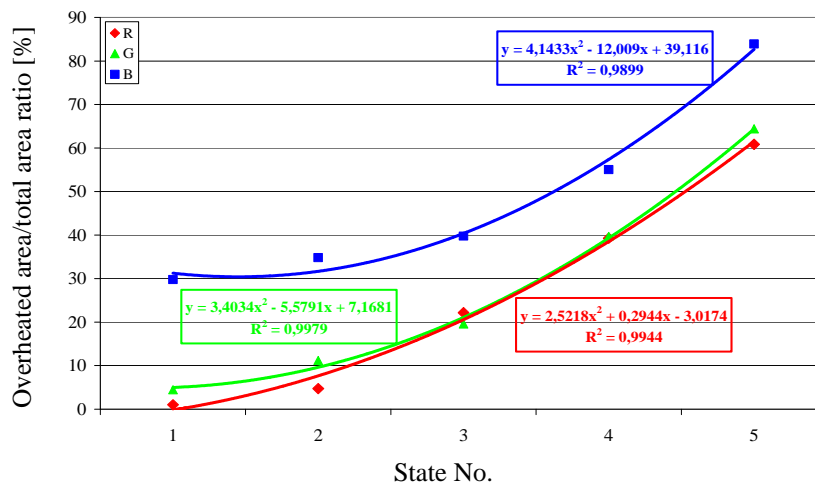
As the technical condition of vanes deteriorates, the overheated area increases (the set of image pixels) – figs. 9c, 10c. The introduction of the plane (criterion of overheating of vane material) to 3D graphs of distribution of RGB colours for images of surface of examined turbine element allows determination of overheated area/total area ratio (fig. 11). The same relation was determined for images recorded with two videoscopes (fig. 12).

Fig. 11. Overheated area/total area ratio – images recorded with digital camera

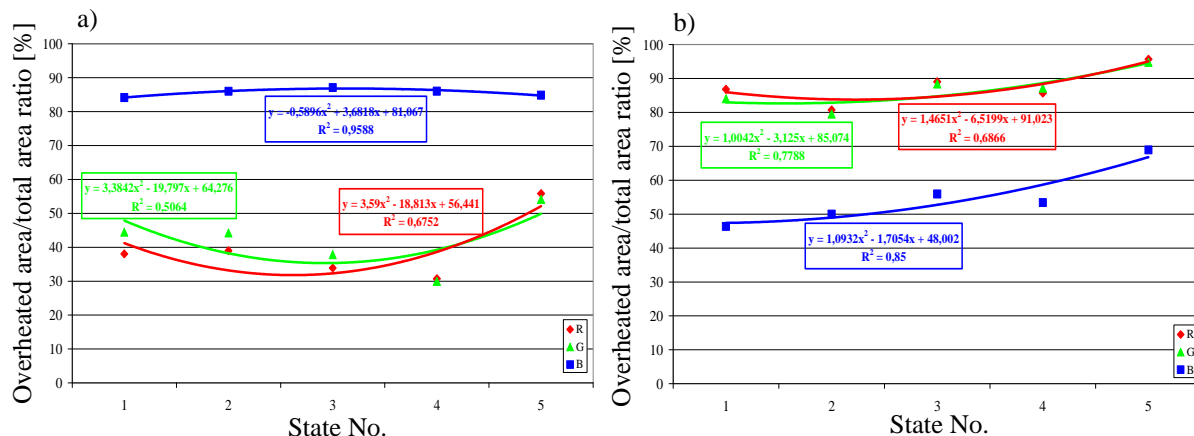
Fig. 12. Overheated area/total area ratio: a) images recorded with a Japanese videoscope; b) images recorded with an American videoscope
