FAILURE OF GAS TURBINE CONE BURNER BY CARBURIZATION

Abstract

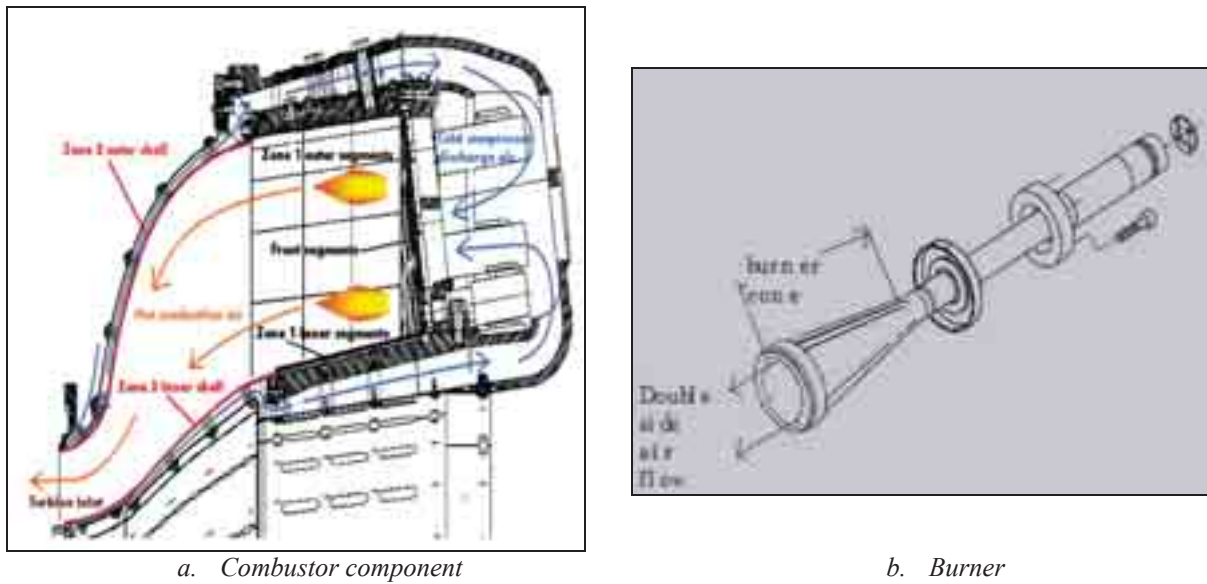
Fig. 1. Annular combustor in gas turbine engine [4]

The gas turbine engine (133.8 MW, 3000 rpm) was commissioned in 1997 and has 72 annulus burners. High-speed diesel oil fuel is injected into the combustion chamber and at the same time, water is also injected through oil lance tip nozzle. The purpose of water injection is to soften the flame and reduced the emission (NOx), and to increase the fuel flow rate that will shift the flame forward. The inhomogeneity of water and fuel distribution will result in inhomogeneous combustion that can damage the burners. Fig. 1 shows the schematic of combustion chamber and the geometry of the annulus burner.
