A. ZIEWIEC*, J. CZECH**, E. TASAK*

WELDED JOINT CRACKING IN MARTENSITIC STAINLESS STEEL PRECIPITATION-STRENGTHENED WITH COPPER

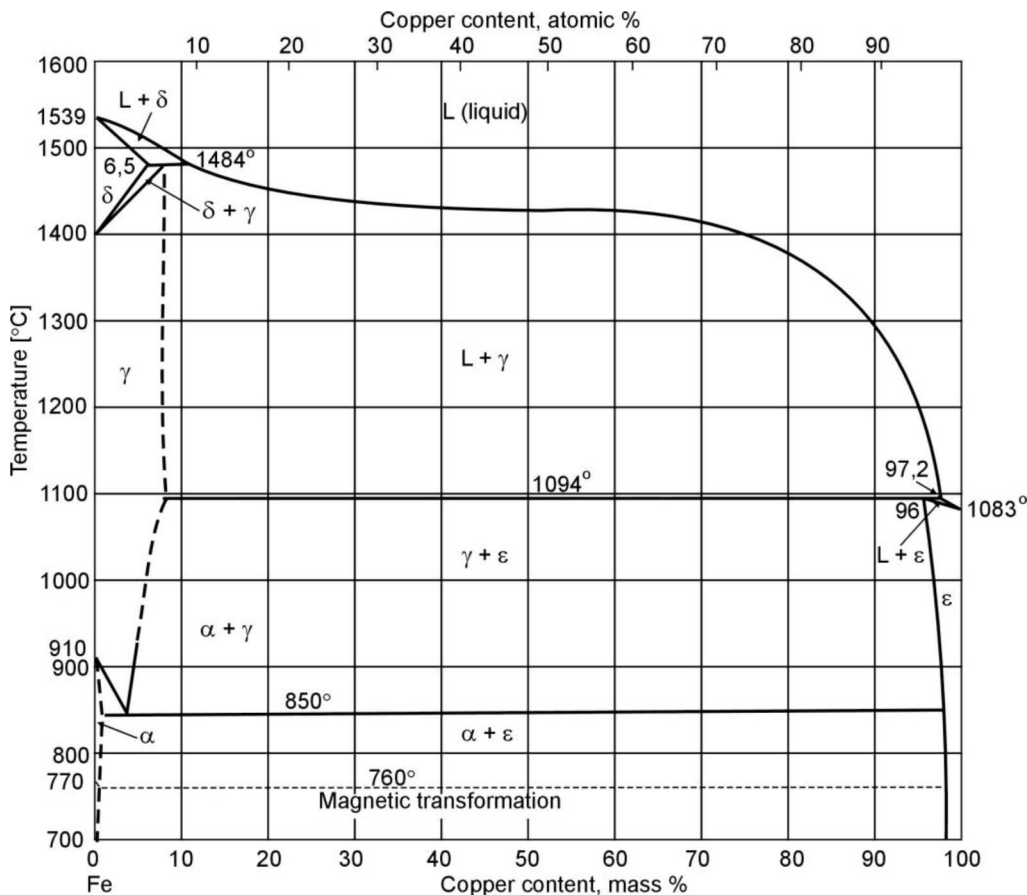
Fig. 9. Fe-Cu equilibrium diagram [9]

It is also possible that Cu vapours are being oxidised in the shielding gas stream and then Cu oxides would be deposited on the base metal surface. Melting point of Cu_2O is approx. 1200°C and for Cu_2O -Cu eutectic it is approx. 1065°C . Therefore, in the area adjacent to the weld bead, where temperature on the steel

surface may reach around 1100°C a liquid layer of pure Cu or Cu_2O may be present. The weld shrinkage during cooling causes the development of stresses and that produce deformation of the material in the vicinity of the weld joint. This deformation in the presence of a liquid phase on the base metal surface results in a hot cracking phenomena. Small amount of liquid promote the development of shallow cracks – up to an observed maximum of $50\ \mu\text{m}$. The development of liquid phase on the base metal surface can be facilitated by relatively little Cu enrichment. Enrichment at the level of 8% of Cu is sufficient to develop liquid phase containing 97.2% of Cu (Fig. 9) as a result of incipient melting at 1094°C [4]. Therefore, even slight enrichment in copper may lead to development of a liquid phase rich in copper, which has a very high wettability of steel and causes hot cracks in the presence of tensile stresses. In the literature [5t÷8], this type of hot cracking in the presence of liquid metals is referred to as LME – Liquid Metal Embrittlement. It must be stated that without tensile stresses and the deformation caused by them – LME does not occur and base material is enriched in Cu by diffusion mechanisms.
