MAREK INEROWICZ, BOŻENA JUSZKIEWICZ, MACIEJ WERNO

Department of Geoen지니어ing and Geoecology
Maritime Institute, Gdańsk

CLIFF RECONSTRUCTION AT JASTRZĘBIA GÓRA

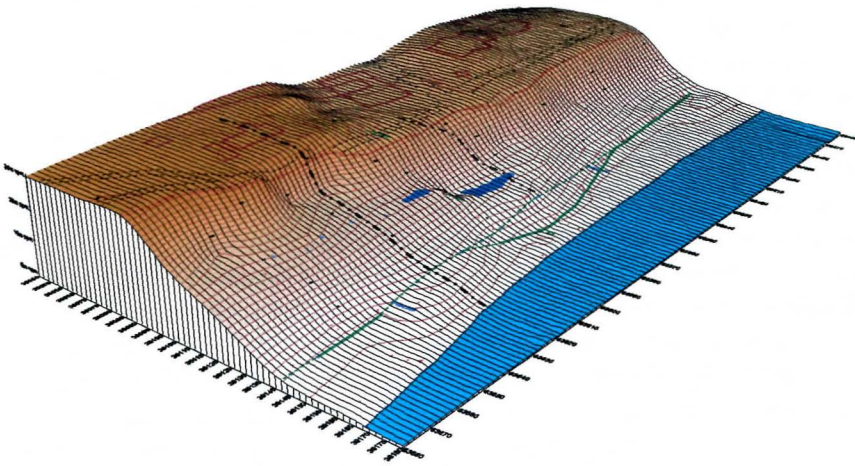
Calculations of stability confirmed that the basic cause of deterioration of the cliff along the investigated stretch is the decrease of shear strength of cohesive soil at the contact with thin water-bearing sandy layers.

Fig. 3. Numerical model of the cliff surface before reconstruction

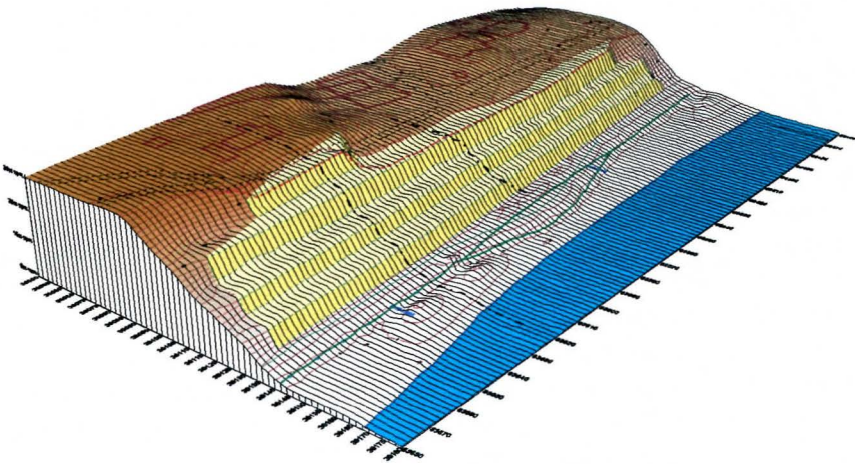
Fig. 4. Numerical model of the cliff surface after reconstruction

In this situation, it was evaluated that for the conditions of the discussed stretch of the Jastrzębia Góra cliff, the most proper and safe method consists in reconstruction the cliff slope with reinforced soil, to its natural shape with two or three landslide steps.

To obtain this objective, first a part of the coluvium is removed, and a horizontal draining system and draining cuts are made. Next, a slope is built of medium and coarse sand and protected from the outside with three or four blocks of reinforced soil, each of 6 metres height, about 6 metres width and a 60° slope. The adopted length of reinforcing (block width) is determined by the condition that this angle of the slope must be maintained. The berms between the consecutive blocks are models of landslide steps occurring in the natural cliff. In this method, the maintenance of cliff slope stability is influenced by three elements:

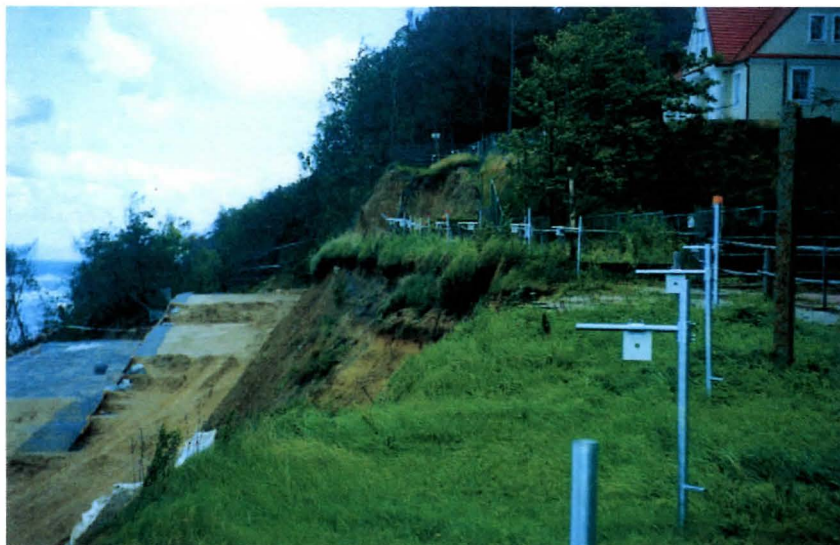
To ensure safety of people working directly under the uncovered slope of the cliff, the Maritime Institute developed and installed a laser emergency system. The principle of operation of the system consists in starting visual, sound and telephone alarms at the moment of appearance of some cliff edge displacement, indicating that a landslide may occur. The signals are generated by a break in the reception of a laser beam at one of the measurement sections installed along the top of the cliff. (Fig. 9). Each 20 m long section consists of 5 benchmarks placed along a straight line. On the outer benchmarks are fixed, on the opposite sides of the section, a laser light emitter and receiver. The benchmarks between the emitter and receiver have shields with a hole in their centre, through which passes the laser beam. If any of the benchmarks is displaced, the beam falls out of the hole causing a break in the reception of the beam at the receiver. This in turn, by means of an optical wave-guide system and electronic system installed in each section, generates a visual alarm (alarm lamp), an audible alarm (warning horn) and a telephone communication with information directed to the Construction Manager. To protect against unnecessary alarms caused by covering the laser beam by e.g. animals and people, the alarm is delayed 30 s from the moment the laser beam is broken.

Fig. 9. The laser emergency system on top of the cliff
