DRAGANA NIŠIĆ*[#], DINKO KNEŽEVIĆ*, NIKOLA LILIĆ*

ASSESSMENT OF RISKS ASSOCIATED WITH THE OPERATION OF THE TAILINGS STORAGE FACILITY VELIKI KRIVELJ, BOR (SERBIA)

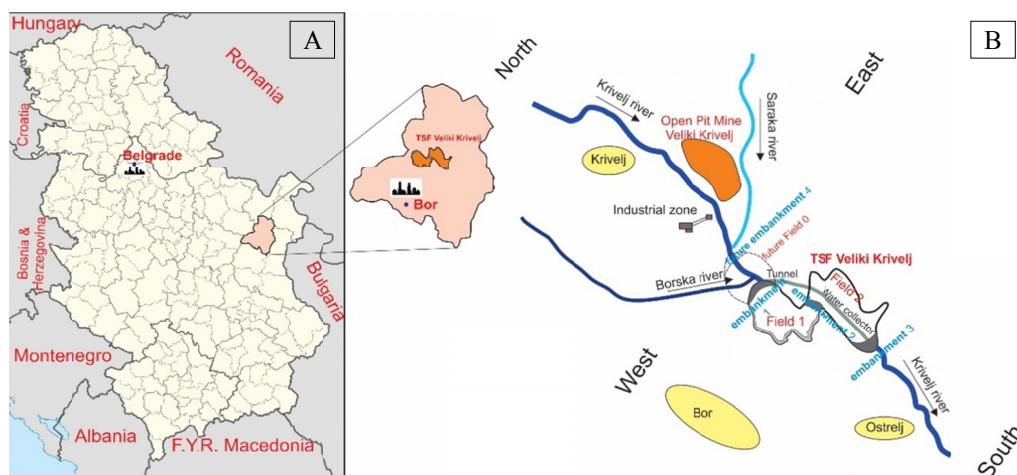
One of the largest TSFs in Serbia is TSF Veliki Krivelj, which is located at about 5 km from Bor (Fig. 1A). This facility was created by damming the Krivelj River valley. It was divided into 2 independent fields. Field 1 was formed by damming the valley with initial embankments, the upstream embankment 1 and the downstream embankment 2. Field 2 was formed by a downstream extension of the TSF and the construction of the downstream embankment 3.

Mining operations commenced in Field 1 and continued from 1982 to 1990. After that the works moved to Field 2 where mining terminated by 2008, at which point Field 1 was reactivated (Fig. 1B).

Fig. 1 Map of Serbia with the location of the TSF Veliki Krivelj (A), Layout of TSF Veliki Krivelj (B)

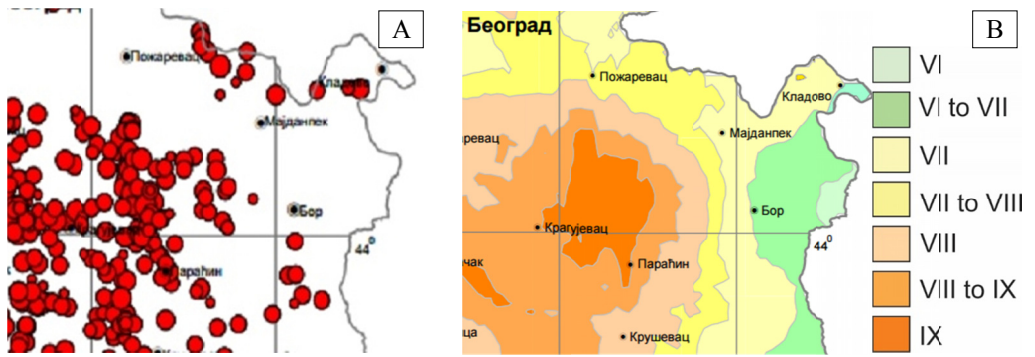
According to the seismic hazard maps in Serbia (Radovanovic, n.d.) for the return period of 475 years (Fig. 2), Bor has never been the epicenter of major earthquakes and this region belongs to the macroseismic intensity scale that ranges between VI and VII degree, according to EMS-98. The earthquakes of this intensity are denoted as “Slightly damaging“ to “Damaging“. Possible consequences are referred to as moderate to noticeable damages to buildings creating consternation and fear in exposed individuals (Seismological Survey of Serbia, n.d.).

After comparing these results it is possible to infer that the factor of safety obtained for dynamic loading is within the prescribed values, which confirms the stability of the TSF Veliki Krivelj in case of possible earthquake events (Institute for Standardization of Serbia, 1980; MMI Bor, 2016). Therefore, the likelihood of seismic hazard scenario is negligibly small, according to the table 1.

Fig. 2. A: Epicenters of the largest earthquakes in Serbia in the period 1456-2012, B: Seismic hazard in Serbia for the return period of 475 years

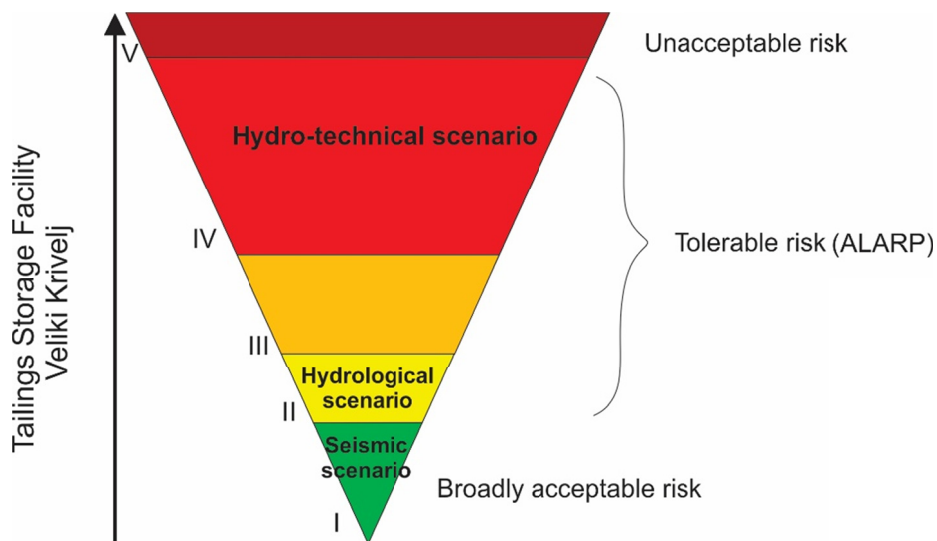
We can acknowledge that there is always a risk involved, but its acceptability is changeable and adaptable. If we analyze the acceptability of risk according to the modified “As Low As Reasonably Practicable” (ALARP) diagram the seismic hazard scenario at the TSF Veliki Krivelj can be classified as a broadly acceptable risk (Fig. 6), which respectively results in a negligible risk ranked with 1. As for the hydrologic hazard scenario the risk is slightly higher, and with factor 4 and rank 2, it belongs to conditionally acceptable risks.

As previously established the hydro-technical hazard scenario is the least favorable, with the highest risk factor (12) it was ranked as high, conditionally acceptable risk (4). The risk with such ranking can easily pass into the category of unacceptable risks, if adequate measures are

Fig. 6. ALARP diagram (David & Wilkinson, 2009)

not taken. More specifically, the hydro-technical hazard scenario, due to which the operations at the TSF may seem unacceptable, is the result of the poor functioning of the drainage system at embankment 1. This situation can cause the increase of seepage water levels and consequently the instability or ultimately embankment failure or break.
