The analysis of temperature disintegration on the body of fuel injector during research on test bench

Key words: *infrared camera, Common Rail system injector, injection and return dosages, fuel high pressure pump, CI engines*

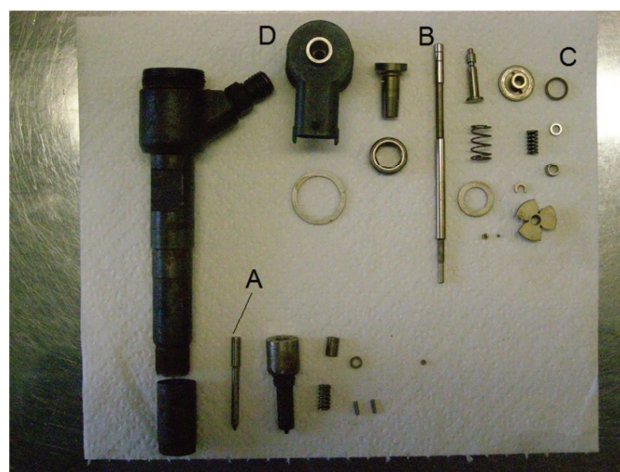
Fig. 1. Electromagnetic Bosch fuel injectors. A – precision element on injector needle, B – fuel injector steering valve, C – valve sealer, D – fuel injector coil

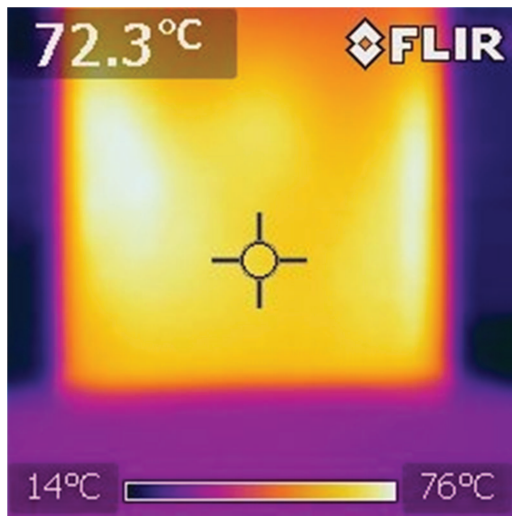
There is possibility to analysis temperature injected fuel (Fig. 3) using infrared camera. Fuel temperature influences on corrosion, cavitation, erosion and friction phenomena. This parameter could be useful to determine phenomena inside injector nozzle.

Fig. 3. Temperature of injection fuel

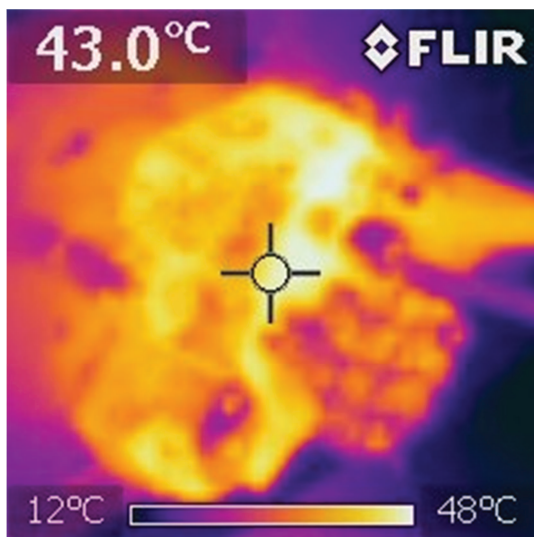
There is opportunity to research fuel injection pump especially high pressure section. If there are leaks it would be visible using infrared camera. Figure 4 presents the picture of high pressure injection pump during research on the bench.

Fig.4. Temperature of fuel injection pump

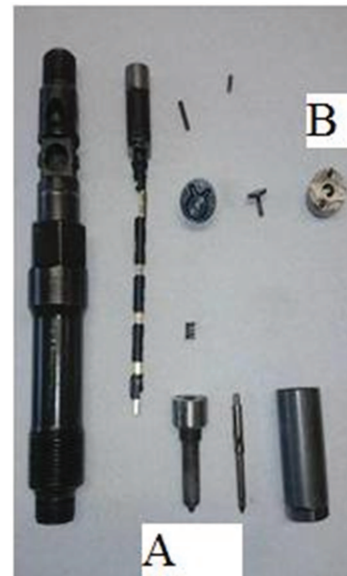
Fig. 5. Electromagnetic Delphi fuel injector dismantled on spare parts: A – injector nozzle area, B – steering valve and electromagnetic coil area
