## THERMAL FATIGUE PROBLEMS OF TURBINE CASING

Lucjan Witek

### **Abstract**

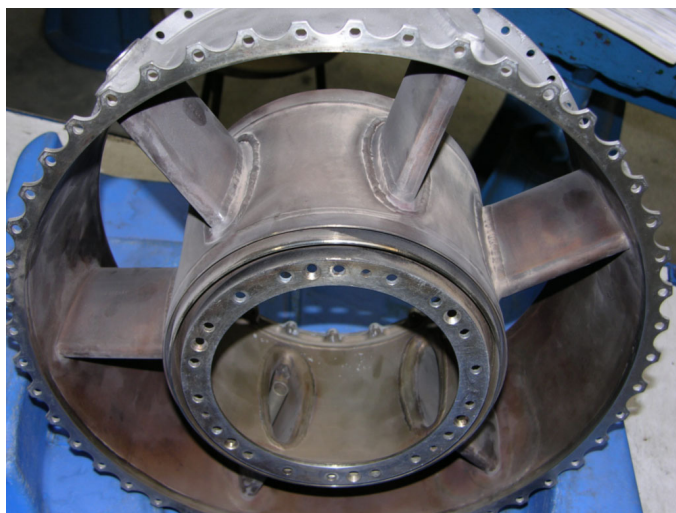
The turbine casing, which joins the power turbine section with an exhaust manifold and a transmission box (Fig. 1), is one of many parts of engine in which the complex thermal and mechanical loads occurs. On the internal surface of casing the bearings of power turbine are mounted, thus in this area the dynamic forces derived from turbine shaft are imposed. The second mechanical load is the elevated pressure of the combustions gases acting on the internal surface of the casing. Additionally the non-uniform temperature field contributes to high stress gradient appearing in turbine casing. Moreover, a corrosion environment of hot exhaust gases has also negative influence on its longevity.

**Fig. 1. View of a turbine casing for small helicopter turbo-engine.**

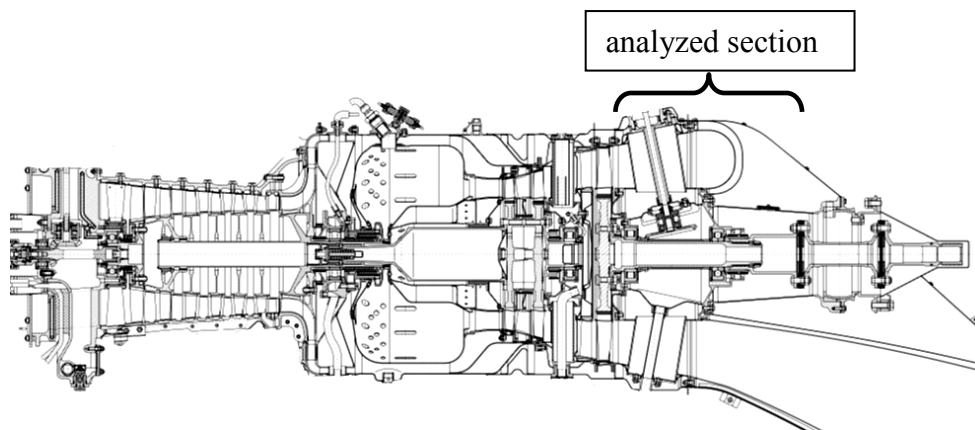
Fig. 3. Cross-section of engine with marked the turbine casing [4].

The component of engine (turbine casing) in which the fatigue cracks were detected is located between power turbine section and the exhaust manifold/transmission box section (Fig.3).

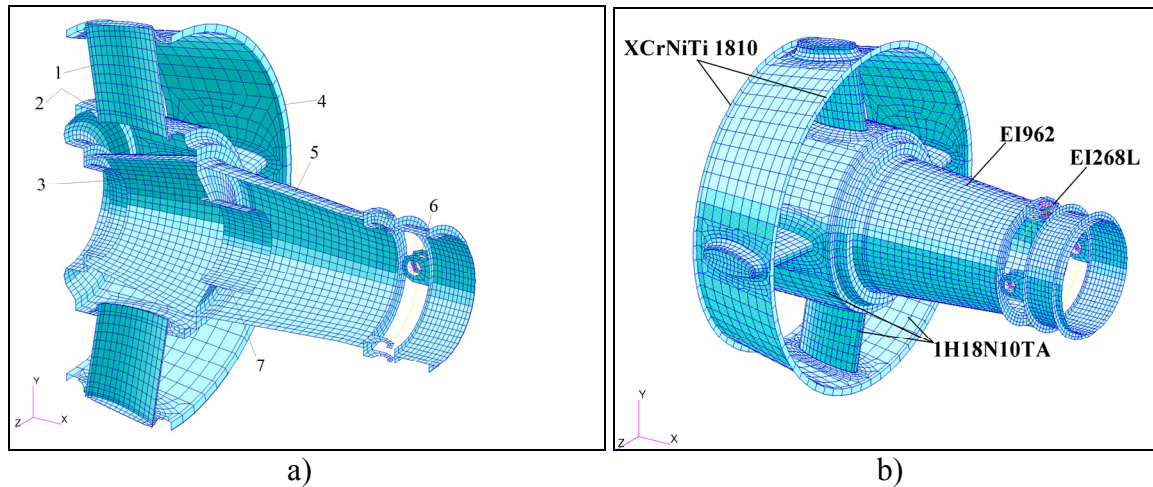
**Fig. 4. Longitudinal cross-section of the turbine casing (a) and materials used in different parts of the numerical model (b).**

The turbine casing consists of following parts (Fig 4a):

1. Deflector.
2. Cylindrical casing.
3. Inner conical casing.
4. Flange.
5. Rear conical casing.
6. Universal couple joint.
7. Bearing casing.

The turbine casing was made of four different types of alloys which are presented in Fig. 4b. In the numerical model appropriate material constants (i.e. Young modulus in function of temperature) were defined for modeling of mentioned alloys. All materials are defined as linear-elastic.

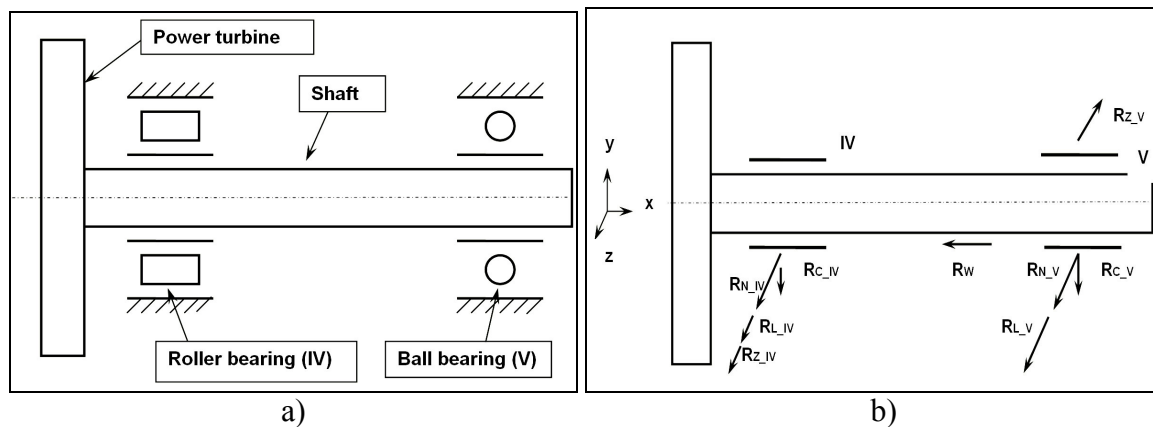
The mechanical forces were defined as a continuous load (with use of the MPC elements), imposed to the surface of model where the bearings are located. The forces transferred from shaft (presented in Tab. 1) can appear in different directions in space. These directions are related with different factors i.e. position of helicopter in space (different direction of the gravity and centrifugal acceleration vectors under aerobatics). In full report [4], four load conditions were defined to model of the few basic cases of engine work. For limit of size of this paper, results for only one load condition (Fig. 5b) are presented.

**Fig. 5. Location of the bearings inside the casing (a) and forces acting from shaft on the turbine casing for one specified load condition (b).**

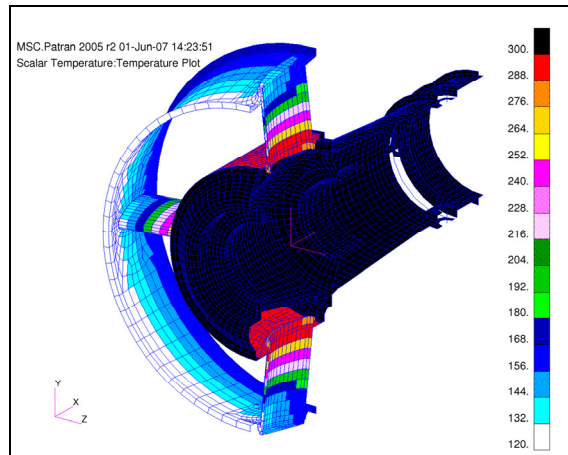
In this analysis, the thermal load was also considered. The temperature field was defined as a two parametric function in the cylindrical coordinates. The temperature values, obtained from technical project of engine are presented in Tab. 2 and Fig. 6.

Fig. 6. Temperature field defined for the numerical model of the casing (Celsius scale).
