Michał BEMBENEK*, Janusz KRAWCZYK**, Krzysztof ZAGÓRSKI***,
Jan PAWLIK****

ON THE WEAR MECHANISM OF HIGH-CHROMIUM GYRATORY CRUSHER MANTLE LINING IN TERMS OF THE ASSESSMENT OF THE USED MATERIAL

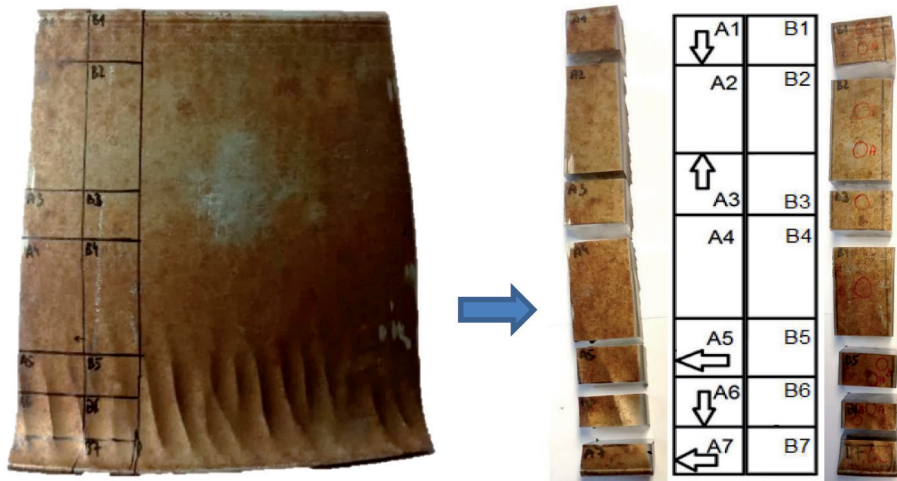
The smaller chunk was diced on a water-abrasive cutter into further pieces, prepared for a series of tests. **Figure 3** depicts the initial cut-out with rectangular zones described with a black marker, indicating the particular test destination. The inspection contained the following steps:

Fig. 3. Picture of the inspected gyratory crusher mantle cut-out. The black grid represents markers for further sample preparation

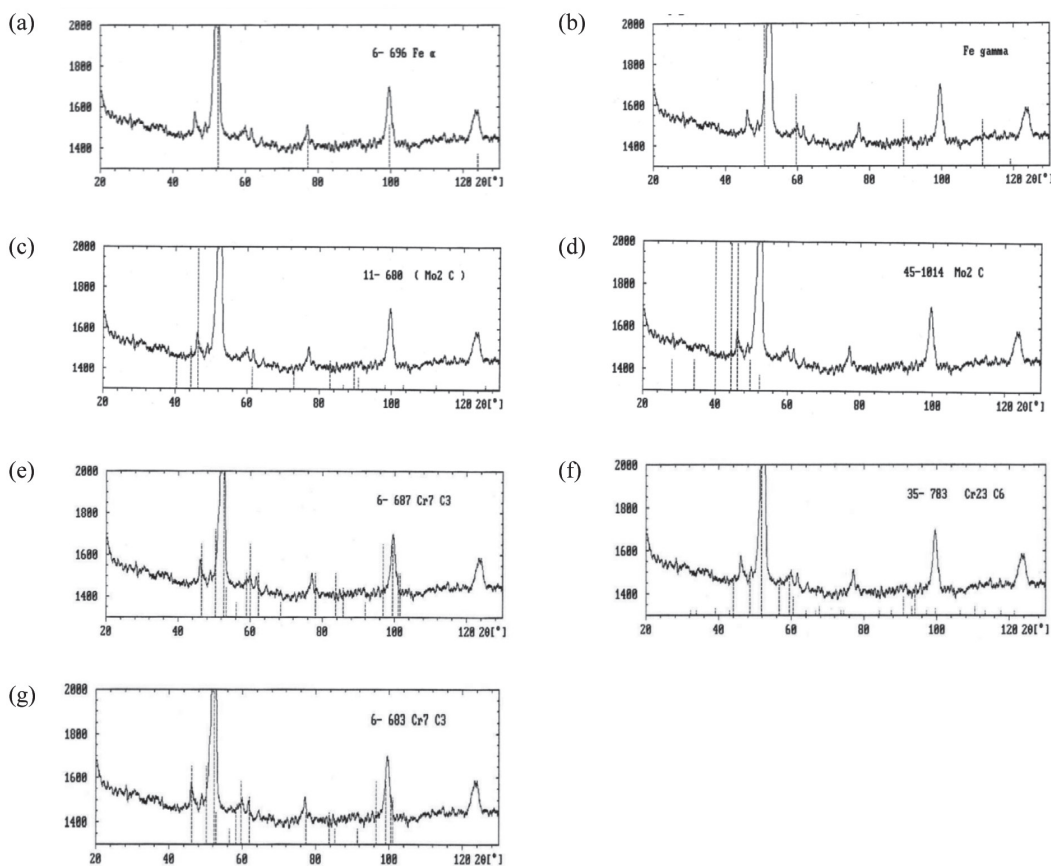
The phase composition of the studied part was evaluated with the aid of Bruker D8 Advance diffractometer. The diffractograms were compared with the ideal element response, depicted as dashed lines in the subfigures (a)-(g) of **Figure 8**.

Fig. 8. Diffractograms of the studied material with vertical dashed lines, marking the match with certain phases
