B. PAWŁOWSKI*, P. BAŁA*, T. TOKARSKI*, J. KRAWCZYK*

PREMATURE CRACKING OF DIES FOR ALUMINIUM ALLOY DIE-CASTING

Keywords: die failure; die-casting; hot-work tool steel; heat treatment

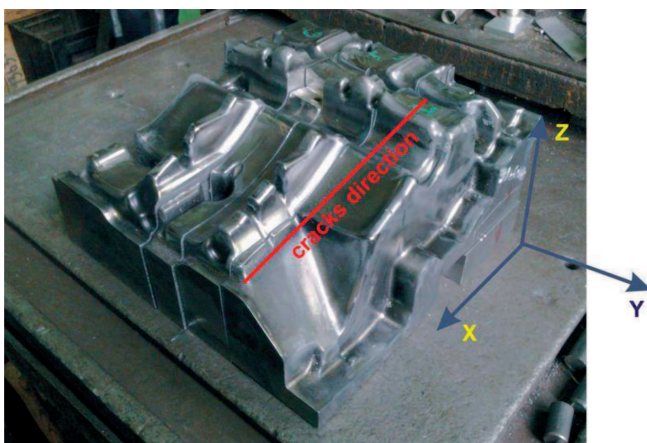
Fig. 4. Coordinate system orientation with respect to direction of surface cracks (red line)

Samples from the damaged dies were cut for metallographic, scanning electron microscope (SEM), dilatometric and fracture toughness investigations. For both dies, the samples were geometrically oriented along the three axes of the coordinate system, in which the X-axis was parallel to the direction of the cracks, as shown in Fig. 4.
