DANIEL WAŁACH\*, PIOTR DYBEŁ\*, MAREK CAŁA\*, JUSTYNA JASKOWSKA-LEMAŃSKA\*

**EVALUATION OF LOAD CAPACITY OF SHAFT COLLAR SUBJECT TO UNINTENDED  
EXCEPTIONAL LOADS****OCENA NOŚNOŚCI GŁOWICY SZYBOWEJ PODDANEJ NIEZAMIERZONYM  
OBCIĄŻENIOM WYJĄTKOWYM**

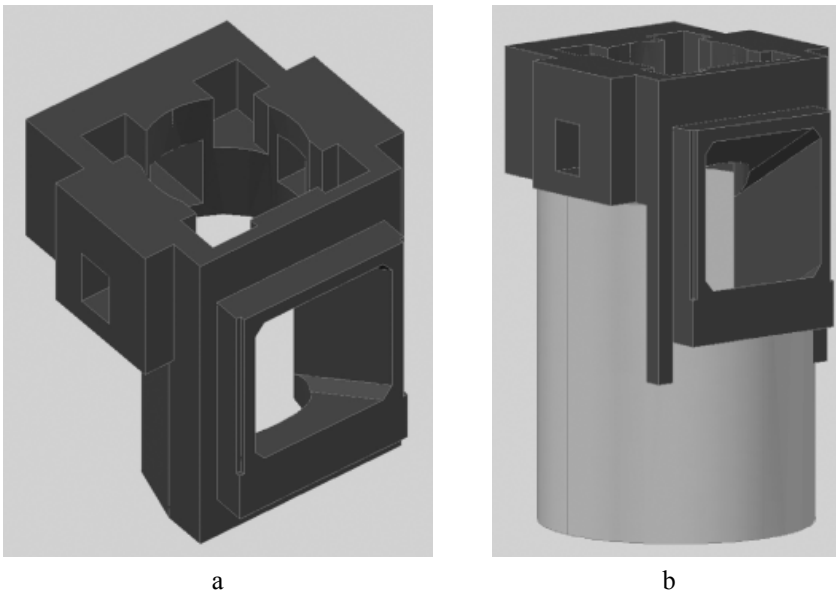
The original shape of the shaft collar was difficult to define due to the lack of appropriate documentation in this respect. Construction of the ventilation drift in its present form was carried out in the 1970s, which could have caused the necessity to ultimately upgrade the shaft collar with pipe-cable duct inlets. For this purpose, a partial demolition of the old collar was carried out, after which a new reinforced concrete construction was built, as presented in Fig. 2.2, the geometry of which is presented in Fig. 2a. The new construction of the shaft collar is based directly on the bricklaying of the shaft support structure, which in this place has a thickness of about 20 m. The method in which the collar is placed on the shaft support structure is presented in Fig. 2b.

Fig. 2. General view of the shaft collar a) Geometry of the reinforced concrete construction of the shaft collar  
b) Method of placing the shaft collar on the shaft support structure

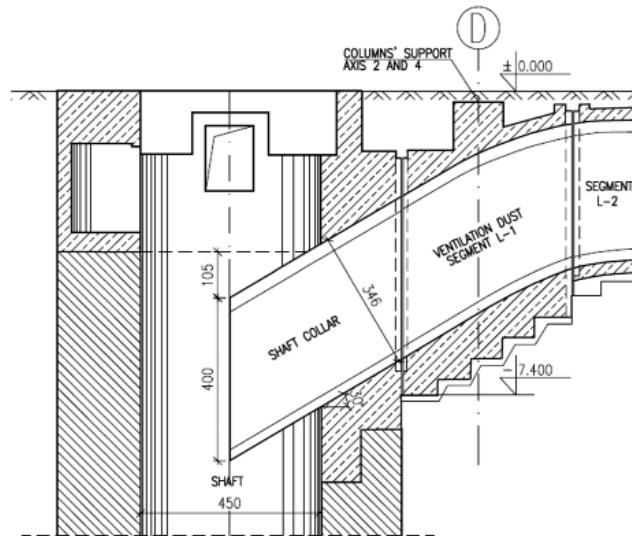
The analyzed construction consists of the shaft collar leaning directly on the shaft support structure. The shaft collar was made of a monolithic reinforced concrete element; however, the shaft has a brick structure support based on cement mortar. The ventilation duct, made of reinforced concrete segments, adjoins the shaft collar with a mutual dilatation from each other (Fig. 6). As a result of displacement of the first segment of the ventilation telescope relative to the shaft collar, it was stated that the possibility of transferring the additional load was not taken into consideration during the design stage. Due to the lack of accurate data in respect of the displacement of the ventilation drift segment and condition of the soil underneath the base plate, calculation of the most adverse case impact of the ventilation drift to the shaft collar had to be accepted. It was assumed that as a result of subsidence and rotation, the first segment of the ventilation drift would transfer horizontal loads to the shaft collar only via the face of the floor slab.

Fig. 6. Longitudinal section through the ventilation duct and shaft collar
