M. HAWRYLUK^{*#}, Z. GRONOSTAJSKI*, M. KASZUBA*, J. KRAWCZYK*,
P. WIDOMSKI*, J. ZIEMBA*, M. ZWIERZCHOWSKI*, M. JANIK^{**}

WEAR MECHANISMS ANALYSIS OF DIES USED IN THE PROCESS OF HOT FORGING A VALVE MADE OF HIGH NICKEL STEEL

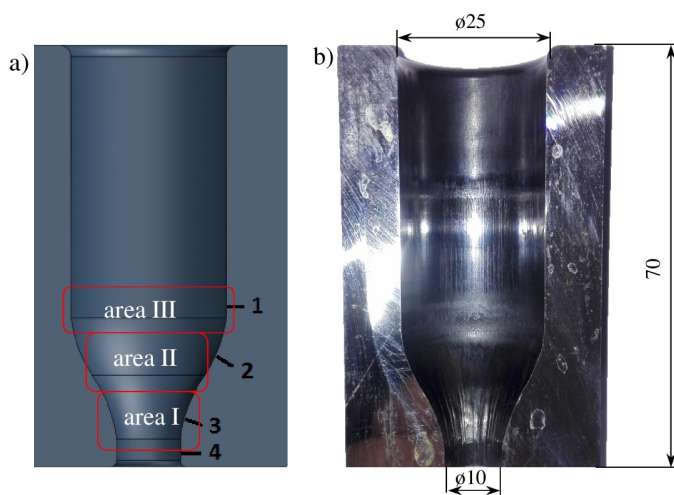
A detailed analysis was performed on dies used in I operation of hot forward extrusion of a long shank tipped with a preliminarily formed element called ‘bulb’. Fig. 2a shows a CAD model together with the distribution of the areas (measure points) of the surface of the tool section, for a better understanding and analysis of the obtained test results. Fig. 2b, in turn, presents an image of one half of a worn die.

Fig. 2. View of the tool section: a) CAD model with marked selected measurement areas, including the microhardness test points, b) exemplary image of a die's half with main dimensions in mm
