Renovation works in buildings in the area of former defensive fortifications

Abstract

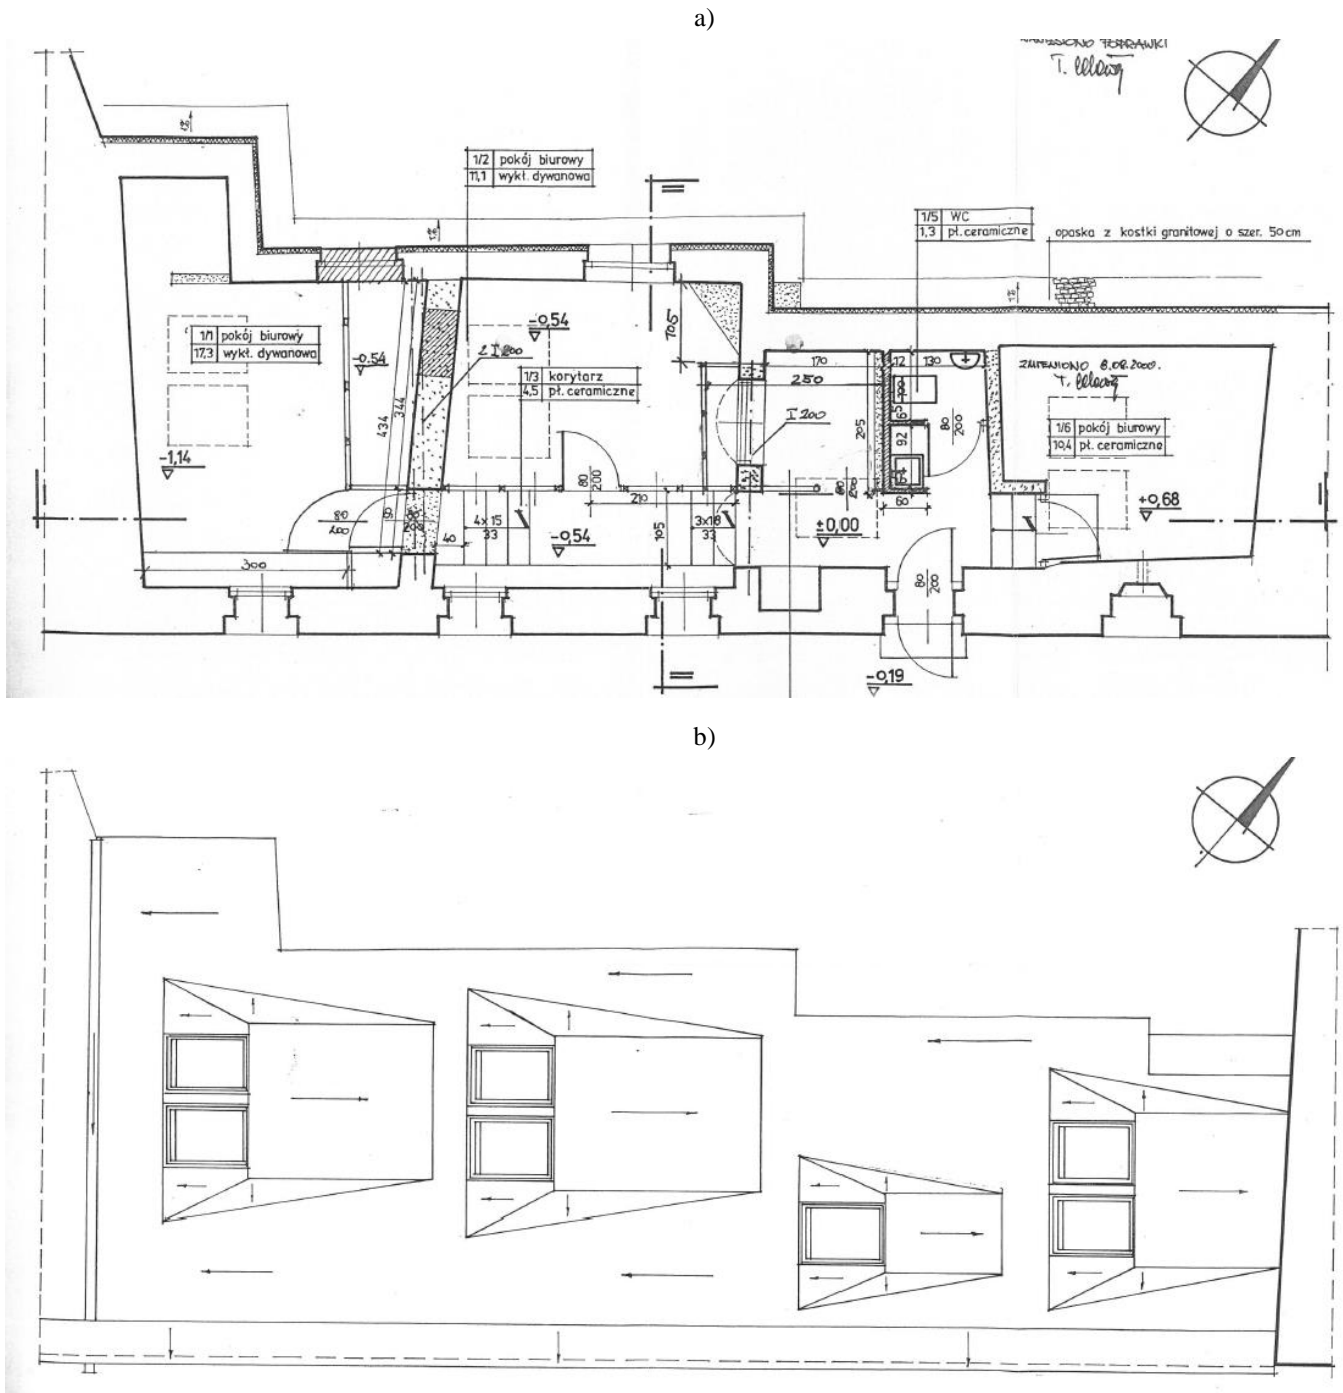
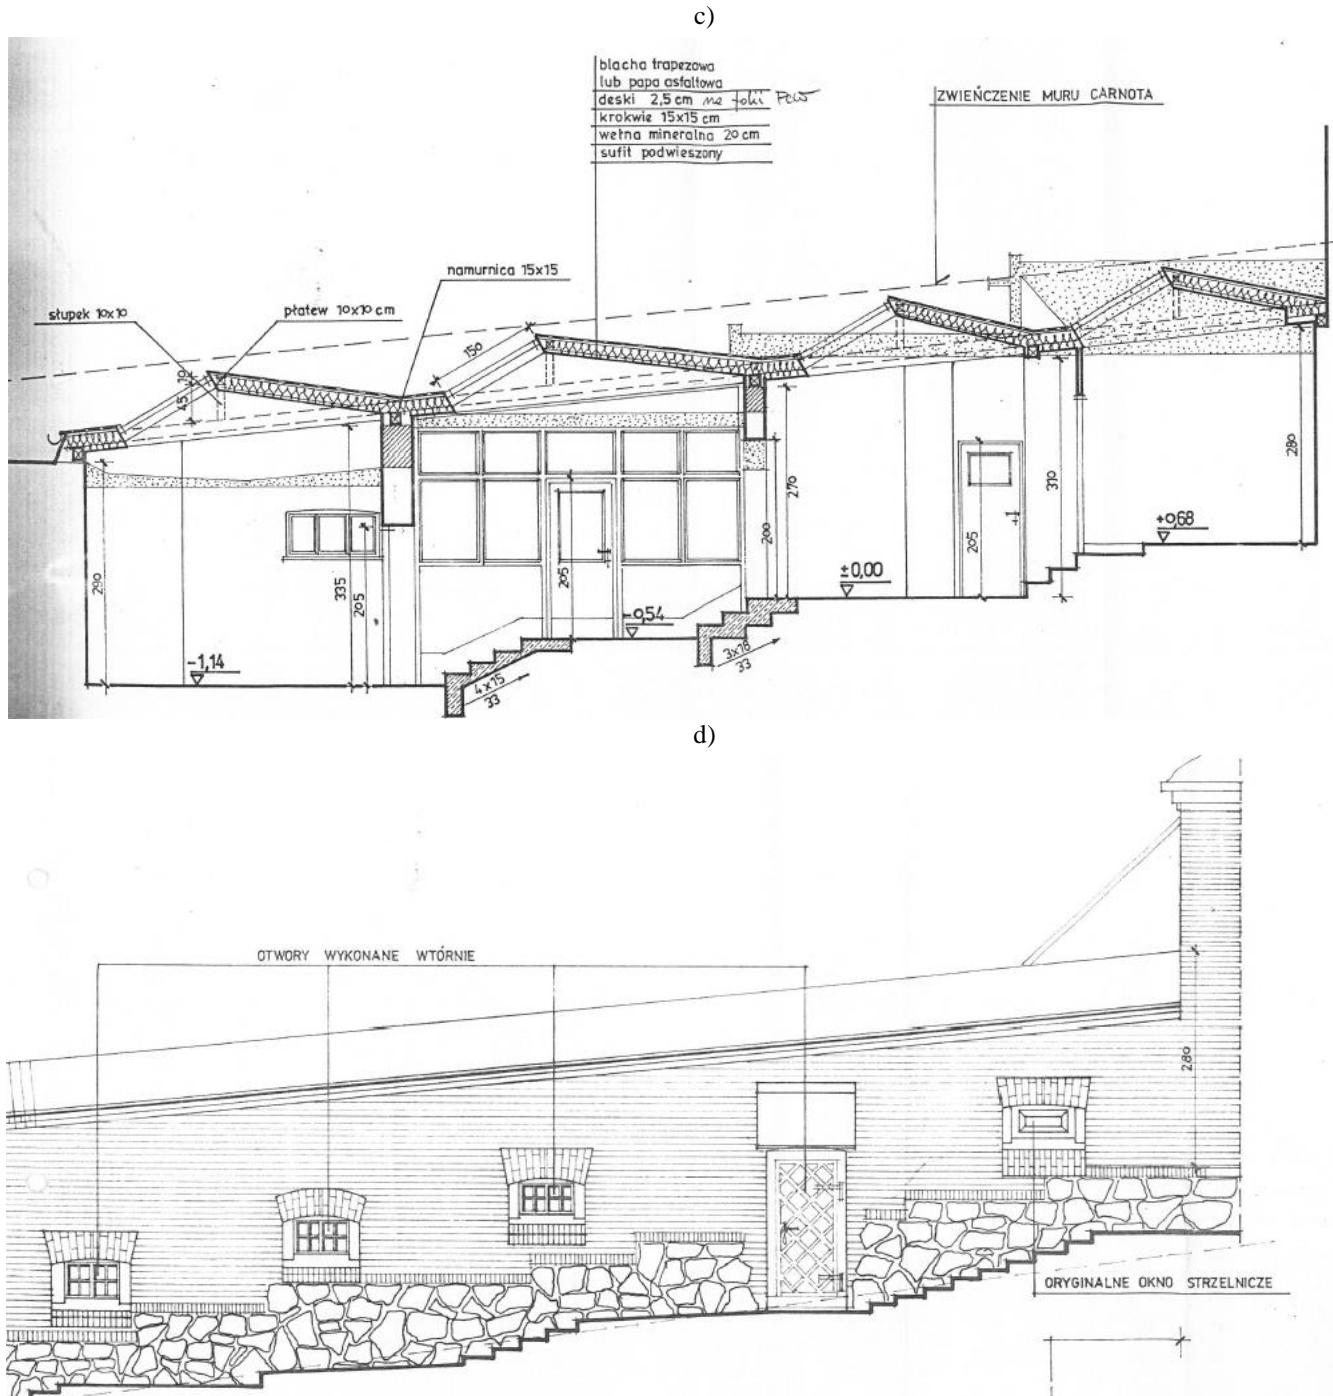
The shape of the roof in the area of part (A) of the Building Complex did not correspond to the state adopted as a solution in the archival design documentation. Probably for cost-saving reasons (optimizing costs and looking for a solution that would be easier and faster to implement), the execution of chalk roofs along the slope of the land was abandoned, and the entire roof slope was made as a single-pitch roof with skylights (Fig. 3) during renovation works.

Fig. 3: Part A of the Complex of Buildings located at the South Guardhouse of the Napoleonic Redita in Gdańsk, in accordance with the solutions included in the design documentation: a) ground floor plan, b) roof plan plan, c) longitudinal section, d) south-eastern (front) elevation (fragment)

Fig. 3: Part A of the Complex of Buildings located at the South Guardhouse of the Napoleonic Redita in Gdańsk, in accordance with the solutions included in the design documentation: a) ground floor plan, b) roof plane plan, c) longitudinal section, d) south-eastern (front) elevation (fragment)
