OPERATIONAL TESTS OF THE TECHNICAL CONDITION OF TRUCK TIRES

Piotr Cieślak, Daniel Pieniak, Leszek Gil, Artur Dmowski, Andrzej Niewczas

Cieślak P., Pieniak D., Gil L., Dmowski A., Niewczas A., Operational tests of the technical condition of truck tires. *Motor Transport* 66 (2), 17-34

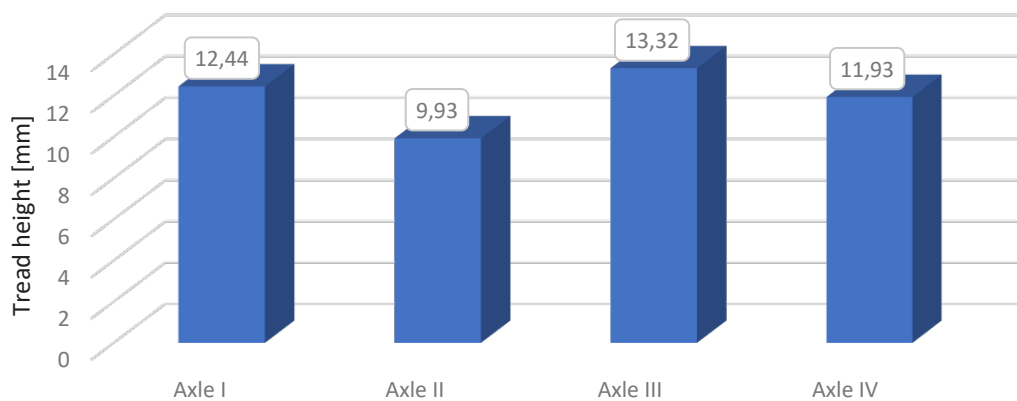
Fig. 7. Average tread height of individual axles of a given group of vehicles

A summary of the average values of the tread height in the groups arranged according to the axle numbers of the vehicles in test I is shown in Figure 7. The results of the calculations show that in the sample of category I vehicles, the highest tread wear was found on the second steering

axle. The average tire tread height was 9.93mm. Significant tread wear was also found on the fourth axle, where the tread height was 11.93mm.

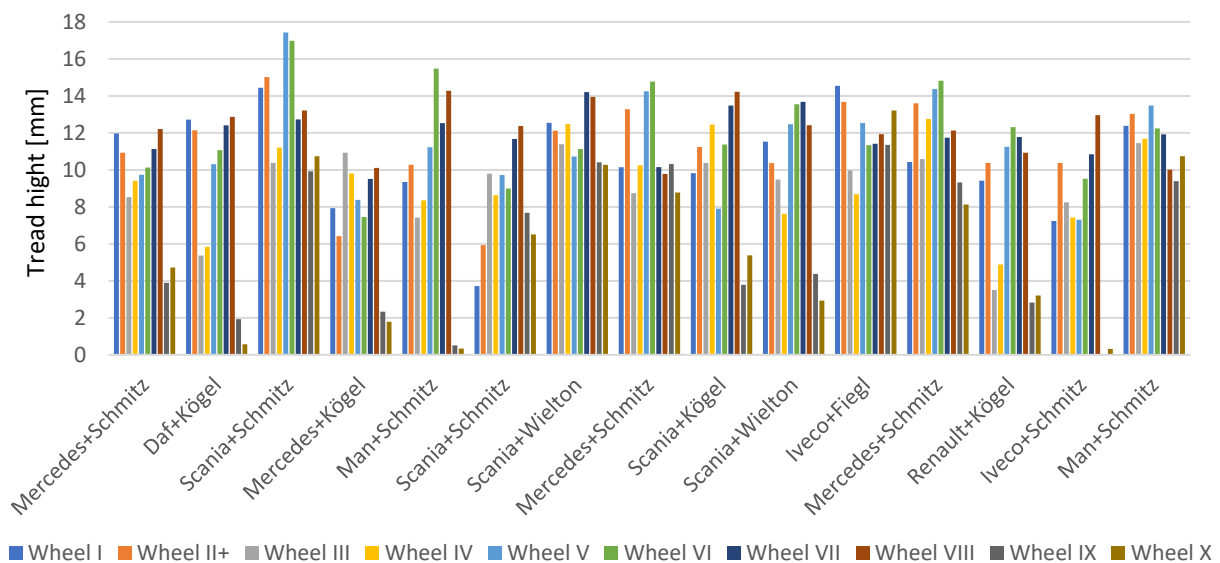
Fig. 10. Comparison of tread height in a sample of category II vehicles

Analysing the measurement results in Table. 4 and Figure 10, it should be stated that the vehicle No. 3 on the third axle of the left wheel had

the highest tread height, 17.43mm. The lowest tread height was found on the fifth axle of the left wheel of vehicle No. 14, 0.00 mm. The carcass of the tire was visible.

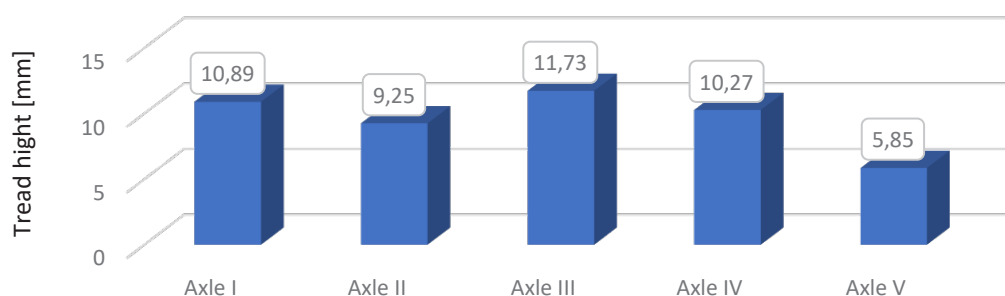
Fig. 11. The average height of the tread with a division into the axles of vehicles in a sample of category II

The results of the measurements in test II were grouped according to the axle numbers of the tested vehicle sets (5 axles). The average values of the tread height in each group were calculated. The results of the calculations are shown in Figure 11. The greatest tire wear was found on

the fifth axle of the set, i.e. the third axle of the semi-trailer (tread height 5.85 mm). Increased tire wear was also noted on the second axle of the set, i.e. the drive axle of the tractor (tread height 9.25 mm).

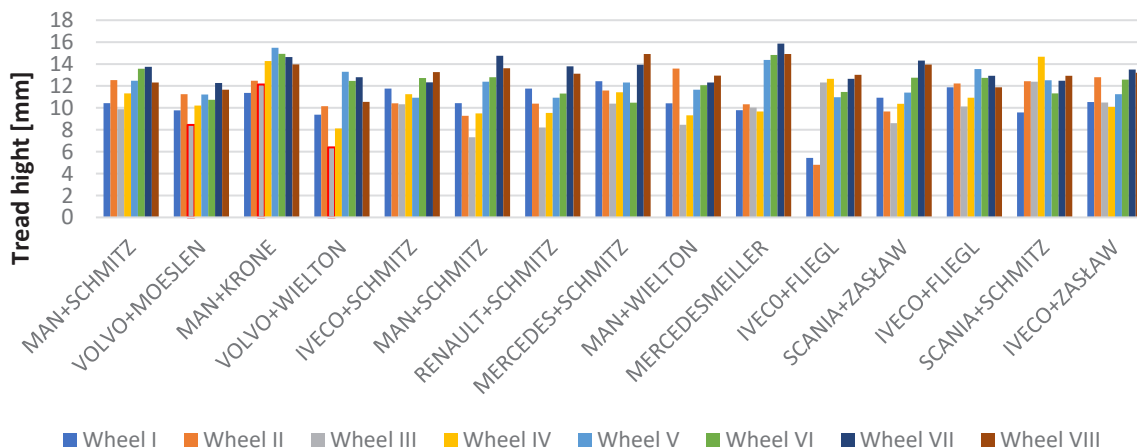
Fig. 14. Comparison of tire tread height in a sample of category III vehicles

Analysing the measurement results presented in Table. 6 and Figure 14, it should be noted that the greatest height of the tread had vehicle no. 10 on the fourth vehicle axle of the left wheel, 15.87 mm. The lowest value of the tread height, 4.80 mm, was found on the first axle of the right wheel in vehicle no. 11. From the data presented in Figure 15, it can be shown that the greatest wear occurs on the second axle of the car in the set. This is the drive axle. The difference in the tread height of the first axle to the second axle is 0.36 mm. In truck trailers, out of the two axles,

the greatest wear occurs on the first axle, which is the steering axle of the vehicle. The difference with the second axle is 0.89 mm.

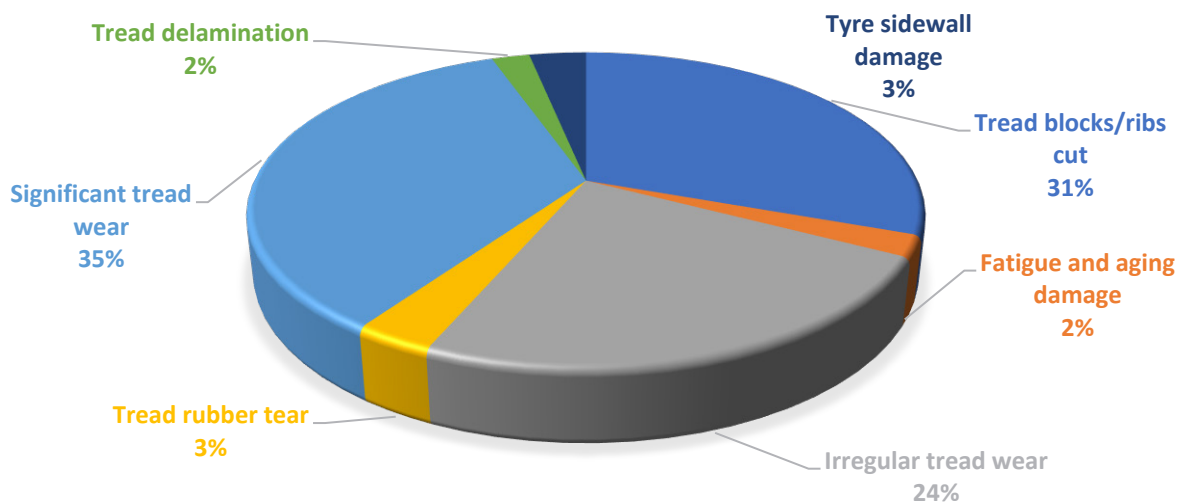
Fig. 25. Breakdown of tire damage types

The most common tire damage (Figure 25) was excessive tread wear – 35% of all damages. The highest damageability of this type occurred in

the second category of vehicles $F_u (II,6) = 15.3\%$, due to long-distance routes of vehicles with heavy loads. The second most frequent type of damage was cutting a block or tread rib (No. 1) – 28 cases, i.e. 30% of total damages. The third most common was uneven tire tread wear (No. 7). This damage occurred in 22 tires, i.e. 24% of the total number. It was probably caused by incorrect tire pressure or bad suspension geometry. The share of each of the other types of damage did not exceed 3% of the total number of damaged tires.

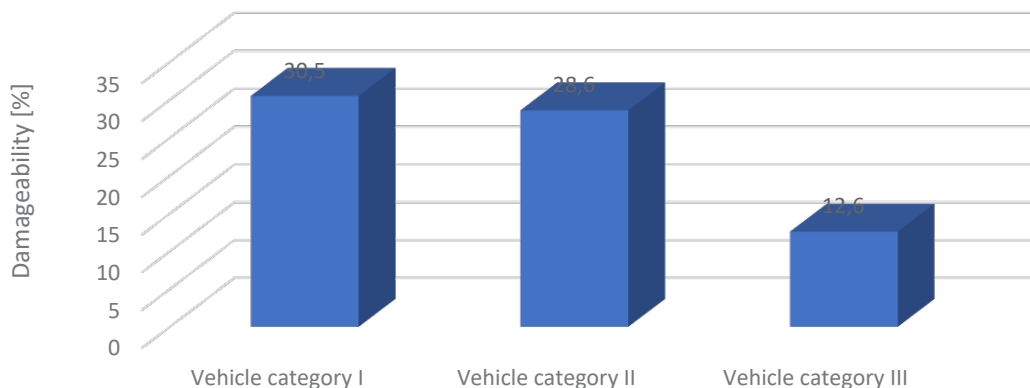
Fig. 26. Diagram of tire damageability for individual vehicle categories

Figure 26 shows the damageability (failure rate) of tires in particular groups of vehicles covered by the tests. The highest failure rate $F_u = 30.5\%$ was recorded in the group of the first category in the sample of cars with an integrated body. The second group of vehicles was ranked second in

terms of damageability $F_u = 28.6\%$. In the third group of vehicles, which included a set of a truck with a trailer, a significantly lower failure rate $F_u = 12.6\%$ was registered.
