The influence of mining activities on the Church of St. Cross in Bytom–Miechowice

Tomasz Lipecki^{1*}, Hanna Ligarska¹ and Małgorzata Zawadzka¹

Abstract

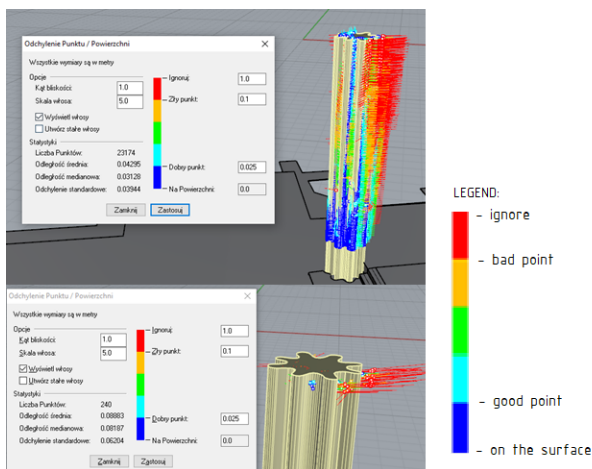
Figure 10. Declination of set points from model – pillar 1

Rhinoceros software allows to determine the limit distance vectors of a given point from the reference model. For tested pillars, the value for the so-called the “good” point was taken 2.5 cm, and for the so-called “wrong” 10 cm. As a result of the analysis, three values are obtained: mean distance – the arithmetic mean of all points distances from the model, median distance – the center distance for the entire set of points and standard deviation – the distance distribution of the points from the model to the average distance. In the first place, the distance of the pillar points from the reference models (Fig. 10)

Pillar	Avg dist. [m]
1	0.043
2	0.046
3	0.040
4	0.065
5	0.058
6	0.055
7	0.052
8	0.043
9	0.042
10	0.056

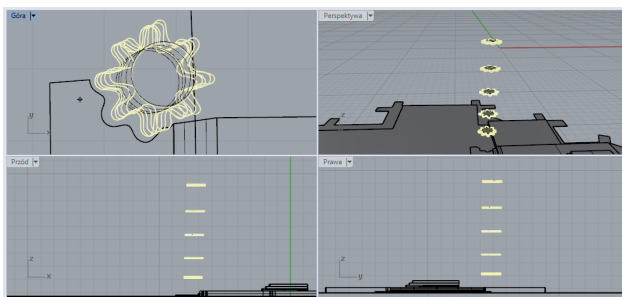
**Figure 11.** Example of modeled sections of pillars for analysis

Because the analysis described above does not speak of the segmental values of declination of the entire pillar height, a detailed analysis of each pillar was performed, by modelling 5 intersections cut-off from the cloud point and reading the fit in each modelled profile of the circles (Fig. 11). Due to this analysis, the values, directions and indirect distortion of each pillar declinations were received (Fig. 12) The maximum declination of the pillars now stands at 29.0 ‰ (Tab. 3). Before the coal exploitation in 2014 it was 25.6 ‰ (Słowik et al., 2015) which

means that as a result of the exploitation, the condition of the church's structural components continues to deteriorate.
