Multifaceted diagnostic inference process for identifying the causes of self-ignition engine faults resulting from PM sediments

Key words: VGT turbocharger, PM particulates, diagnostic tester, spectral analysis, error codes

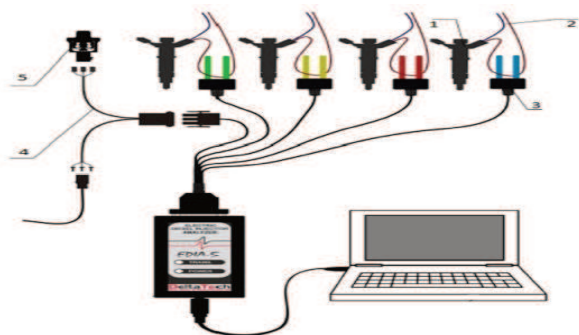
An EDIA-5 analyzer (Fig. 5) which allows for the registration of injection control signals was used to investigate the causes of the fault. [11]. It is possible to view the control current characteristics for the four injectors with the reference of these values to the high pressure fuel sensor signal on the fuel rail (Fig. 6). The measurement allows the analysis of signal timing, amplitude and high pressure rise. Profound observation and interpretation of the injection timing characteristics and the pressure drop allows for the quick fault diagnosis.

The recorded characteristics show the high pressure maintenance conditions for the 3rd cylinder injector over the extended periods of time, suggesting the possibility of "clogging the atomizer openings". In this case, one aspect is worth noting of the injector damage condition in the absence of fault indications generated by the MIL indicator [15]. Contaminated fuel and improper filtering quality lead to permanent defects of the injector's ball control valve,

Fig. 5. Connection diagram of EDIA-5 analyzer [11]. 1 – injector, 2 – injector wires or dedicated connector, 3 – measuring probe, 4 – pressure sensor connection cable 5 – pressure sensor
