# Characterization of oxide layers formed on 10CrMo9-10 steel operated for a long time in the power industry

**Abstract.** This paper presents the results of diagnostic examinations conducted on the coils of super-heaters made of 10CrMo9–10 steel that were operated in industrial conditions at 480°C for 130 thousand hours. The tube was exposed in a coal-fired boiler. The chemical and phase composition of the oxide/deposit layers formed on both sides of the tube walls (outside – flue-gas side and inside – steam side) and their sequence was examined using optical microscopy, scanning electron microscopy with electron backscatter diffraction and energy-dispersive X-ray spectroscopy, and X-ray diffraction. The changes in the mechanical properties caused by corrosion and aging processes were concluded from the hardness measurements. In addition, the nature of cracks in the oxide layers caused by pressing a Vickers indenter was determined. The results of these examinations have shown a high degradation of steel on the flue-gas inflow side and identified the main corrosion products and mechanisms.

**Key words:** power industry; 10CrMo9–10 steel; oxide layers.

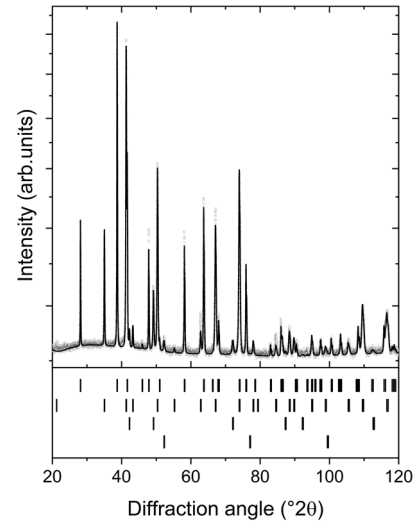
According to the XRD pattern depicted in Fig. 2, the inner side of the pipe contains  $\text{Fe}_2\text{O}_3$  (hematite),  $\text{Fe}_3\text{O}_4$  (magnetite),  $\text{FeO}$  (wustite) and  $\alpha\text{-Fe}$  (ferrite/ $\alpha'$ -martensite). The refined lattice parameters of ferrite and iron oxides are summarized in Table 1. Assuming an increasing oxygen concentration between the core of the tube and its surface, it is expected that  $\text{Fe}_2\text{O}_3$  is located at the sample surface and followed by  $\text{Fe}_3\text{O}_4$  and  $\text{FeO}$ . As the XRD measurements were performed on the sample surface and the penetration depth of X-rays reaches approx. 10  $\mu\text{m}$  in iron oxides, the amounts of the phases located near the sample surface are overestimated in Table 1, while the amounts of the phases located deeper in the samples are underestimated. The optical micrographs of the inner surface confirmed an initial stage of the oxide layer formation (Fig. 3). The macroscopic tests performed showed that the oxide layers formed on the tested steel were discontinuous in places. Superficial damage is clearly visible over a large area of the layer surface in places of small cracks, which then take a more developed form with irregular shapes, reaching deep into the layer.

**Fig. 2.** Diffraction pattern of the inner side of the pipe (small circles) and the Rietveld fit (solid line). The bars in the bottom part of the figure mark the positions of the diffraction lines from  $\text{Fe}_2\text{O}_3$ ,  $\text{Fe}_3\text{O}_4$ ,  $\text{FeO}$  and  $\alpha\text{-Fe}$  (from the top to the bottom)

Quite small but deeper chipping of the layer can be observed. Based on the analysis of the chemical composition (SEM) and X-ray diffraction (XRD), it was shown that three zones have been distinguished in the oxides layer formed.  $\text{Fe}_2\text{O}_3$  occurs at the surface, followed by magnetite ( $\text{Fe}_3\text{O}_4$ ) and wustite ( $\text{FeO}$ ). Microscopic observations show discontinuities in the oxide layers. In the oxide layer produced on the 10CrMo9-10 steel, there are numerous defects in the form of pores and gaps, as shown in

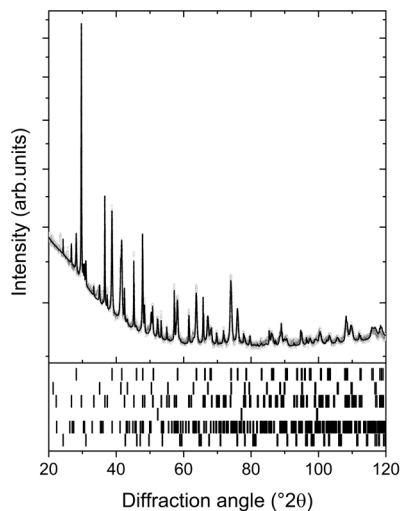
molybdenum, and manganese. In the case of columnar magnetite, other elements precipitate outside of magnetite. On the outer side of the pipe, hematite (Fe<sub>2</sub>O<sub>3</sub>), magnetite (Fe<sub>3</sub>O<sub>4</sub>) and bits of ferrite or alpha-martensite were found as well (Fig. 6 and Table 2). However, the dominant crystalline phase was calcium sulphate (CaSO<sub>4</sub>), as it covers the outer surface of the worn pipe. CaSO<sub>4</sub> is a product of the reaction of SO<sub>2</sub> emitted from the burned fuel with CaCO<sub>3</sub> (8).

Minor deposits were low quartz (SiO<sub>2</sub>) and a phase whose crystal structure is very similar to the chemical composition of sillimullite [23] that has the general chemical formula (Al, Fe, Ti, Mg)<sub>8+4x</sub>Si<sub>4-4x</sub>O<sub>20-2x</sub> with  $x = 0.02$ . The presence of these phases was substantiated by the results of the EDX analysis, which revealed 68 at. % O, 9.6 at. % Si, 7.5 at. % Al, 5.9 at. % S, 5.2 at. % Ca, 1.5 at. % Fe and 0.3 at. % Ti on the outer surface of the worn pipe. As shown by the (macro and microscopic) tests, the oxide/sediment layer on the outer side was characterized by a more attacked surface as compared to the inner side (Fig. 7). The macroscopic tests performed showed that the oxide layers formed on the tested steel were discontinuous in places. Superficial damage is clearly visible over a large area of the layer surface in places of small cracks, which then take a more developed form with irregular shapes, reaching deep into the layer, down to the steel substrate. Macroscopic observations show that the outer layer consists of deposits under which hematite occurs, as evidenced by the red-brown color of the scratch. Under this layer, iron-black magnetite is visible.

**Fig. 6.** Diffraction pattern of the outer side of the pipe (small circles) and the Rietveld fit (solid line). The bars in the bottom part of the figure mark the positions of the diffraction lines from  $\text{Fe}_2\text{O}_3$ ,  $\text{Fe}_3\text{O}_4$ ,  $\text{CaSO}_4$ ,  $\alpha\text{-Fe}$ , "sillimullite" and low quartz (from the top to the bottom)
