Dominika GRYGIER*

EVALUATION OF THE OPERATIONAL WEAR OF THE SANDVIK CV117 CENTRIFUGAL CRUSHER

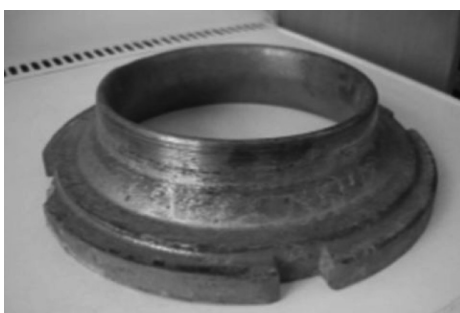
Fig. 2. Macroscopic image of the tested directional sleeve (feed inlet) of the SANDVIK CV117 centrifugal crusher

Macroscopic examinations showed that the reason for the replacement was excessive wear of the part directed towards the chamber (Figs. 7 and 8). No visible fractures or cracks in the lower edge were observed. The working surface was used in the range of 20%, and the total weight loss of the element was 22% (Table 1).

The directional sleeve should be replaced when the part facing towards the rotor chamber is worn away to a maximum height of 6mm above the top abrasion-resisting plate. This wear should be even up to the head; therefore, it is important to position the pipe correctly. It also affects the wear of the upper abrasion-resisting plates. Incorrect assembly or use may cause cracks and fractures of the bottom edge.

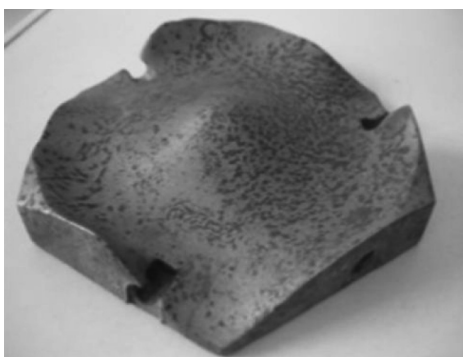
Fig. 3. Macroscopic image of the tested partition of a SANDVIK CV117 centrifugal crusher distributor

dispenser partition. In the case of the post-operational components from the mine in Grzędy, macroscopic examination showed that the reason for the replacement was wear in places corresponding to the feed inlets to the rotor (Figures 9 and 10).

The partition of the distributor from the mine in Grzędy used up evenly and was replaced accordingly with the manufacturer's recommendation (leaving

The distributor baffle wears in three areas opposite the impeller inlets. The partition is replaced when around 3–5 mm of material remains in the most-used place. Often, its premature wear is caused by oversize of the grain in feed, the dropping of the feed from the conveyor at high speed and sliding it directly onto the

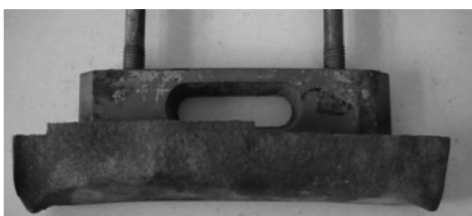
Fig. 4. Macroscopic image of the tested lining of the rotor ends in the SANDVIK CV117 centrifugal crusher

Macroscopic studies showed that the reason for the exchange was even wear of the elements in the central part and visible fractures in places of material narrowing (**Figs. 13 and 14**). The exploited surface was worn in the range of 8%, and the total weight loss of the element was 17% (**Table 4**).

The assessment of the amount of wear on the impeller tip is carried out by checking the degree of wear on the cartridges, and the tip is replaced before exceeding 95% of the consumption of the middle part of the cartridge. They are also replaced in the event of breakage, cracking, or visible wear of the insert. A signal announcing the need to replace the impeller tip is also the appearance of a large amount of mesh fraction (oversize particles) in the feed, as well as cast steel and cast iron debris.

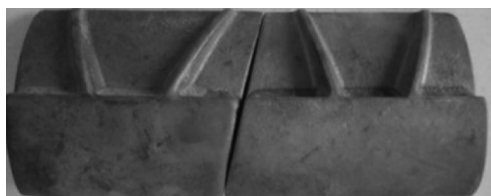
Fig. 5. Macroscopic image of the examined hammer assembly of the SANDVIK CV117 centrifugal crusher

The standard hammer assembly is replaced before their wear reaches the rotor body. They are replaced in sets, e.g., all top or bottom ones, in order to maintain proper balance of the entire rotor. Macroscopic studies have shown that the reason for the exchange was a large loss of material from a fragment of the hammer directed

to the stream space (the place of the feed outlet from the rotor). A much higher wear of the upper element is also visible compared to the lower one (**Figs. 11 and 12**). The exploited surface was worn in the range of 12%, and the total weight loss of the elements was 13% (**Table 3**).
