Michnej M, Młynarski S, Pilch R, Sikora W, Smolnik M, Drożyner P. Physical and reliability aspects of high-pressure ammonia water pipeline failures. *Eksploracja i Niezawodność – Maintenance and Reliability* 2022; 24 (4): 728–737, <http://doi.org/10.17531/ein.2022.4.13>

Physical and reliability aspects of high-pressure ammonia water pipeline failures

The object of the study is the high-pressure ammonia water pipeline of the coke oven battery complex. The pipeline is placed on sliding supports with certain movement restrictions and fixed supports. The supporting elements are brackets connected with the trestle bridge common to two other process pipelines. The entire route of the pipeline runs with a slope of 3 ‰ to 8 ‰ between successive supports. The pipeline is operated in the natural ambient conditions of the coke oven battery. The pipeline components are protected against weather conditions with a varnish coat. The ambient temperature of the pipeline is defined as being between -25°C in winter and +30°C in summer. The structure of the pipeline ensures compensation of changes in its length due to temperature changes. Length change compensators were made by local U-shaped profil

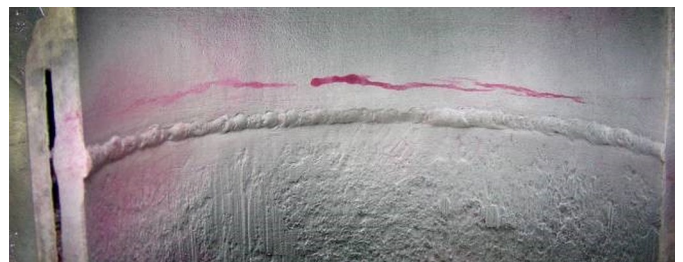
Fig. 10. Cross-sections of A1 (left) and C1 (right) welded joints

material of the pipeline in various places around the welded joints A1 and C1 are shown in Fig. 10. These cracks are located in the material outside the joint.

All the cracks in the pipeline near the joints were located in its bends and propagated from the inside of the pipeline. Where the crack reached the outer surface of the pipe, the medium penetrated the gap and the pipeline began to leak. Defects of joints visible in the cross-sections, such as shifts of the joined edges, may be of significant importance for the operation of the joint and the occurrence of the observed defects.

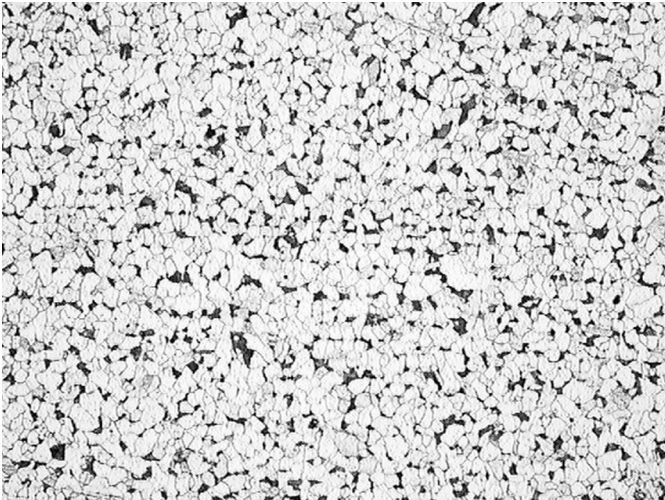
Fig. 12. Structure of the pipe material. 500x magnification, nital etching

The examination of the material structure of the pipeline elements was carried out on metallographic specimens obtained from parts of pipes and bends. The aim of the study was to identify the material from which the individual elements of the pipeline had been manufactured. The identification of the structure was necessary to further verify the causes of the failures. The structure of the pipe material is shown in Fig. 11 and 12 at magnifications of 100x and 500x. The observed structure was ferritic-pearlitic. The particles of perlite were lamellar. There were no irregularities in the examined structures in the form of inclusions or discontinuities.

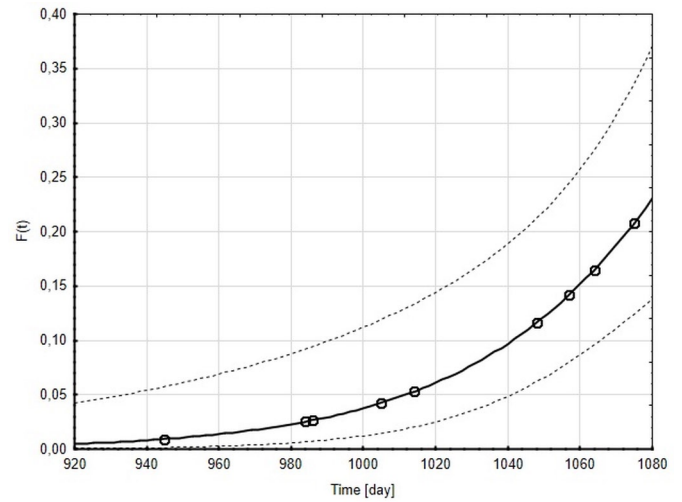
Fig. 23. Cumulative distribution function course for a single pipeline element with 95% confidence interval

The initial part of the cumulative distribution function $F(t)$ (for complete data) with the determined 95% confidence interval is presented in Fig. 23.

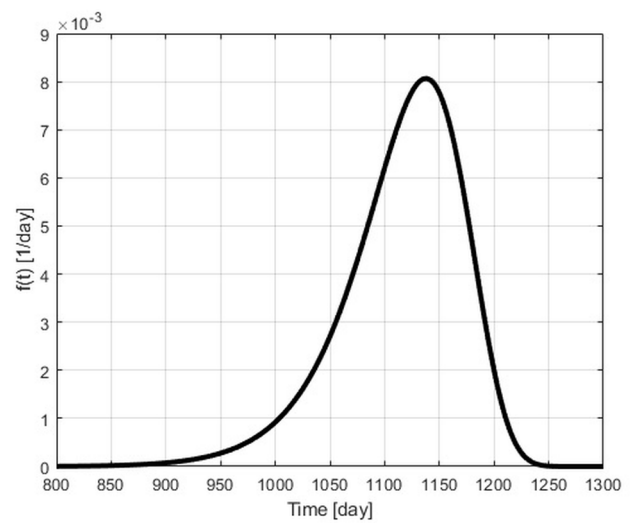
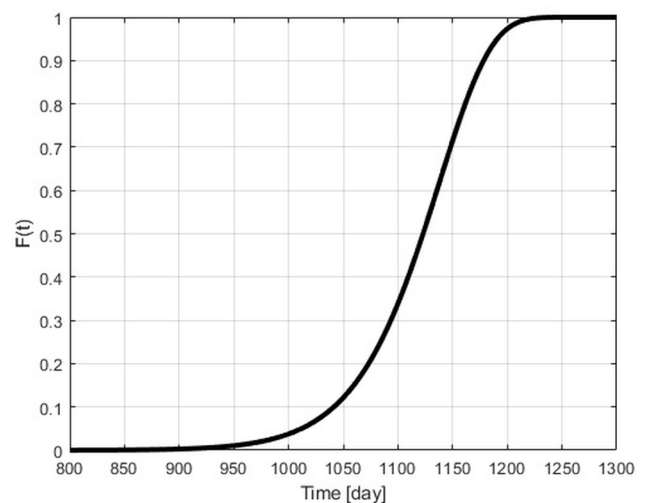
Fig. 24. Failure probability density function a) and cumulative distribution function of the operation time till failure b)

Next, for the obtained distribution, the course of the forecasted failure probability density function $f(t)$, cumulative distribution function $F(t)$ and failure rate $\lambda(t)$ were plotted over a period longer than the time adopted for the complete data (Fig. 24, 25).

The graphs show an accumulation of the failure probability density between 1000 and 1200 operation days and a rapid increase in cumulative distribution function values during this time. The determined course of the failure rate shows its characteristic feature which is the intense increase over time. From this fact it can be directly concluded that the probability of failure of each element increases significantly with each subsequent period that it survives without a failure.

The determined changes in the values of the failure stream parameter, the survival function as well as the cumulative distribution function, the failure rate and the expected value of operation time till failure amounting to 1115 [days] allow one to suggest that in order to avoid subsequent failures of the pipeline, appropriate preventive

measures should be taken with regard to all available (undamaged) elements, as the probability of failure indicated by the indexes is high and increases rapidly over time. It should be borne in mind that the assumption adopted in the reliability analysis about the crack initiation and propagation in the welded joints areas does not actually have
