Diagnosis, Repair, Strengthening and Monitoring of a Postindustrial Heritage Site: Flyover of the Odra Cement Factory

Keywords: historical structure, reinforced concrete, diagnosis, strengthening, flyover

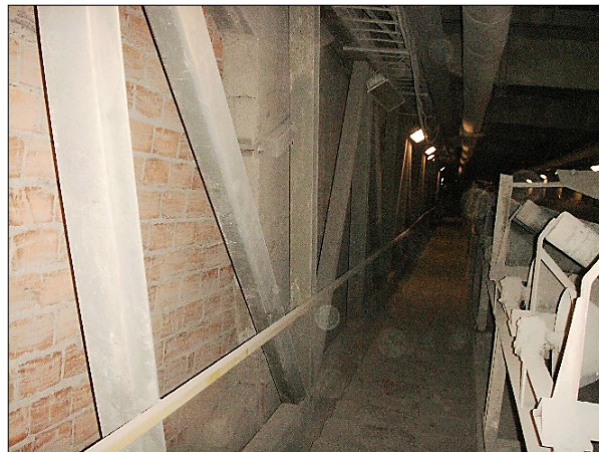
Fig. 4. Interior reinforced concrete flyover, 2008; photo by D. Bajno

was monitored, which is a spatial two-span reinforced concrete truss (Fig. 3). Inside this structure is a conveyor or belt that transports the raw material for cement production from the excavation level above one of Opole's streets, which is heavily trafficked. Its destination is the mills of the aforementioned cement factory. The building is covered by a flat roof with a slope of approximately 21° and is finished with corrugated galvanized steel sheets. As mentioned above, the flyover structure was constructed using wet technology, in the form of a three-dimensional reinforced concrete skeleton topped with a massive reinforced concrete floor, with the vertical spaces between the columns filled with solid ceramic brick, approximately 12 cm thick, at the bottom, and reinforced transverse concrete bolts, with spacing coinciding with the spacing between the longitudinal posts of the trusses. It is a two-span structure with support spacing (reinforced concrete columns) equal to 22 and 17 m. The exterior surfaces of the flyover in 2007 were covered with a layer of bound cement dust, approximately 2 cm thick.
